| US Army Corps of Engineers® | Flood Damage Red Inspec | uction Segment / S tion Report | ystem | |
| Name of Segment / System | n: ISAL / Iao Stream Flood Control Project | | | |
| Corps of Engineers Inspect | tor: Dan Meyers | | Date of Inspection: | 11/6/2008 |

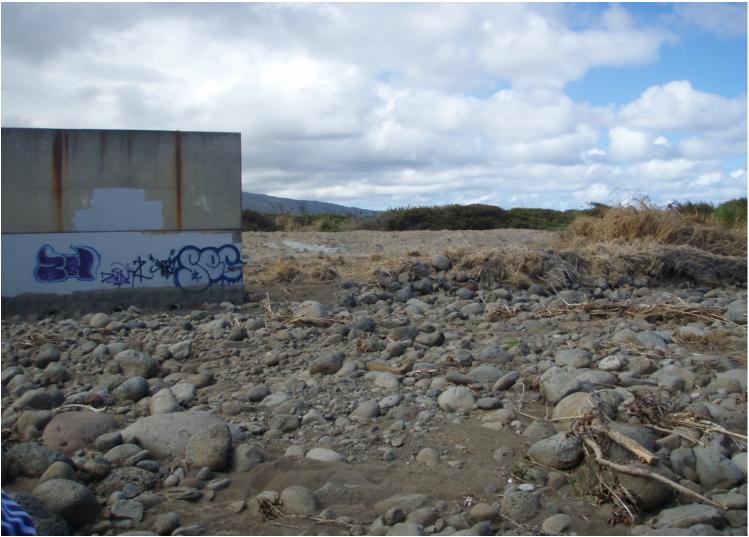
| Rated Item | Rating | | Rating Guidelines | Location/Remarks/Recommendations |
|---|---|---|---|---|
| 12. Riprap Revetments & | Α | Α | | ISAL_2009_a_0001: Riprapp in good condition: NA (A) ISAL_2009_a_0003: Riprap in good condition: NA (A) |

Inspect ID: ISAL_2009_a_0001 **Name:** Levee Embankment **Caption:** Sta. 4+70, LB Riprap in good condition, concrete surface in good shape

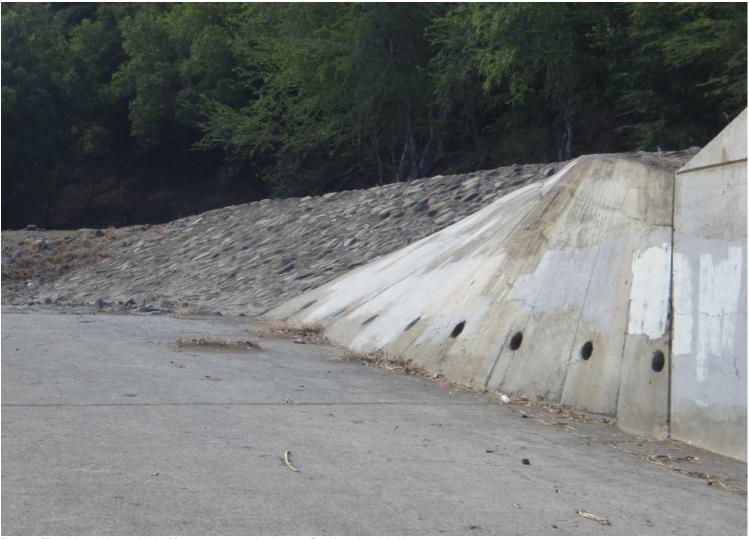
Inspect ID: ISAL_2009_a_0003 **Name:** Levee Embankment **Caption:** Sta. 22+00, LB Rippapbank protection in good condition

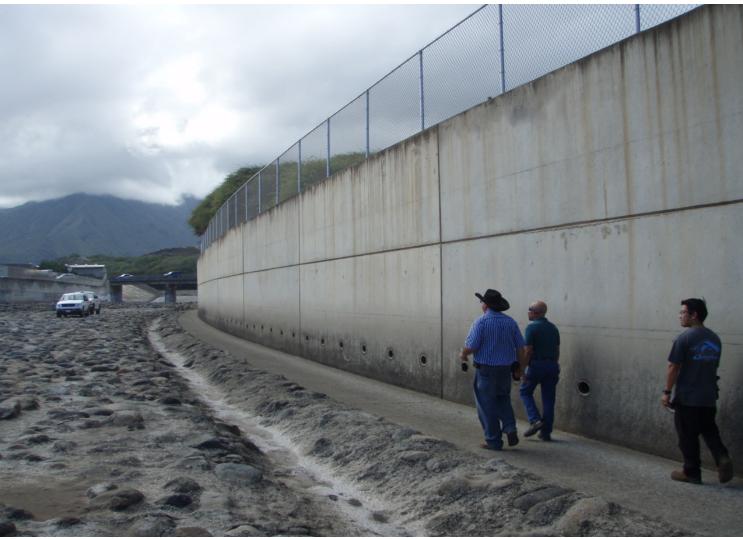
Inspect ID: ISAL_2009_a_0002 **Name:** Floodwall **Caption:** Sta. 13+70, LB Concrete floodwall in good condition, joints caulked, flapgate lubricated, fence recently replaced, weep holes clean

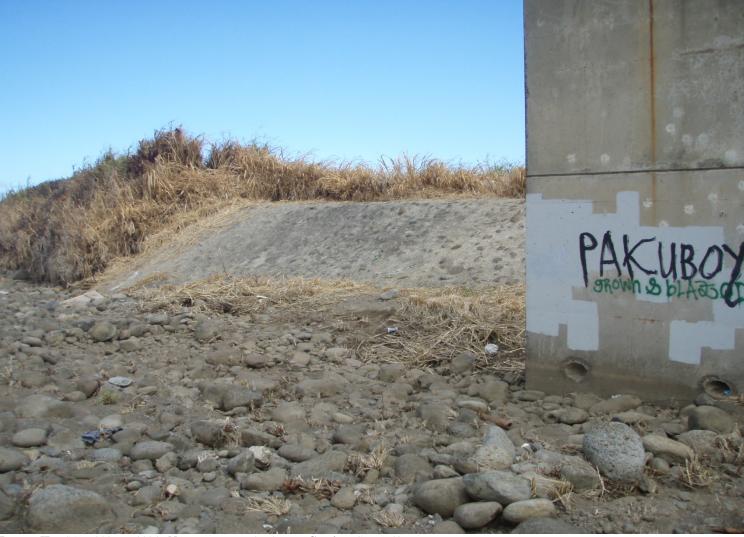
Inspect ID: ISAR_2009_a_0004 **Name:** Levee Embankment **Caption:** Sta. 5+40, RB End of flood control channel, riprap bank protection in good condition Fence in good repair

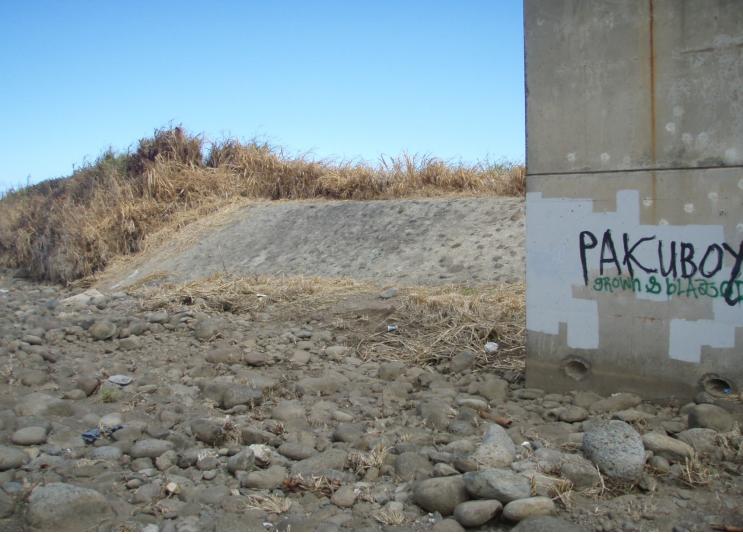
Inspect ID: ISAR_2009_a_0004 **Name:** Levee Embankment **Caption:** Sta. 5+40, RB End of flood control channel, riprap bank protection in good condition Fence in good repair

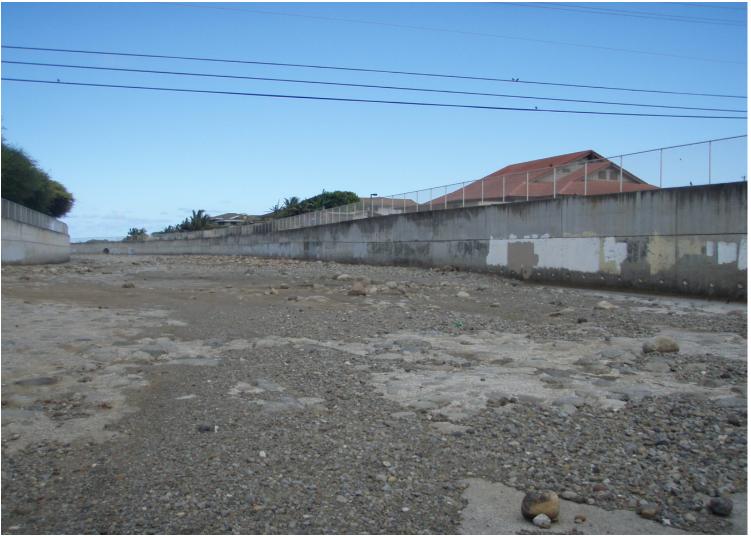
Inspect ID: ISAR_2009_a_0001 **Name:** Flood Reduction Channel **Caption:** Sta. 19+20 No major vegetation or debris in the floodway

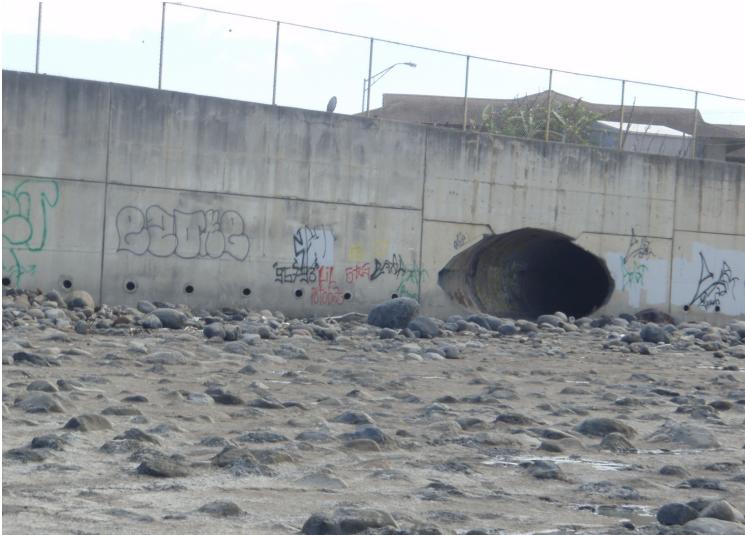
Inspect ID: ISAR_2009_a_0003 **Name:** Interior Drainage **Caption:** Sta. 6+70,RB 8 foot culvert, clear of debris and trash

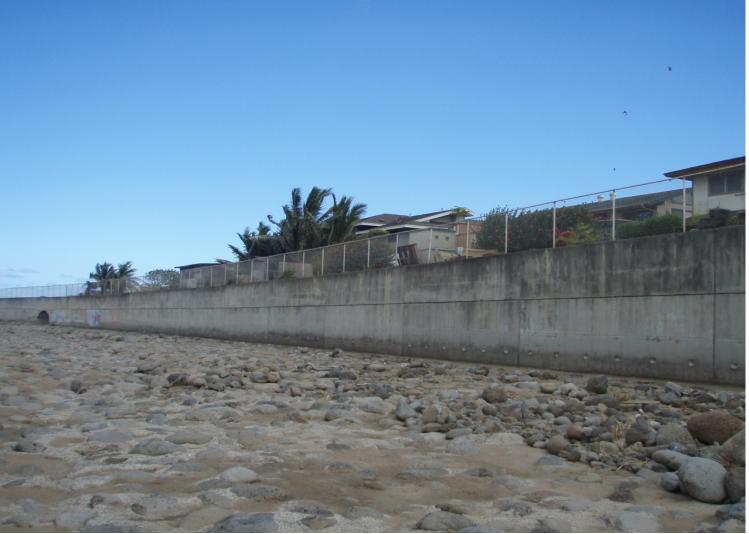
Inspect ID: ISAR_2009_a_0002 **Name:** Flood Reduction Channel **Caption:** Sta. 13+30, RB Approximately 7 properties have blocked the maintenance access way Unacceptable

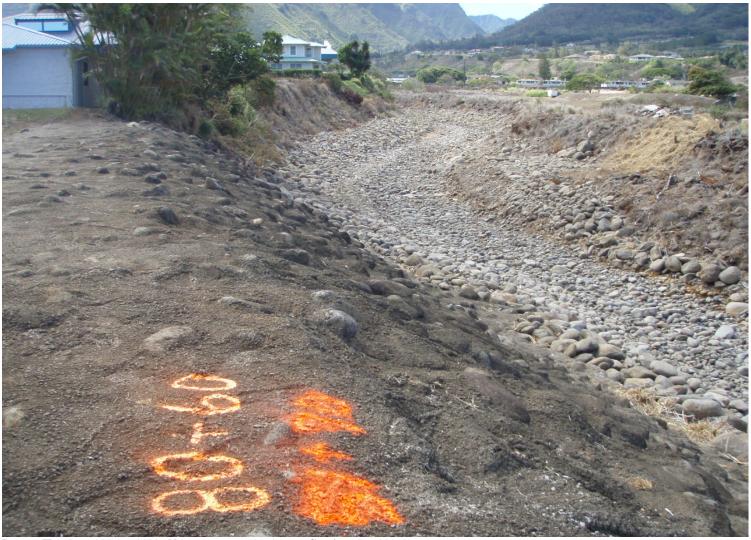
Inspect ID: ISLE_2009_a_0002 **Name:** Levee Embankment **Caption:** Sta. 80+60, (Levee E) Vegetation removed, chul cleaned

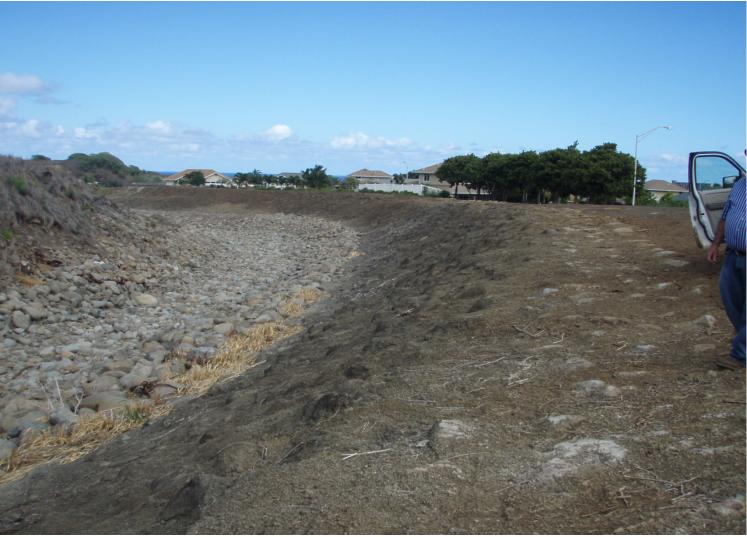
Inspect ID: ISLE_2009_a_0003 **Name:** Levee Embankment **Caption:** Sta. 67+00, (Levee D) Unwanted vegetation removed, sideslope and natural chnl being maintained

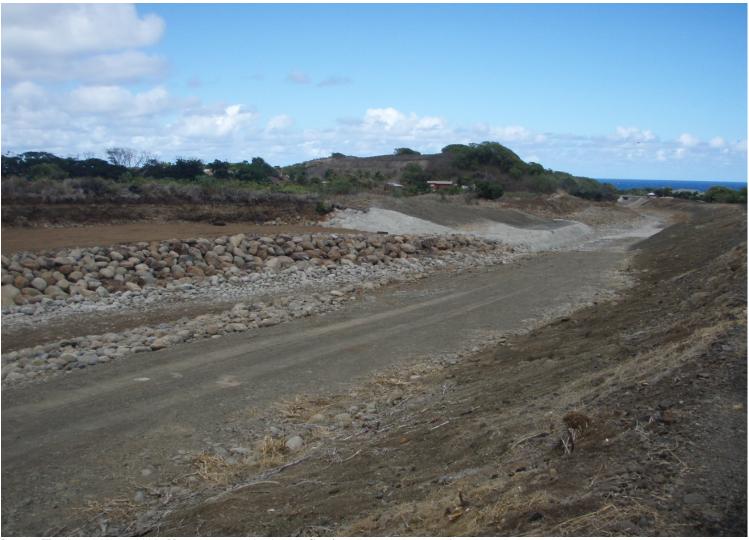
Inspect ID: ISLE_2009_a_0004 **Name:** Levee Embankment **Caption:** Sta. 51+10 (Levee C) Repairs have been made to stabalize the levee

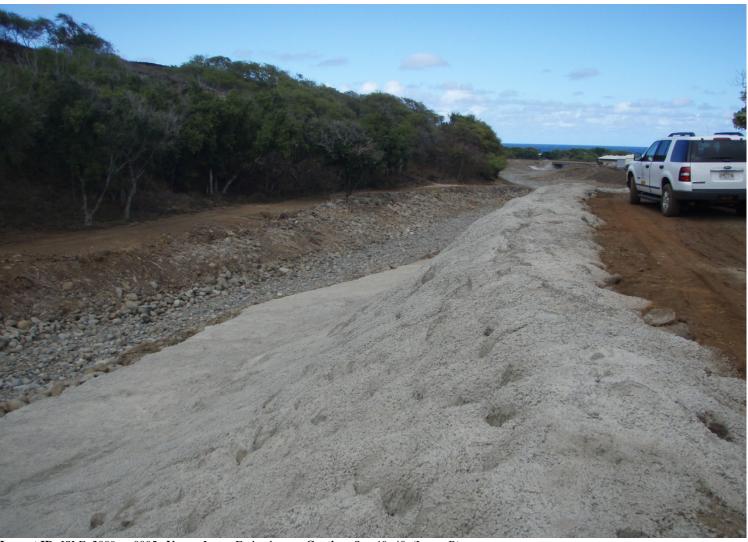
Inspect ID: ISLE_2009_a_0005 **Name:** Levee Embankment **Caption:** Sta. 40+40, (Levee B) Repair made to sideslope. Excellent work

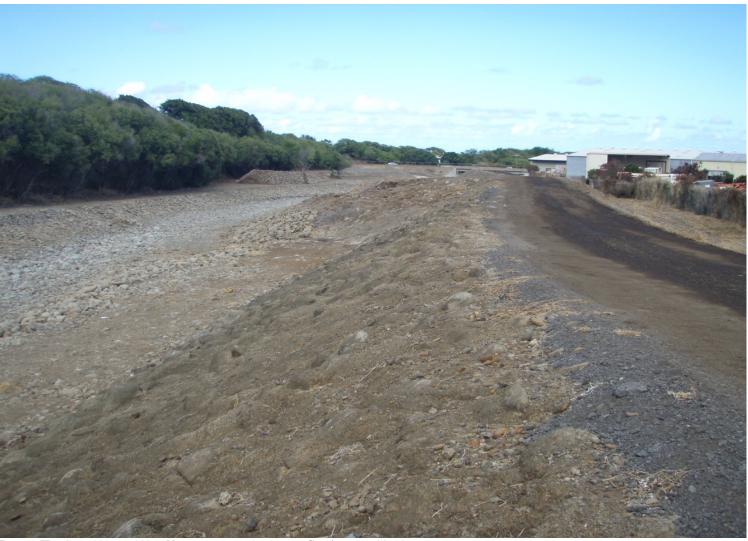
Inspect ID: ISLE_2009_a_0006 **Name:** Levee Embankment **Caption:** Sta. 33+10 (Levee A) Concete slopelining in good condition

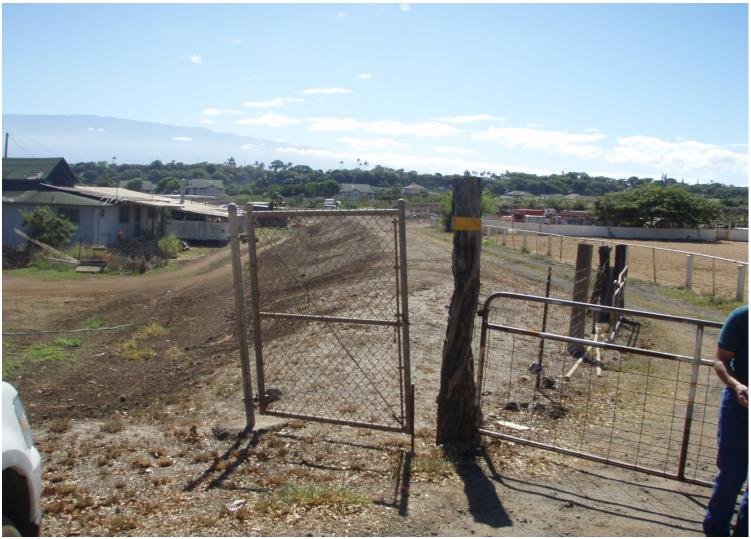
Inspect ID: ISLF_2009_a_0001 **Name:** Levee Embankment **Caption:** Sta. 51+50, LB Unwanted vegetation has been removed

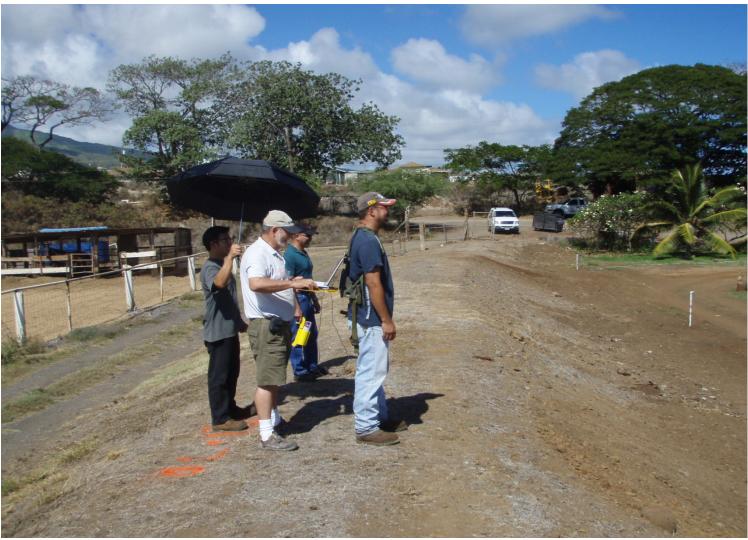
Inspect ID: ISLF_2009_a_0002 **Name:** Levee Embankment **Caption:** Sta. 51+70, LB All encroachemnts removed, steps, trees and waterline

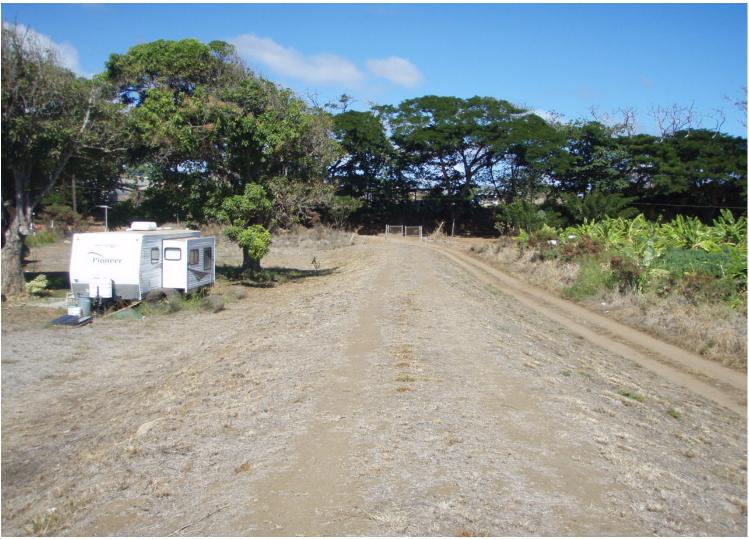
Inspect ID: ISLF_2009_a_0004 **Name:** Levee Embankment **Caption:** Sta. 51+20, LB 24 inch flapgate in good condition & lubricated Levee Crown ans Sideslopes clear of all unwanted vegetation

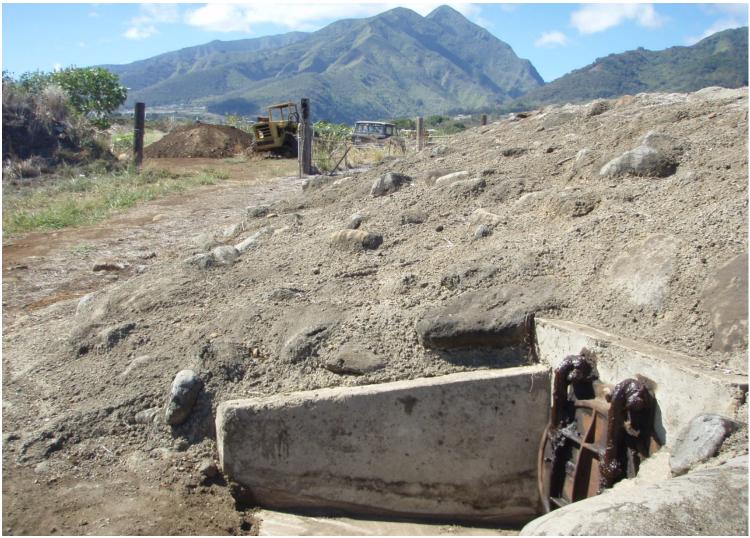
Inspect ID: ISLF_2009_a_0003 Name: Interiod Drainage Caption: Sta. 51+30, LB 24 inch flapgate in good condition and lubricated Encroachment //// Verify easement at toe of levee //// Fence

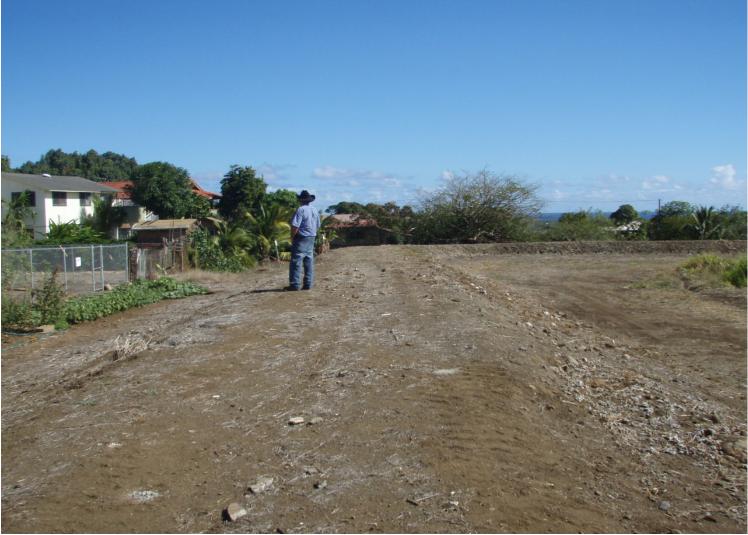
Inspect ID: ISLG_2009_a_0001 Name: Levee Embankment Caption: Sta. 89+90, LB No woody vegetation on levee Continue to maintain

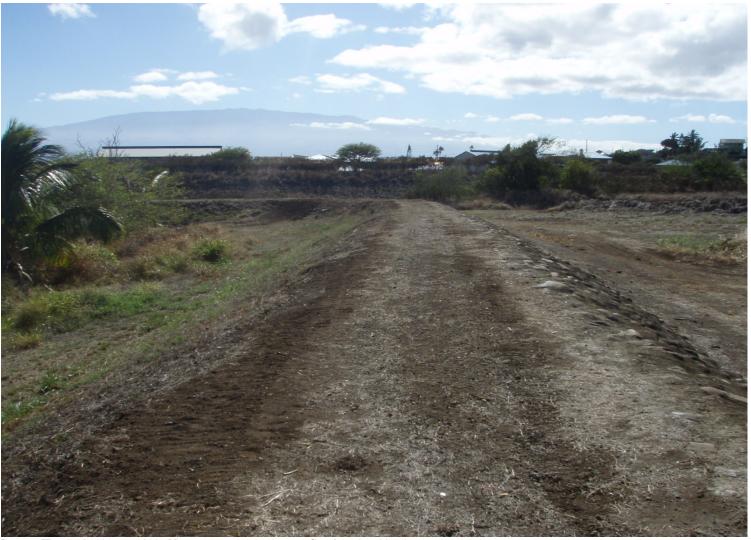
Inspect ID: ISLG_2009_a_0002 **Name:** Levee Embankment **Caption:** Sta. 88+60, LF Minimal rutting & depressions on levee crown Add material as needed to restore

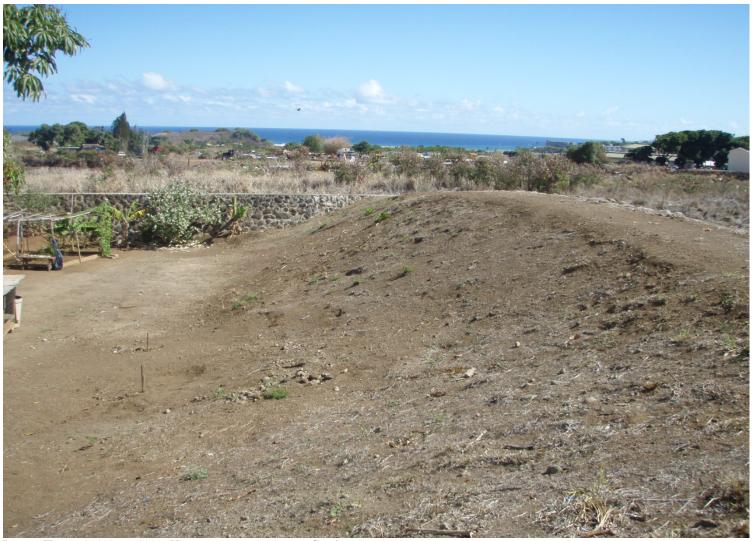
Inspect ID: ISLG_2009_a_0004 **Name:** Levee Embankment **Caption:** Sta. 87+20, LB Large trees and encroachments have been removed Good Work

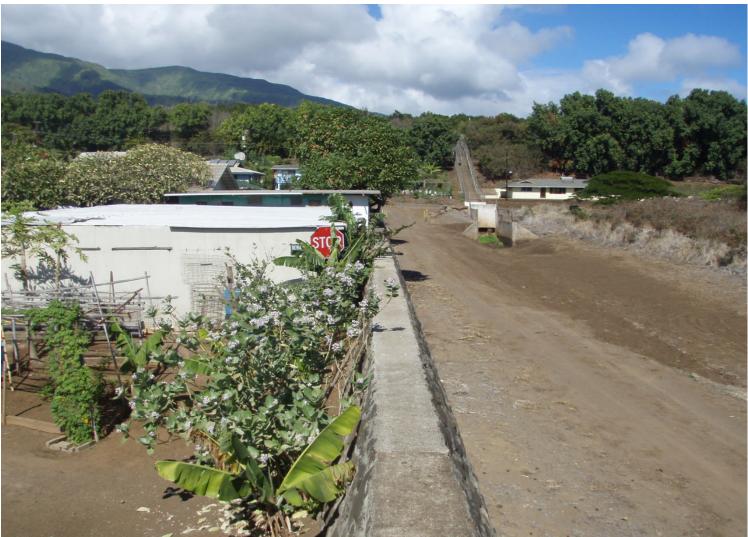
Inspect ID: ISLG_2009_a_0005 **Name:** Floodwall **Caption:** 24 inch flapgate in good condition floodwall in good contition Monitor

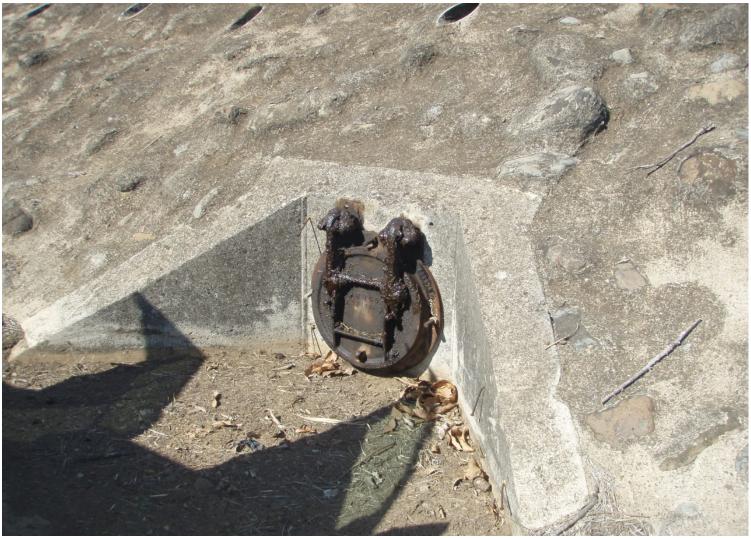
Inspect ID: ISLG_2009_a_0003 **Name:** Interior Drainage **Caption:** Sta.88+20, LB 24 inch flapgate in good condition & lubricated No debris or sediment build-up

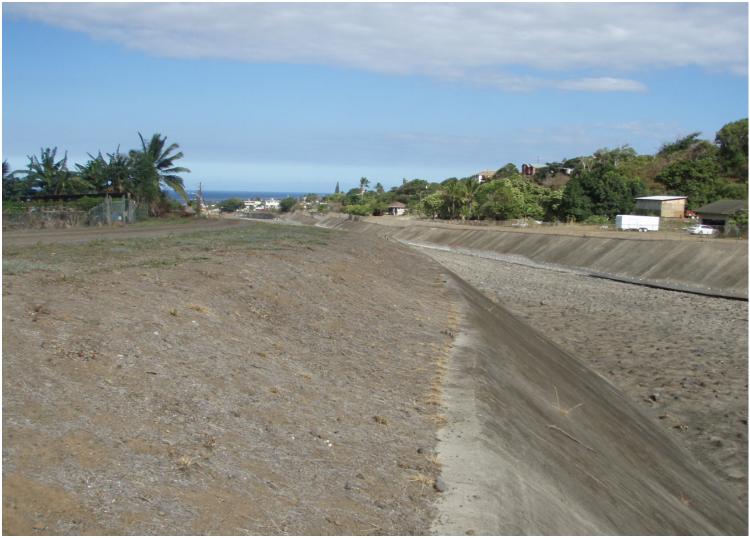
Inspect ID: ISHL_2009_a_0001 **Name:** Levee Embankment **Caption:** Sta. 125+50, LB, No vegetation on levee crown, no woody vegetation on sideslopes

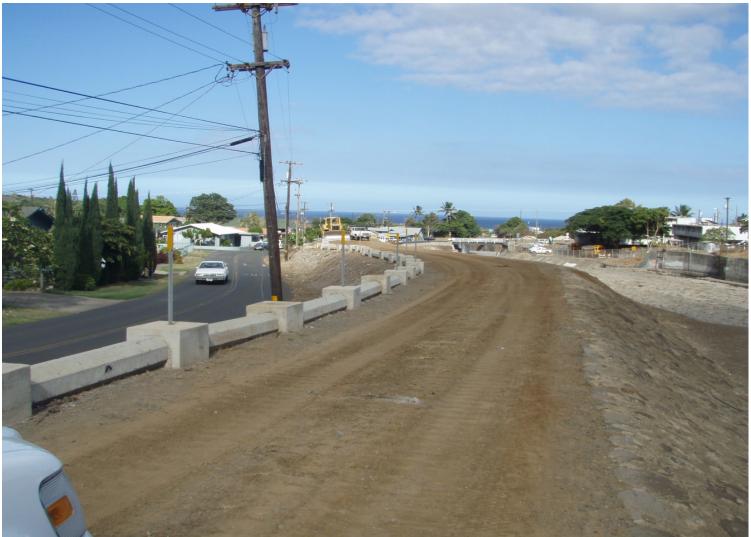
Inspect ID: ISHL_2009_a_0004 Name: Levee Embankment Caption: Sta. 109+80, LB Minor rutting on levee crown Note traffic barriers on LS of levee GREAT idea, Maintenance access in good condition

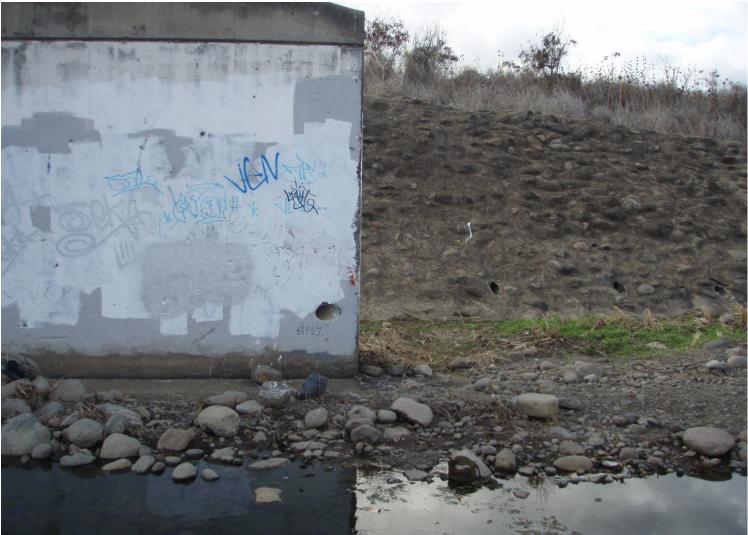
Inspect ID: ISHL_2009_a_0008 **Name:** Floodwall **Caption:** Sta. 92+40, LB Foundation ok, no scouring, low flow channel in good condition

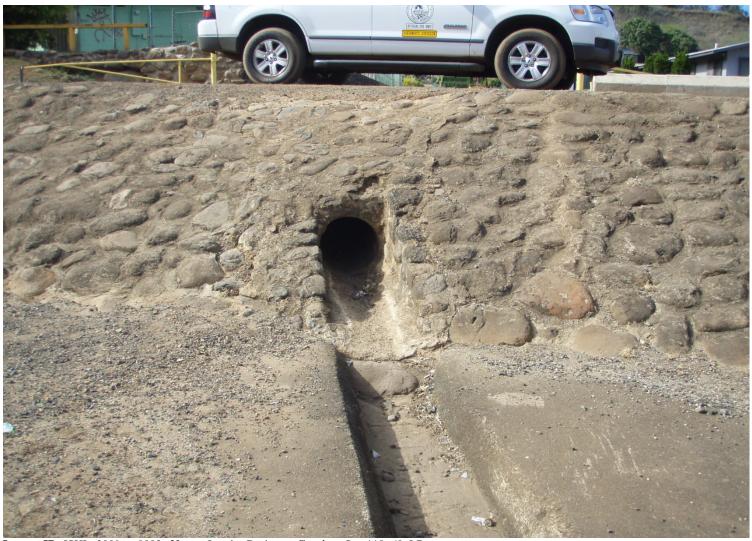
Inspect ID: ISHL_2009_a_0002 **Name:** Interior Drainage **Caption:** Sta. 118+60, LB Culvert is clear, no obstructions to flow

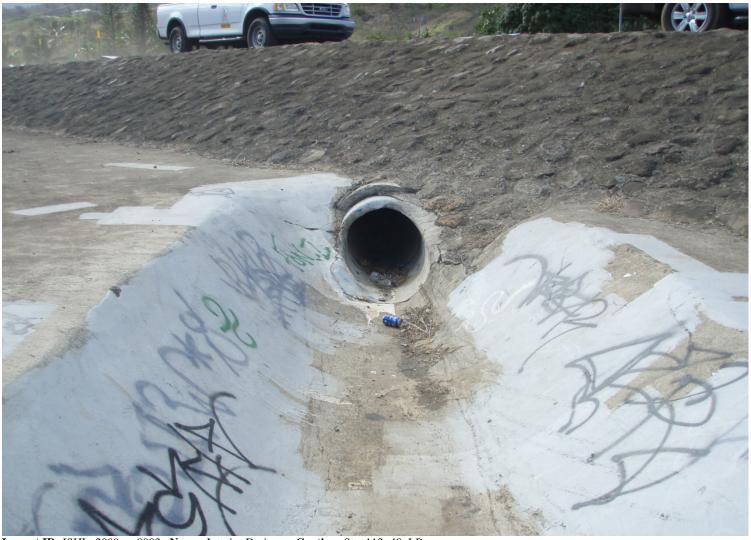
Inspect ID: ISHL_2009_a_0003 **Name:** Interior Drainage **Caption:** Sta. 113+40, LB No obstruction to concrete culvert, continue to maintain

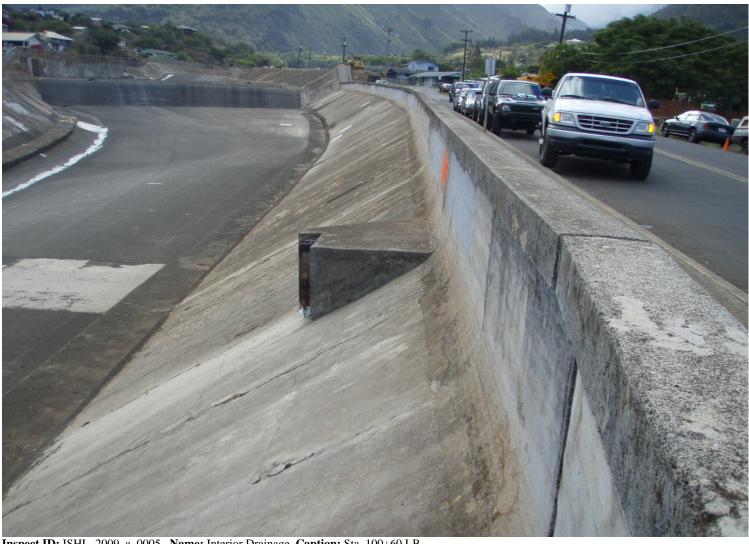
Inspect ID: ISHL_2009_a_0005 **Name:** Interior Drainage **Caption:** Sta. 100+60,LB No vegetatio no obstructions 24 inch flapgate is lubricated

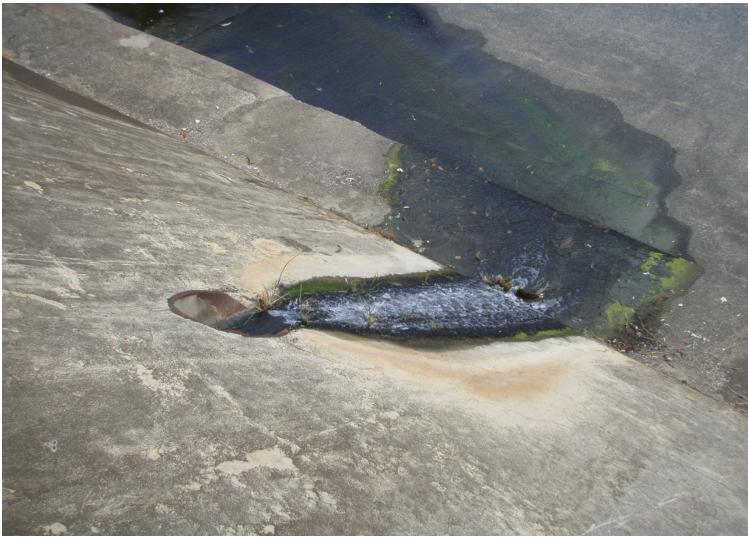
Inspect ID: ISHL_2009_a_0006 **Name:** Flood Reduction Chnl **Caption:** Sta. 100+50, LB No obstructions to concrete culver minor spalling, patch as needed

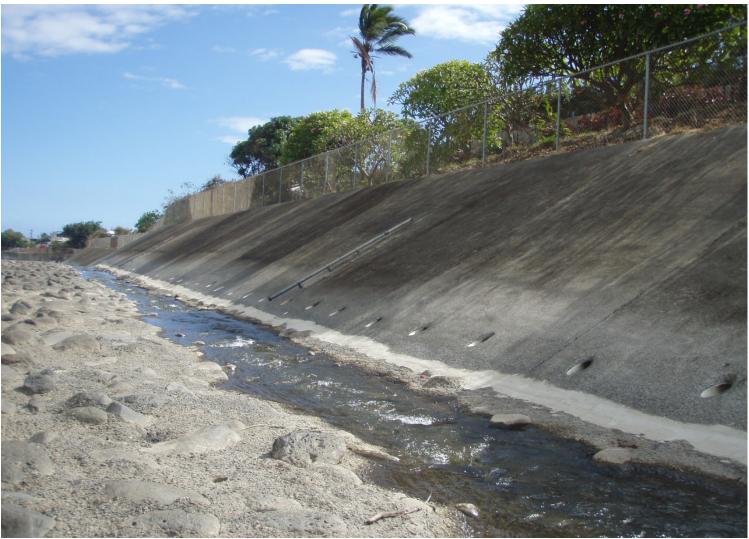
Inspect ID: ISHR_2009_a_0004 **Name:** Levee Embankment **Caption:** Sta. 116+30, RB Fencing replaced since previous inspection Concrete surface repaired at toe of sideslope

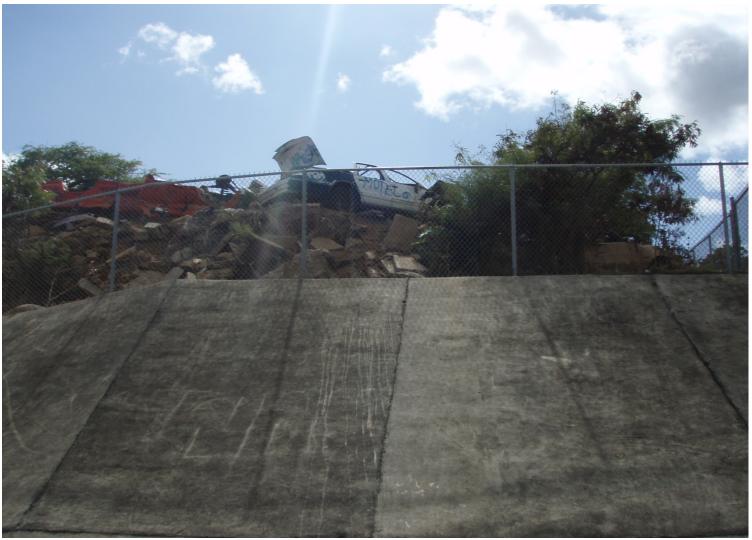
Inspect ID: ISHR_2009_a_0006 **Name:** Levee Embankment **Caption:** Sta.110+10, RB Encroachment at levee crown, Minimally Acceptable, at Drop structure # 3

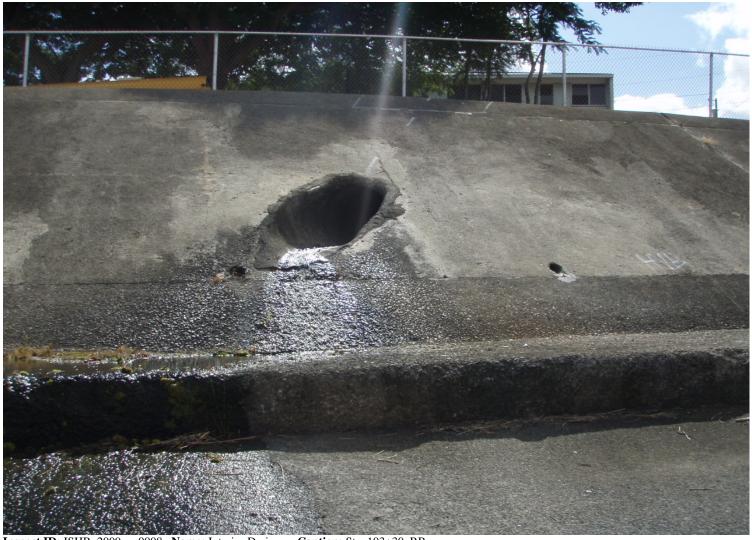
Inspect ID: ISHR_2009_a_0008 **Name:** Interior Drainage **Caption:** Sta. 103+30, RB 24 inch culvert in good condition, no obstruction adjacent to maintenance access ramp

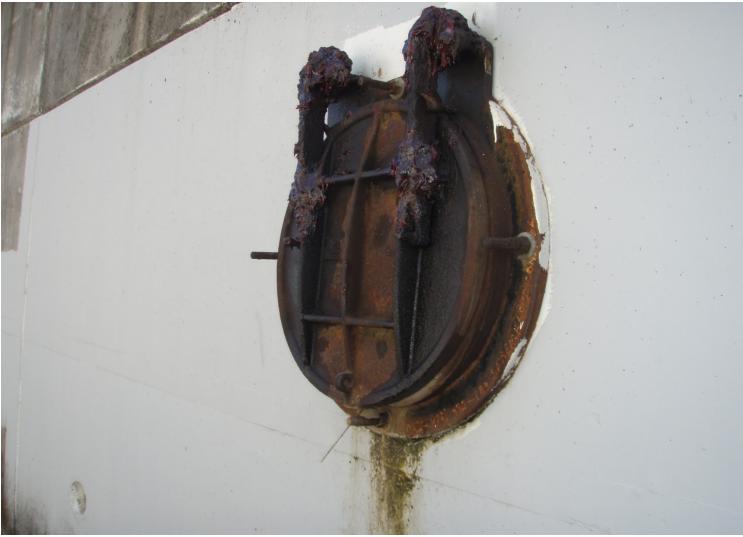
Inspect ID: ISHR_2009_a_0009 **Name:** Interior Drainage **Caption:** Sta. 97+20, RB 24 inch flapgate in good condition and greased

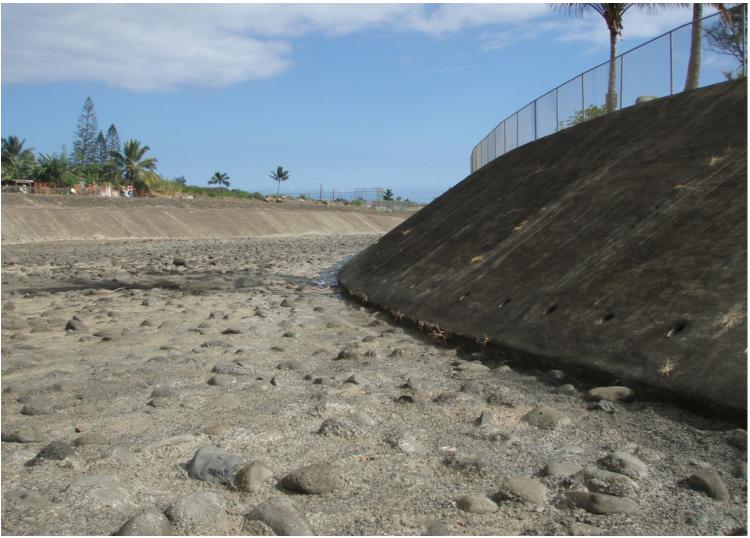
Inspect ID: ISHR_2009_a_0001 **Name:** Flood Reduction Chnl **Caption:** Sta. 125+90, RB No vegetation or debris in channel

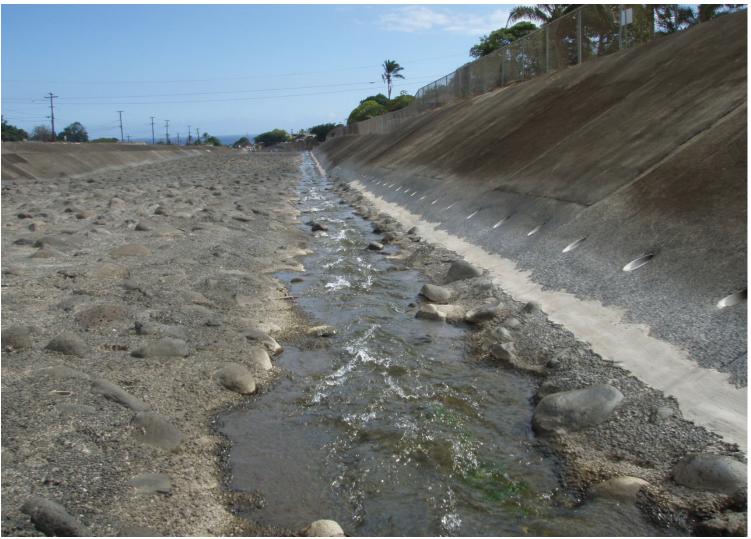
Inspect ID: ISHR_2009_a_0002 **Name:** Flood Reduction Channel **Caption:** Sta. 120+80, RB Start of recent repairs to toe/invert at low flow channel

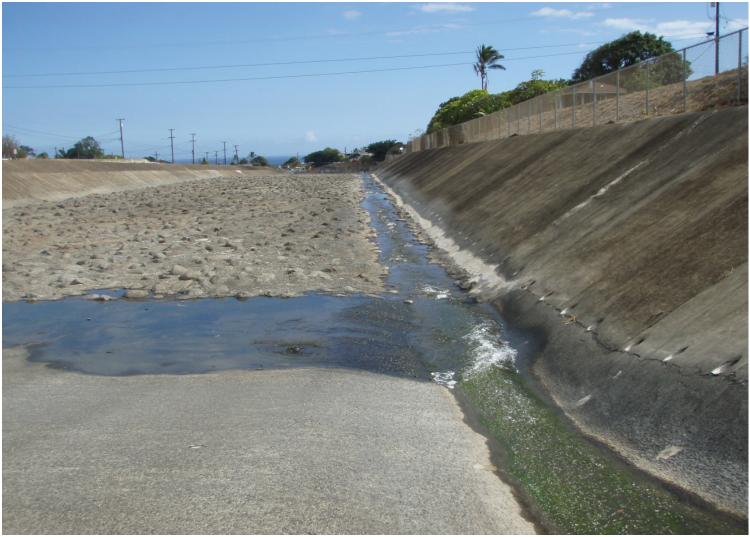
Inspect ID: ISHR_2009_a_0003 **Name:** Flood Reduction Channel **Caption:** Sta. 119+10, RB 1st Drop structure, concrete in good condition Additional repairs to low flow channel just below this point

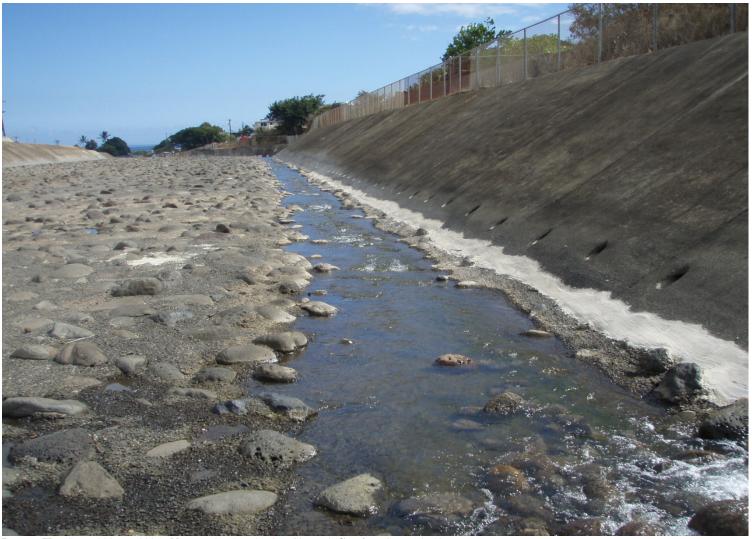
Inspect ID: ISHR_2009_a_0005 **Name:** Flood Reduction Channel **Caption:** Sta. 114+40, RB Drop Structure # 2, Sideslope repaired

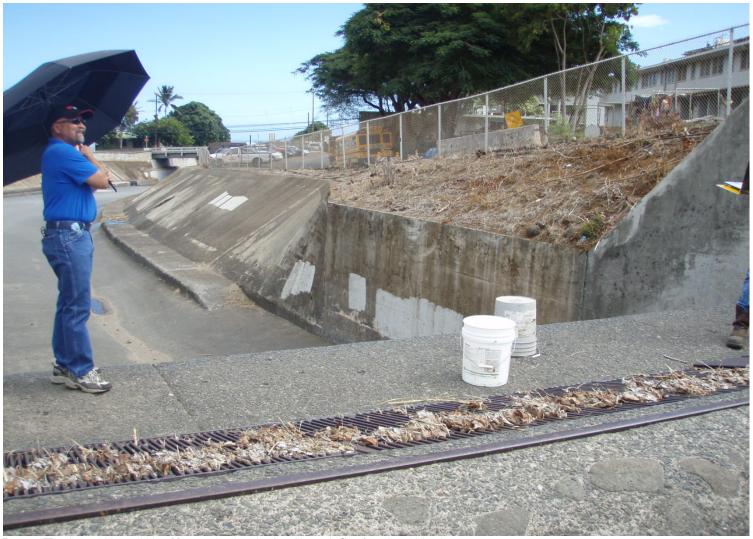
Inspect ID: ISHR_2009_a_0007 **Name:** Flood Reduction Channel **Caption:** Sta. 104+70, RB Drop structure # 4 ; HC&S Water intake

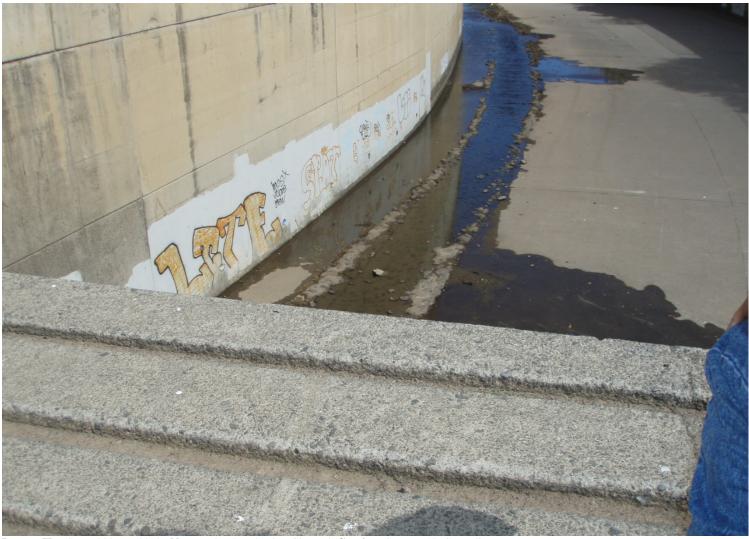
Inspect ID: ISHR_2009_a_0010 **Name:** Flood Reduction Channel **Caption:** Sta. 97+10, Centerline Concrete channel in good condition no debris no obstructions adjacent to 25 ft drop)

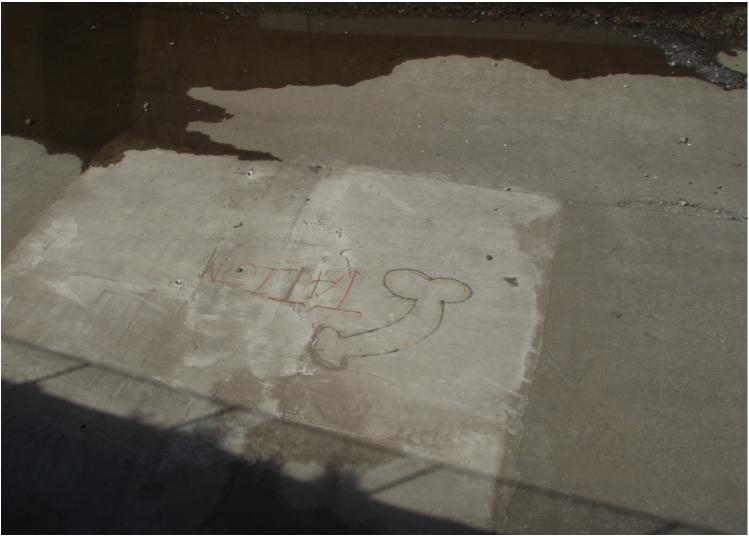
Inspect ID: ISHR_2009_a_0011 **Name:** Flood Reduction Channel **Caption:** Sta. 93+60, RB invert Concrete channel repaied at invert

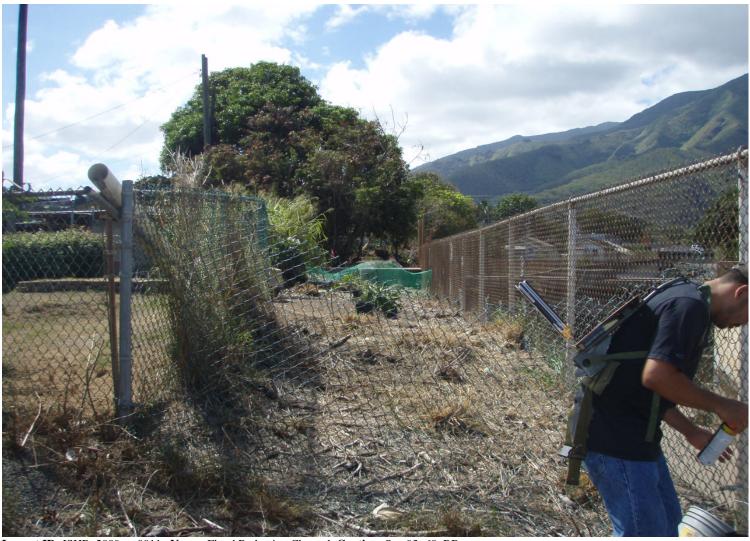
Inspect ID: ISHR_2009_a_0011 **Name:** Flood Reduction Channel **Caption:** Sta. 93+60, RB Maintenance access restblished, in good condition

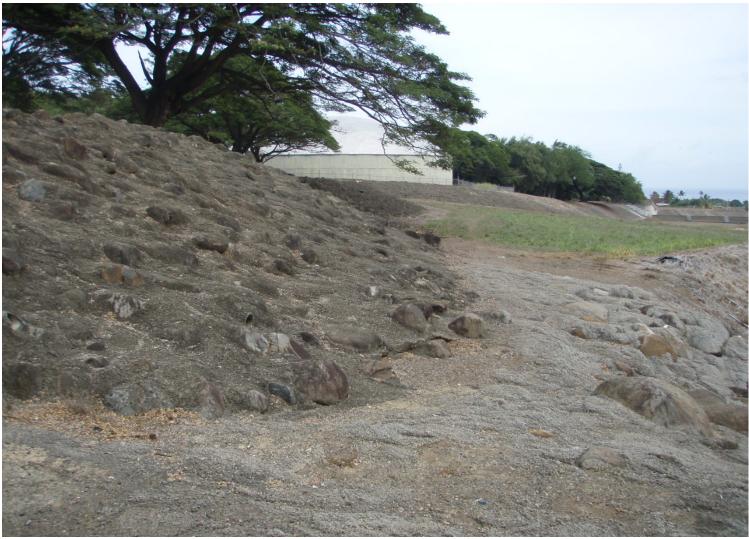
Inspect ID: ISIL_2009_a_0001 **Name:** Levee E **Caption:** Sta. 139+20, LB, P-1 No woody vegetation on sideslope or crown, good maintenance

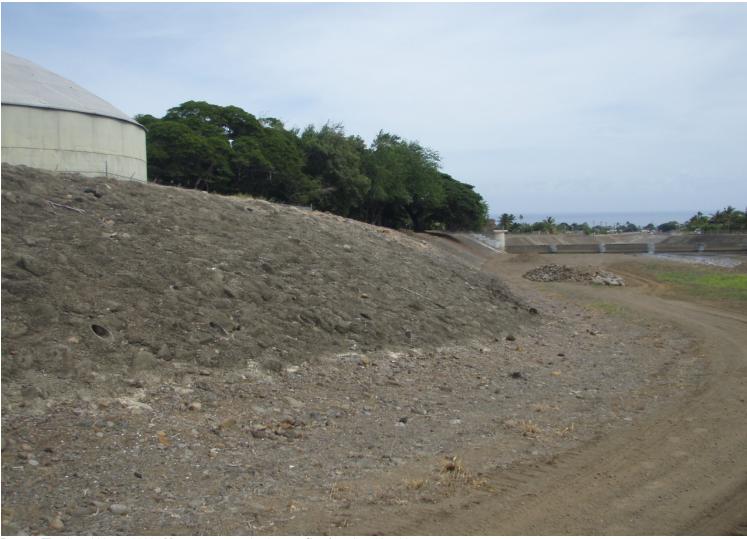
Inspect ID: ISIL_2009_a_0002 **Name:** Levee Embankment **Caption:** Sta. 136+20, LB, Typical condition of vegetation control, very good

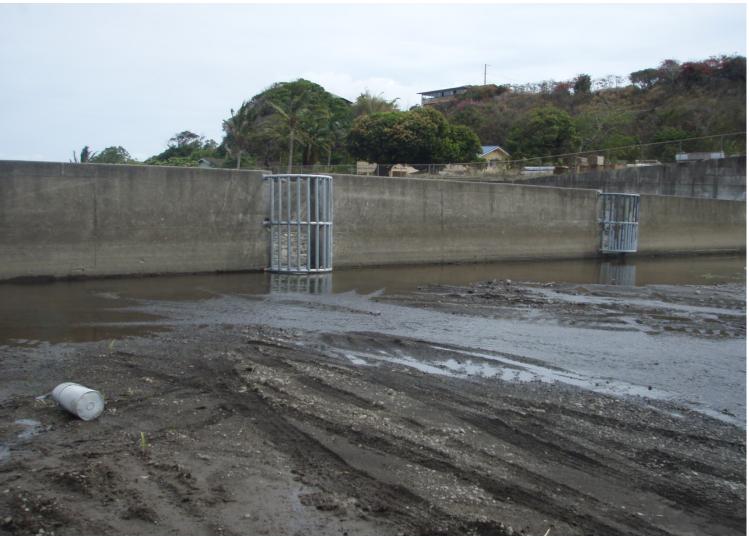
Inspect ID: ISIL_2009_a_0006 **Name:** Floodwall **Caption:** Sta. 127+60, LB to Centerline Gates have been repaired since last inspection. No rust, good maintenance.

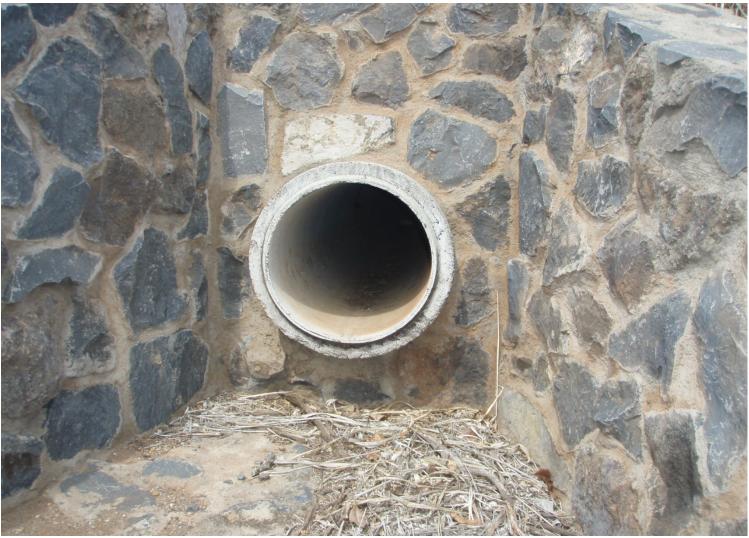
Inspect ID: ISIL_2009_a_0003 **Name:** Interior Drainage **Caption:** Sta. 132+90, LB, P-4 Culvert discharge pipe clear (free of debris / trash) Continue to maintain

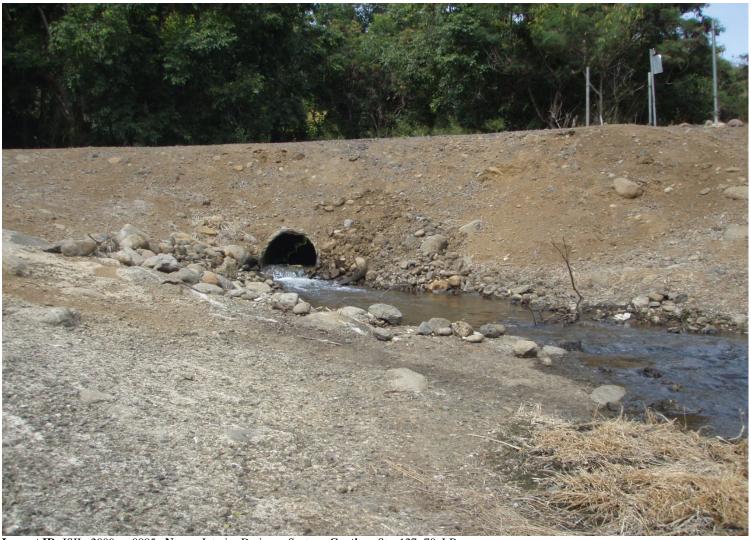
Inspect ID: ISIL_2009_a_0005 **Name:** Interior Drainage System **Caption:** Sta. 127+70, LB Culvert discharge pipe is in good condition no obstructions, continue to maintain.

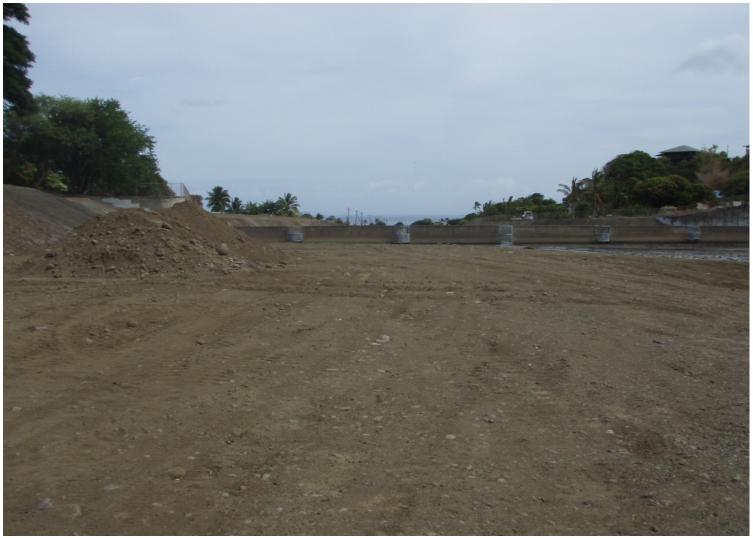
Inspect ID: ISIL_2009_a_0004 **Name:** Flood Reduction Chnl **Caption:** Sta. 130+90, Left of centerline Continue to remove stockpile of debris Unresolved

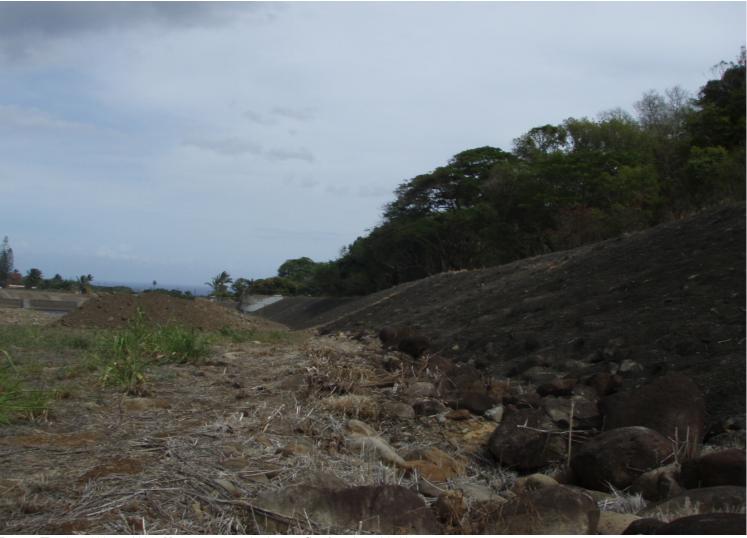
Inspect ID: ISIR_2009_a_0001 **Name:** Levee Embankment **Caption:** Sta. 134+80, RB No woody vegetation, weep holes clear.

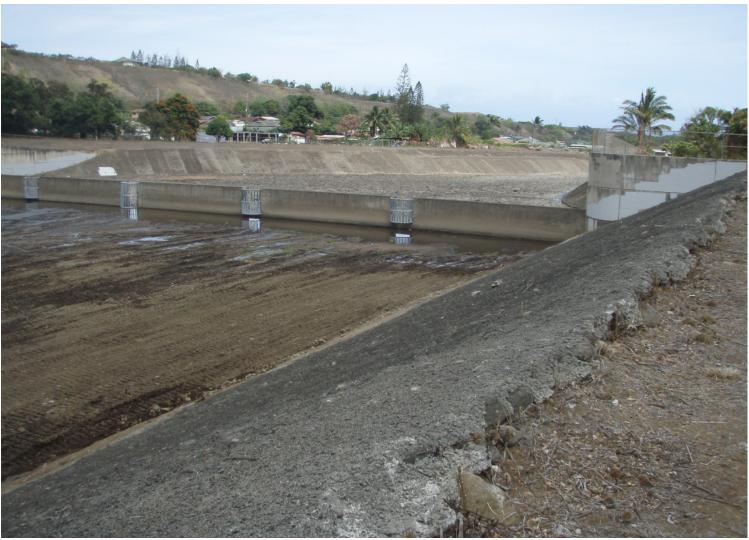
Inspect ID: ISIR_2009_a_0003 Name: Levee Embankment Caption: Sta. 129+90, RB No woody vegetation on sideslope or crown of levee Good maintenance access

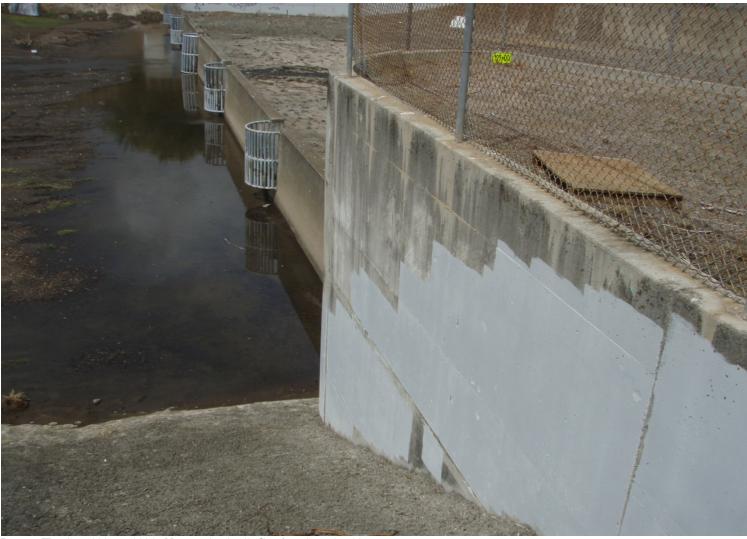
Inspect ID: ISIR_2009_a_0004 **Name:** Floodwall **Caption:** Sta. 127+20, RB No spalling, no deterioration noted

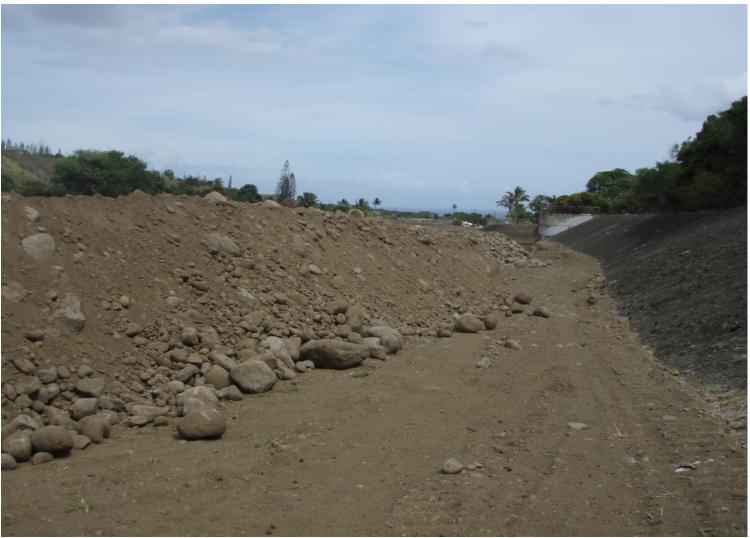
Inspect ID: ISIR_2009_a_0002 **Name:** Flood Reduction Chnl **Caption:** Sta. 133+50, RB Sholing minimally acceptable remove stockpile of sediments
