O&M REPORT
FOR Kahului Bay Prevention & Mitigation of Shore Damages
Honolulu Engineer District
CEPOH-EC-T

1. Project Name: Kahului Bay Prevention & Mitigation of Shore Damages
2. Date of Inspection: October 14, 2010
3. Inspection Personnel:

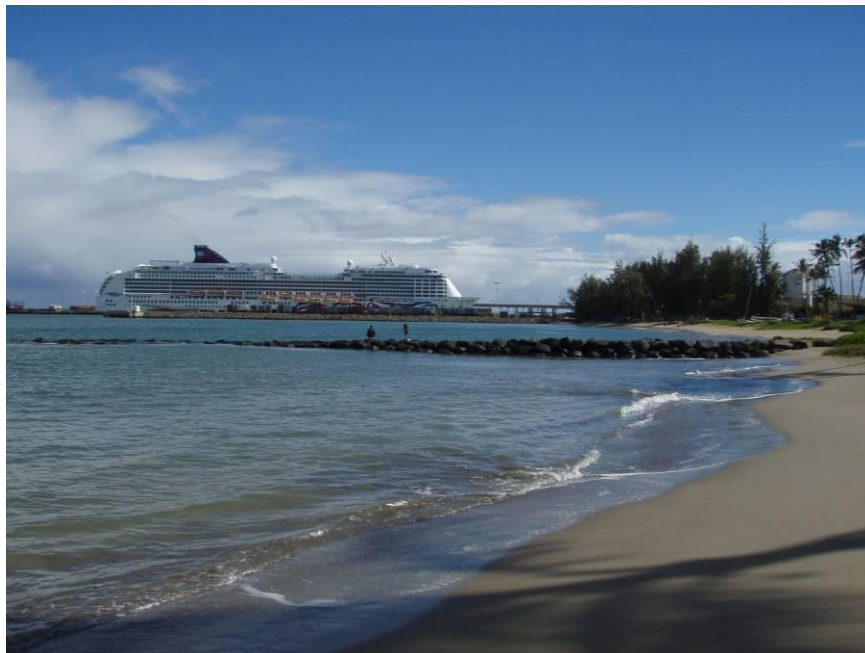
- a. Sta. 0+10, Overview of the East Groin.

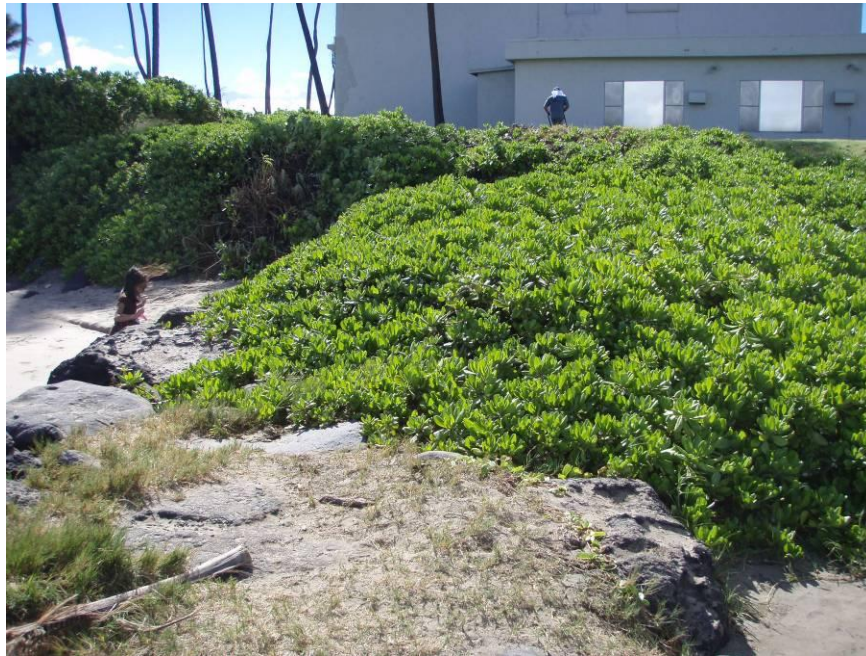
- b. Sta. 0+00, structure covered with vegetation, unable to inspect.

Recommend that a study be conducted to evaluate the present condition of the breakwater structure to determine if a repair to the structure is required. The study should also include a historical beach profiling of the project area where sand was placed back in 1976, to determine if the shoreline has stabilized over the years or if there is a continuing erosion of the shoreline. Recommend the removal of the vegetation on the root of the East Groin and the removal of the tree at Sta. 0+68 on crest of the Revetment.

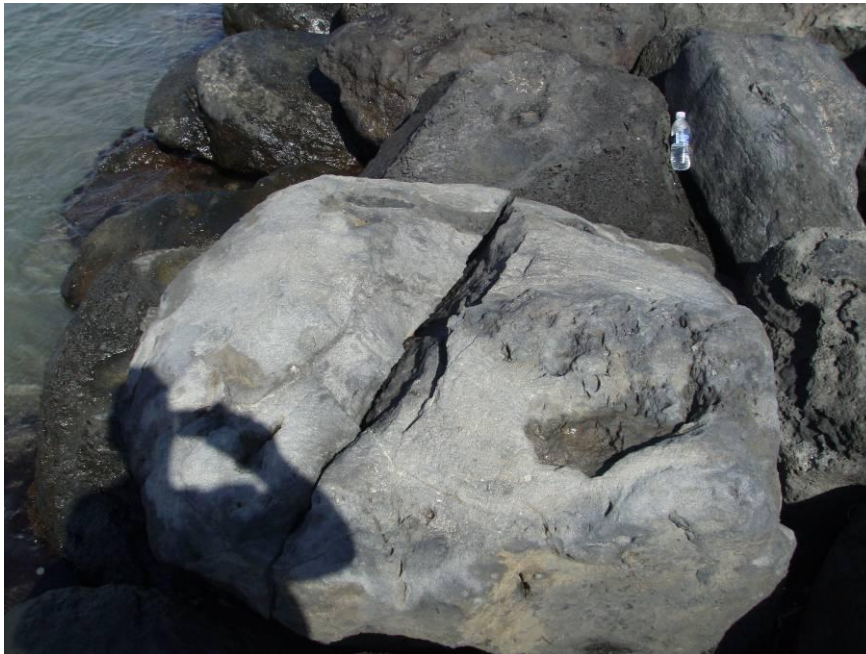
- c. Sta. 0+75, Left Side (LS) as looking toward the head of the groin - 1 ea. cracked armor stone, no changes this year.

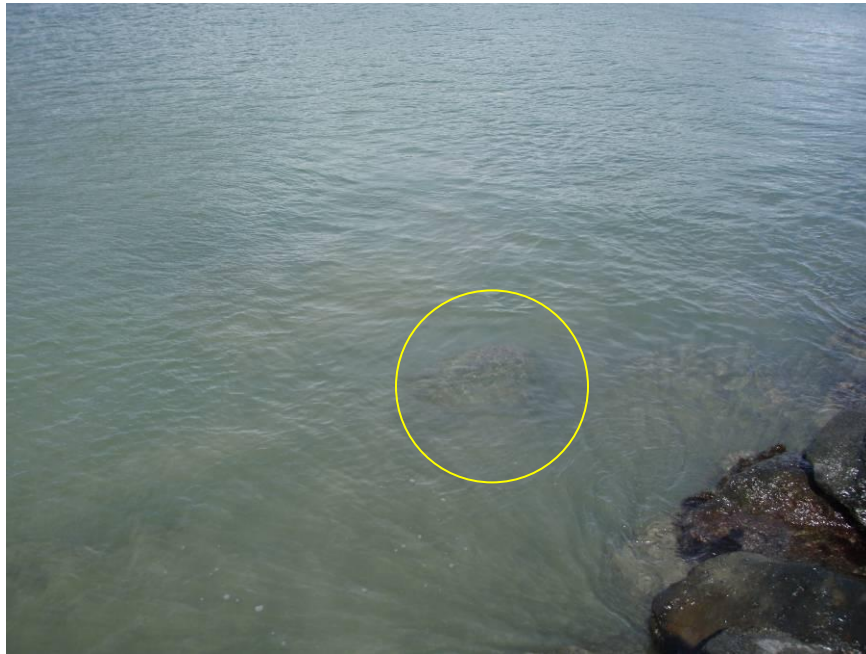
- d. Sta. 1+00, 1 ea. dislodged armor stone - no obvious void in the structure. No change this year.

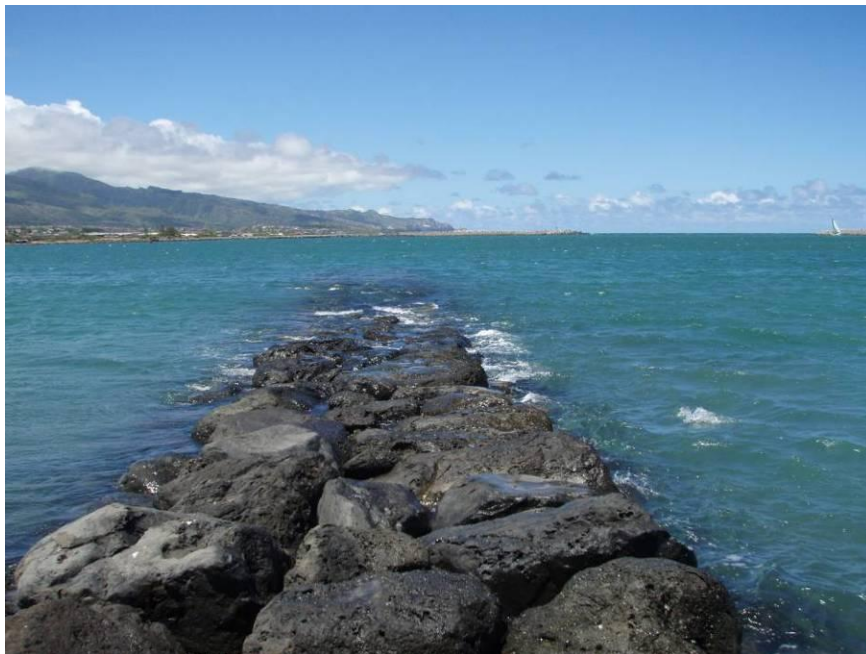
- e. Sta. 2+00, Overview, photo for reference. No changes this year.

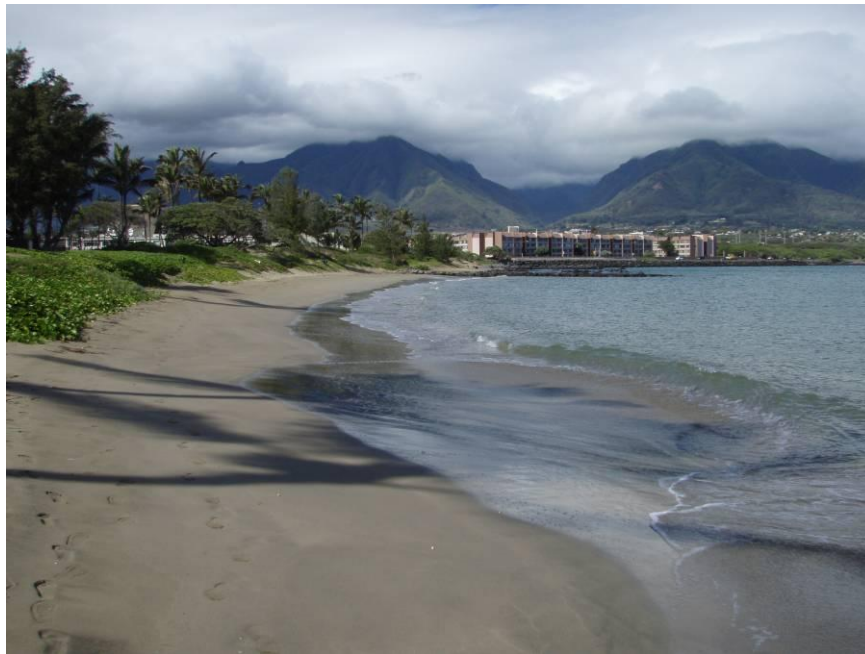
- a. Overview of the beach fill area. Beach profile looks the same as it did in 1997 inspection report.

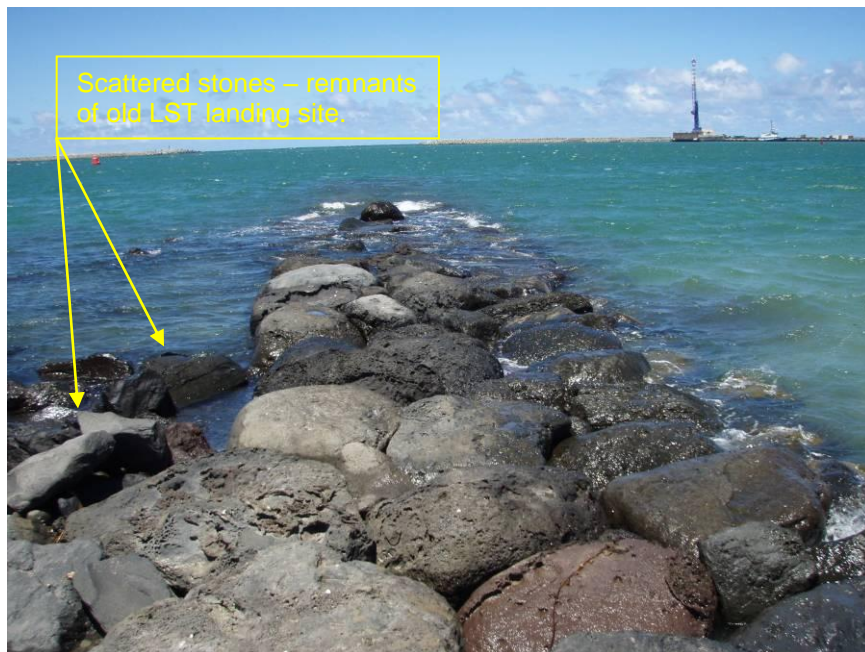
- a. Sta. 1+48, Left Side (LS), Scattered stones are remnants of the old WWII LST landing site. No changes this year.

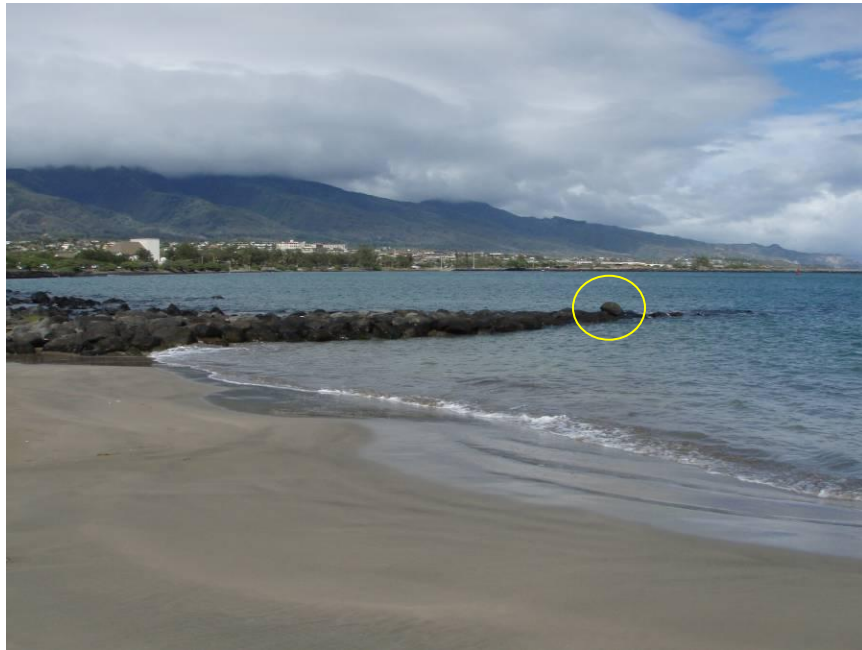
b. Sta. 2+00, 1 ea. perched armor stone. No changes this year.

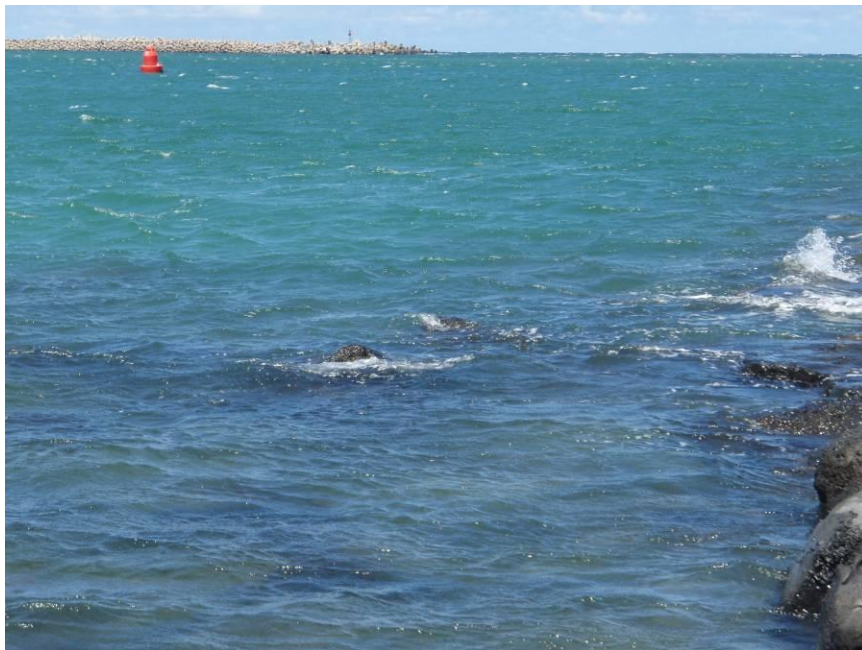
c. Sta. 1+50, Centerline Crest (CL), Scattered stones are remnants of the old LST landing site. No changes this year.

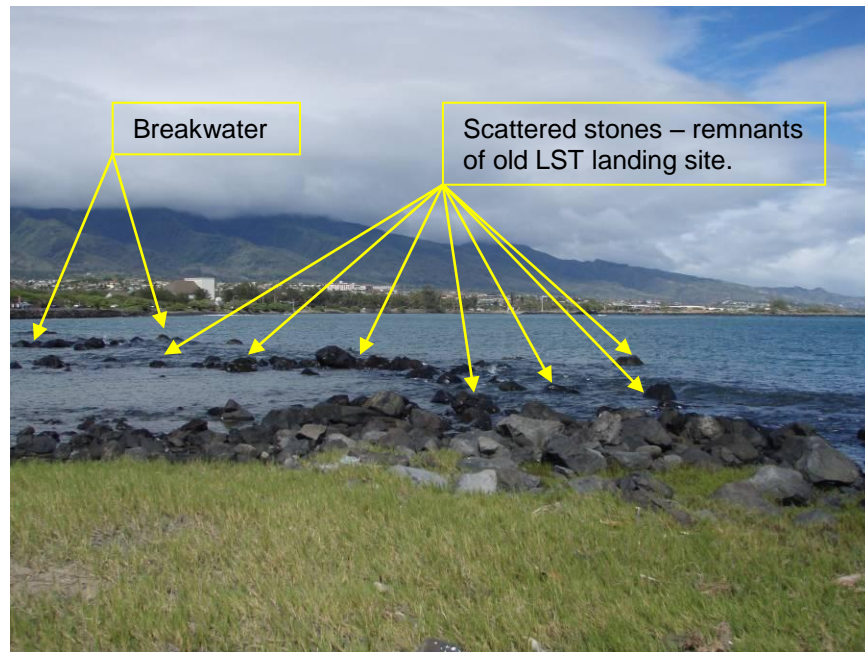
- a. Breakwater Overview. Scattered stones are remnants of the old LST landing site.

The overall project is in marginal condition. The East and West Groin structures are in good condition, although there is some vegetation growth on the root section of the East Groin. The Revetment is in good condition. The breakwater is in marginal condition.

The Corps Honolulu District will budget for an Initial Appraisal report to evaluate the present condition of the breakwater structure and adjacent shoreline, to determine if a repair to the breakwater and renourishment of the shoreline is required. The report will be conducted, subject to the availability of funds.

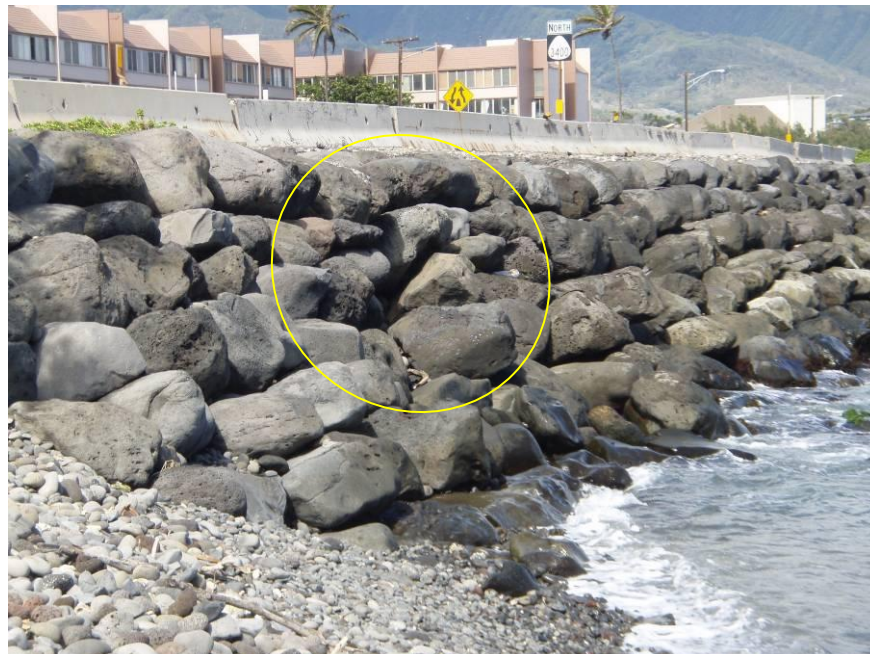
- a. Sta. 0+51, There appears to be additional sideslope sliding this inspection. Continue to monitor this section of revetment.

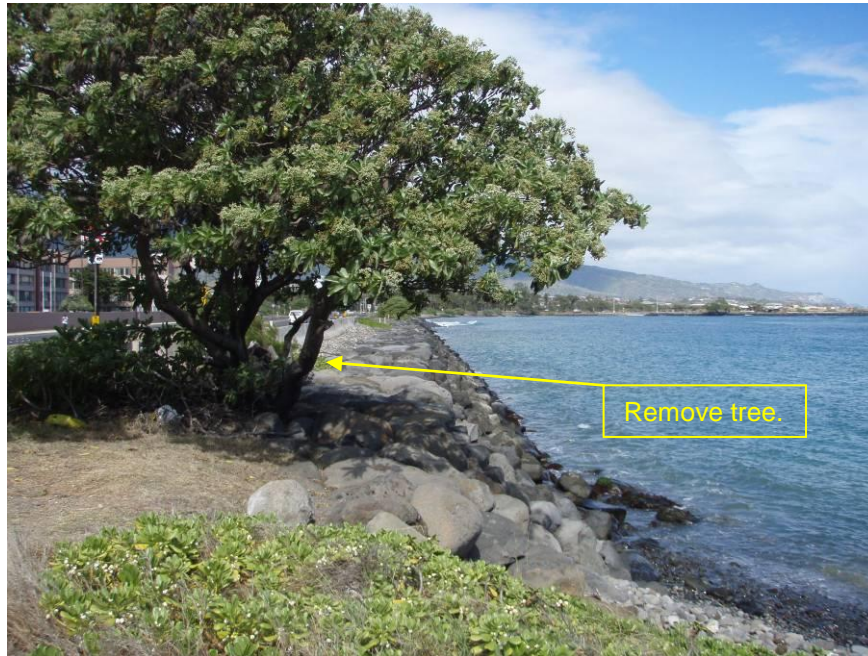
- b. Sta. 0+68, Monitor settling at the crest and remove tree from structure.

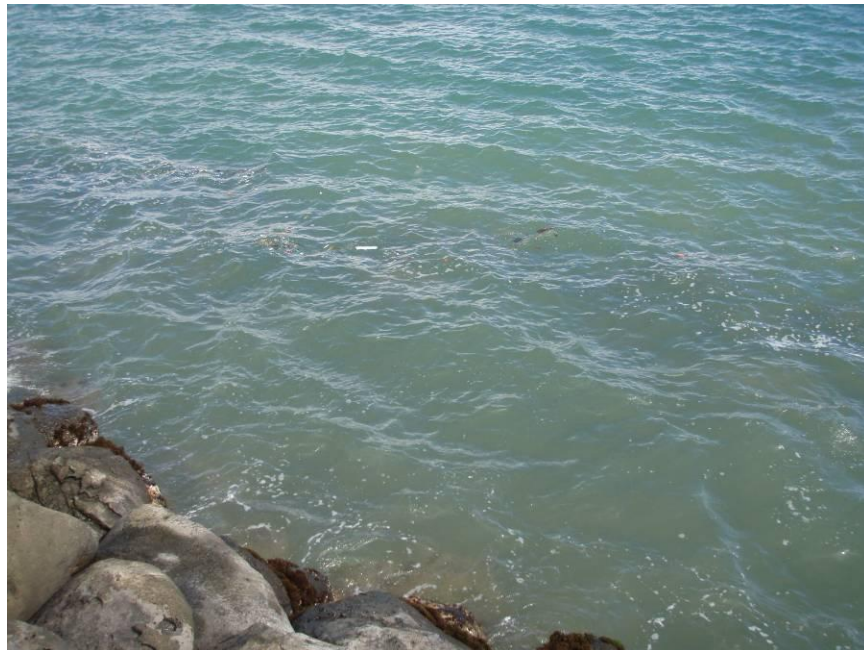
- c. Sta. 2+00, 3 ea. Dislodged armor stones, slight change this year.

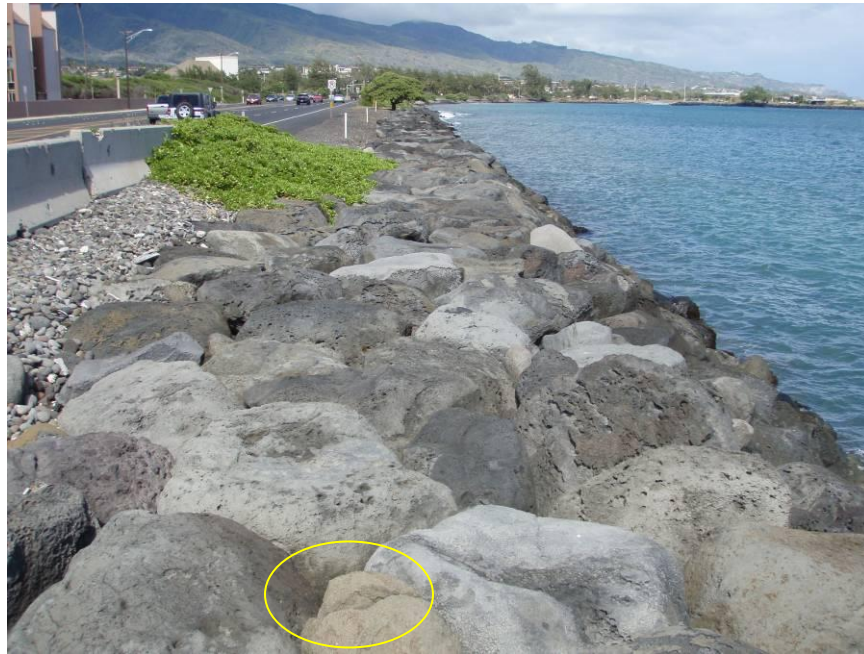
- d. Sta. 2+63, 1 ea. Cracked armor stone, photo for reference.
No changes this year.

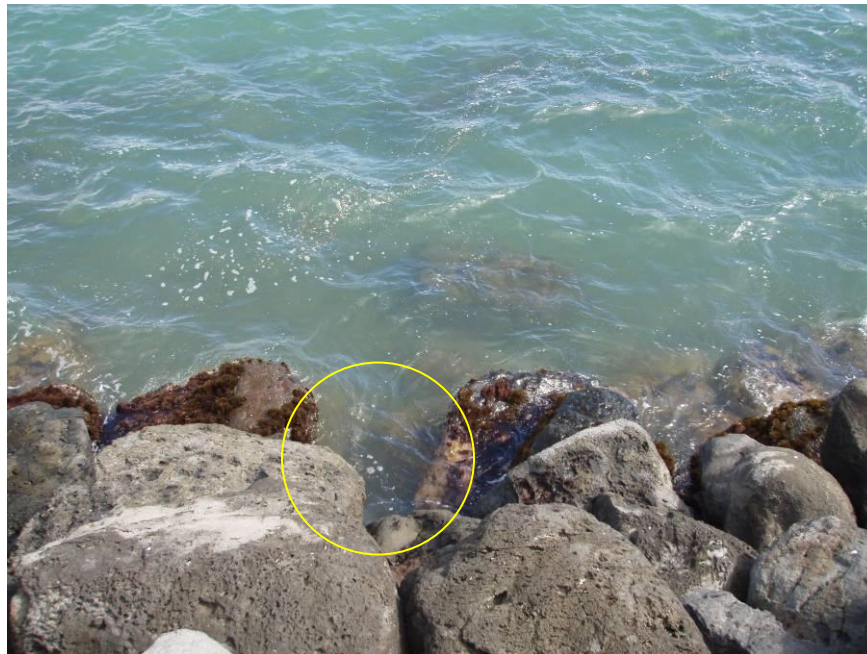
- e. Sta. 2+97, Monitor 1 ea. missing armor stone at the toe.
No change this year.

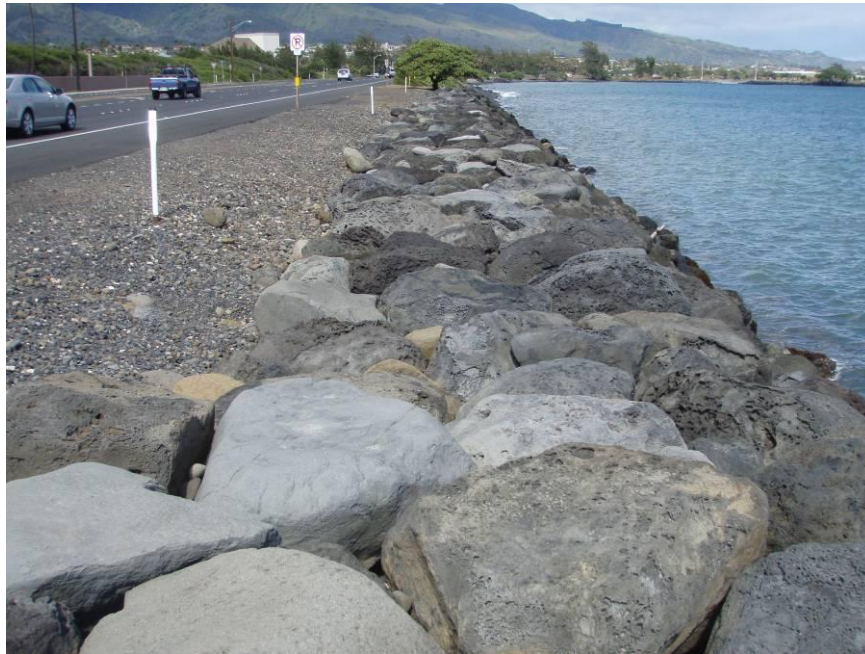
- f. Sta. 3+60, Monitor Settling at the crest. No changes this year.

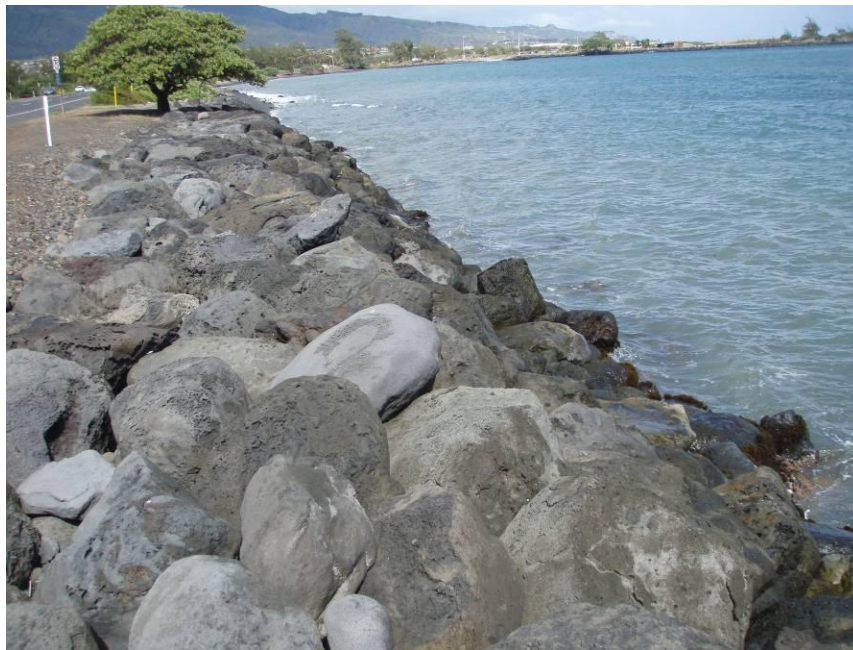
- g. Sta. 5+28 - Sta. 5+40, Monitor 3 ea. flipped as armor stones and settling on crest.

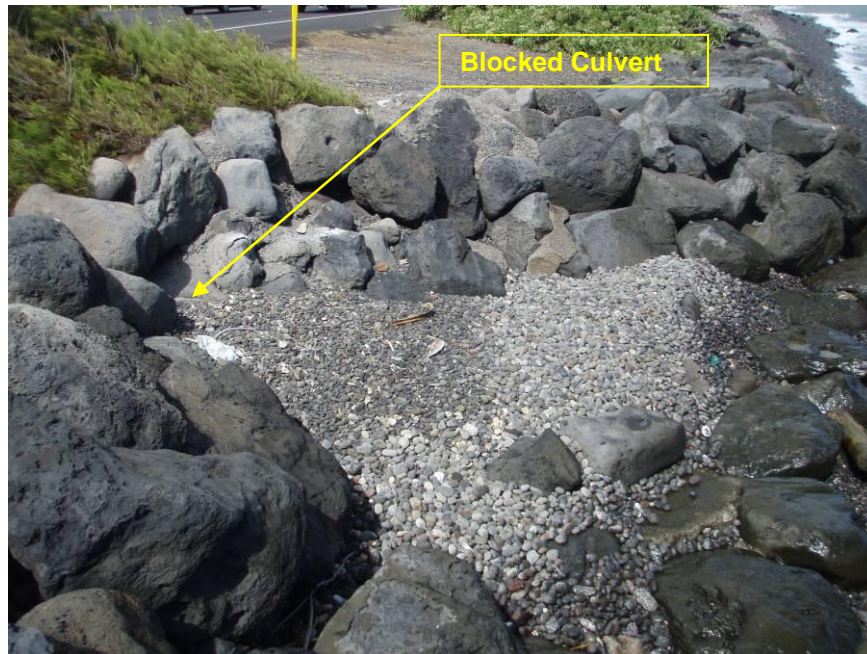
h. Sta. 7+81, Monitor void at the crest. Road culvert blocked.

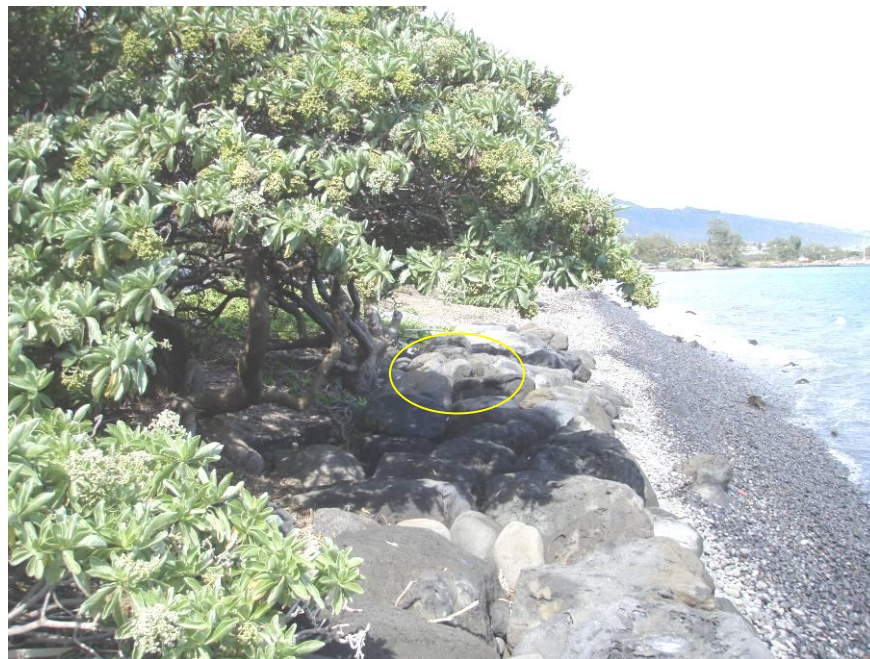
i. Sta. 8+90, Monitor settling at crest. No additional settling this inspection.

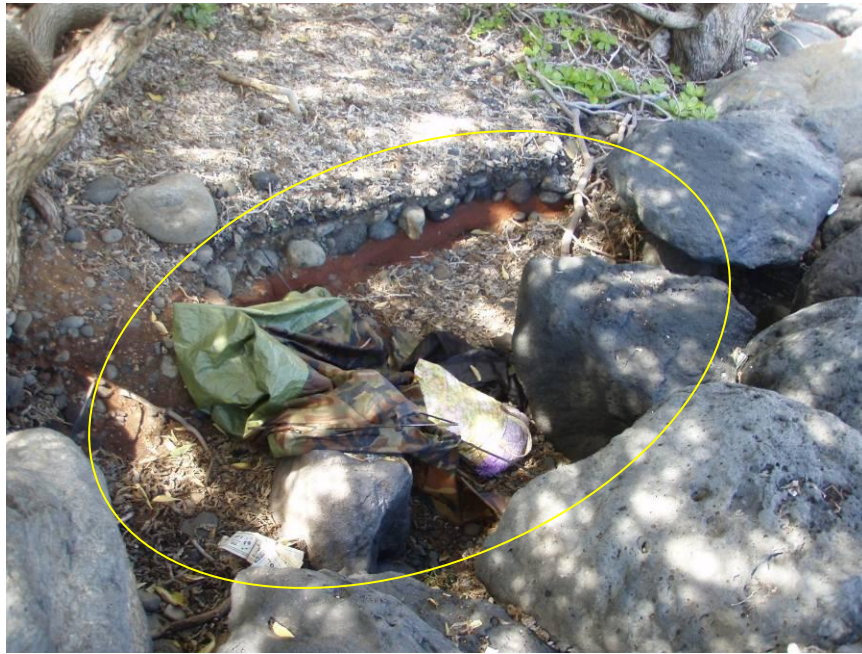
- j. Sta. 8+90, Monitor settling at crest. No additional settling this inspection (Close-up Photo).

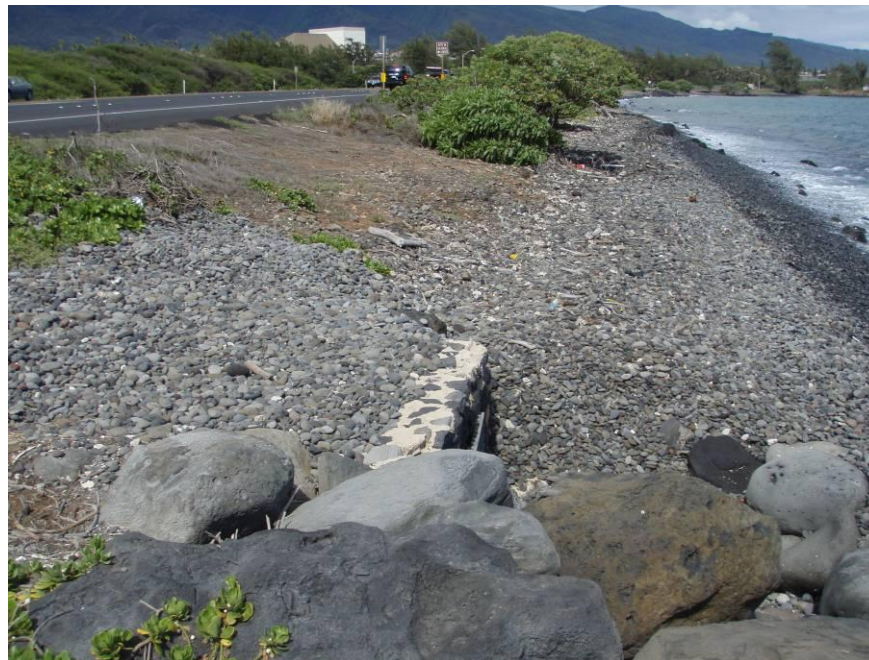
- k. Sta. 9+06, End of Project.
