1. Project Name: Kahului Wastewater SPP
2. Date of Inspection: September 16, 2009
3. Inspection Personnel:

The project consists of 450 LF of revetted shore protection. The project begins on the west side at Sta. 11+50 and ends on the east side (beach park) at Sta. 16+00. Damages have occurred at Sta. 11+50 and Sta. 15+50. These damages were first noticed during the inspection by the CEI and are may be due to the high waves associated with Hurricane Felicia. The Department of Environmental Management (DEM) is planning on extending the SPP approx. 1,500 LF. This will impact both ends of the existing structure.

CONTINUING ELIGIBILITY INSPECTION (CEI) REPORT  
 FOR HURRICANE & SHORE PROTECTION PROJECTS  
 Honolulu Engineer District  
 CEPOH-EC-T

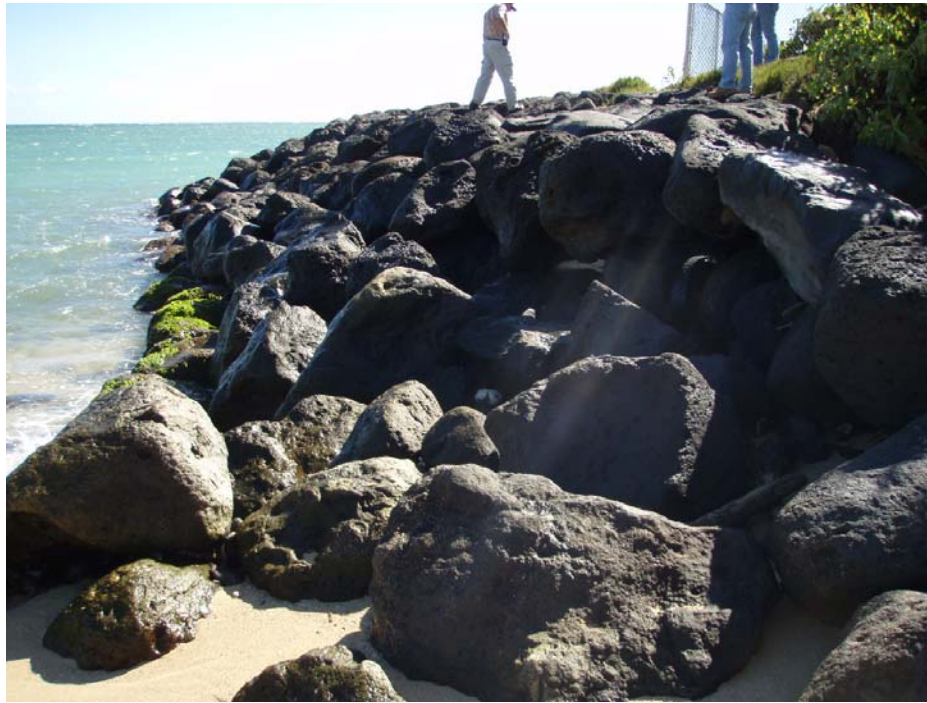
- a. Sta. 11+50, Beginning of project, west-end, recent damages approximate 20 to 25 LF of armor stone & underlayer exposed, needs to be reset.

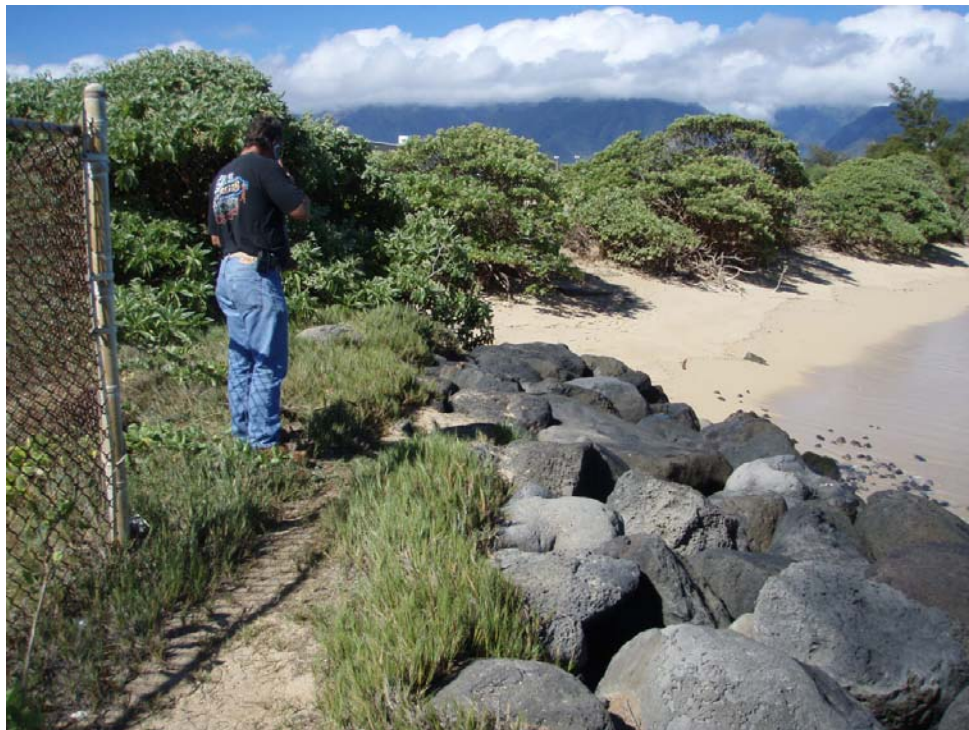
- b. Sta. 12+00, Remove the vegetation from the crest of the structure, as needed.

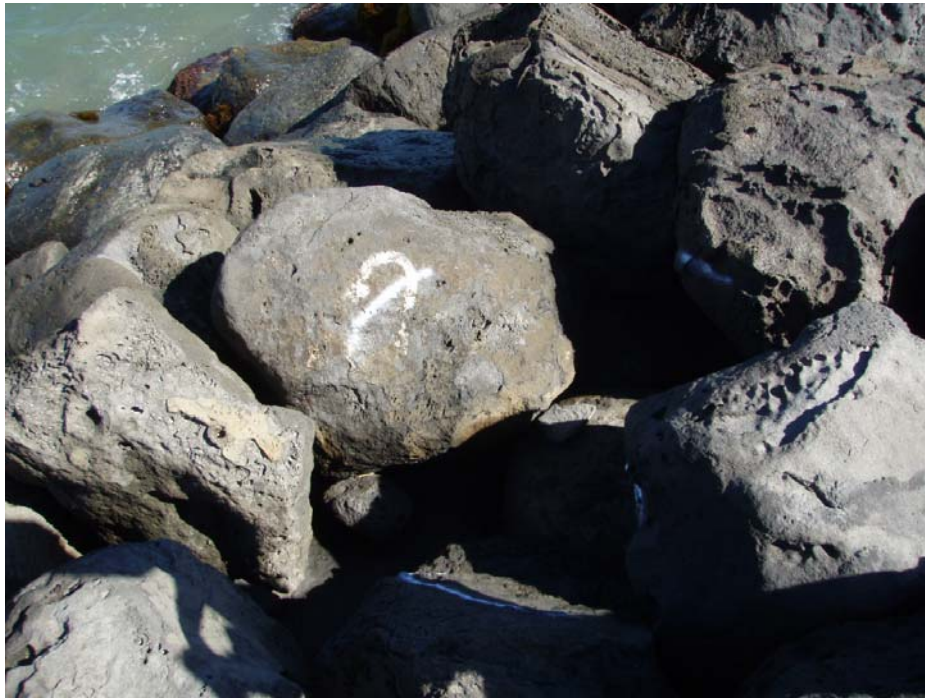
c. Sta. 12+00, Reset armor stone in 2 ft. void on sideslope.

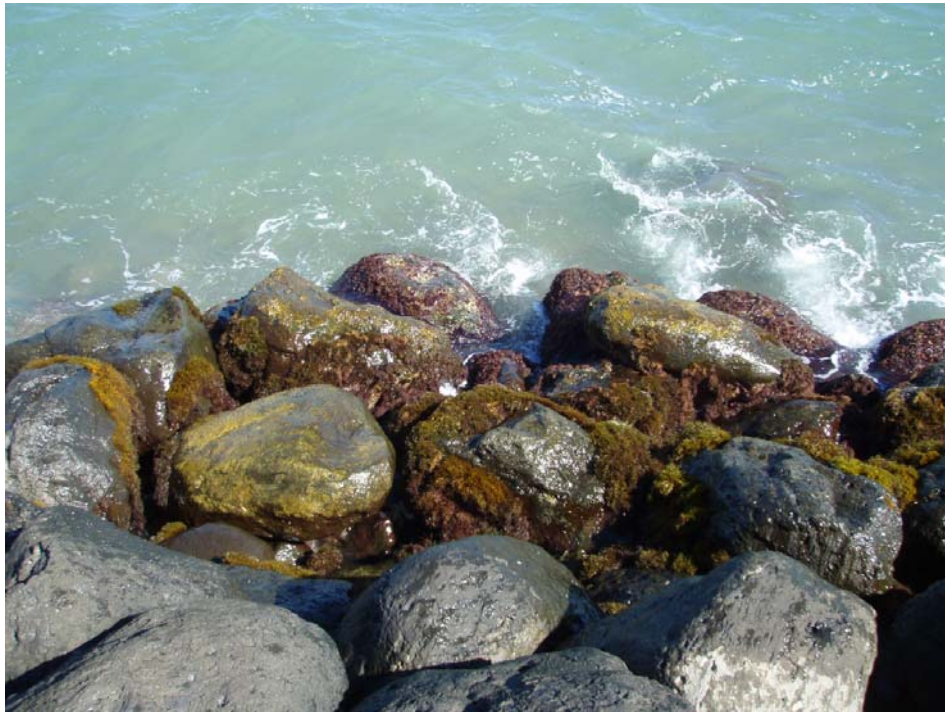
d. Sta. 12+50, Monitor void and bridging armor stone on the sideslope.  
minor change this year.

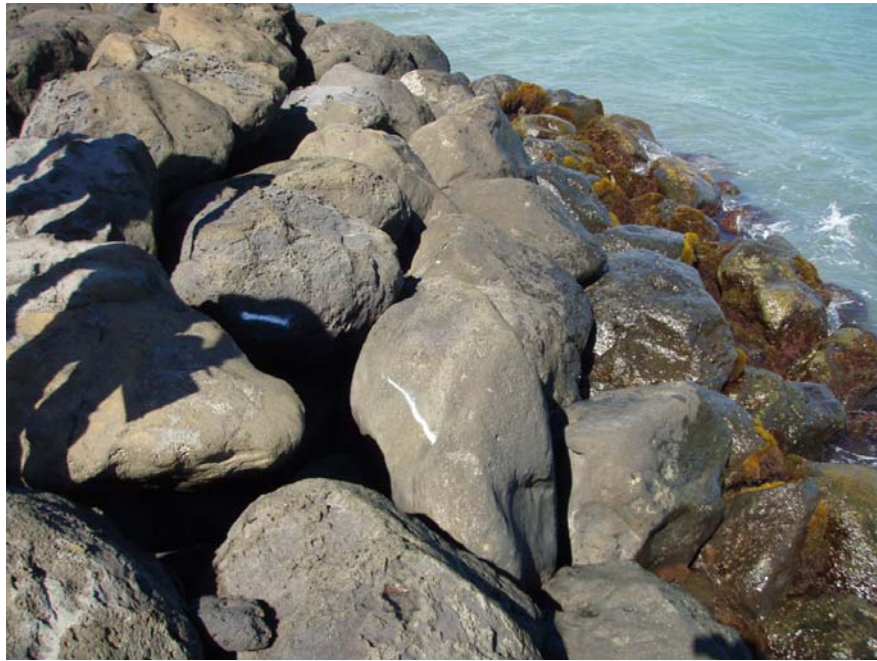
- e. Sta. 12+75, reset flipped armor stone or add new armor stone to void.

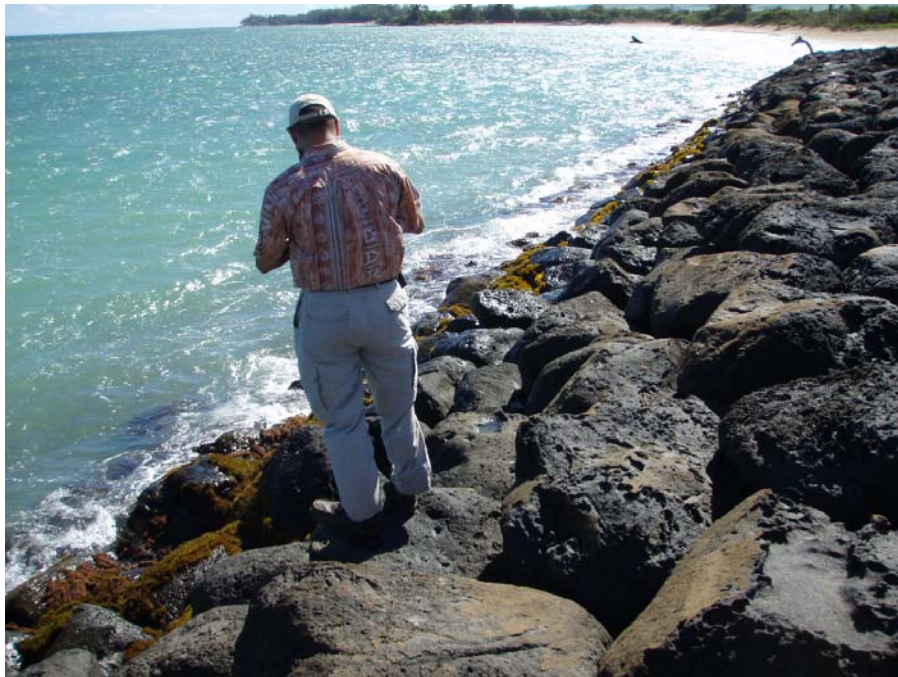
- f. Sta. 13+14, Monitor settling at the crest. No change this year.
- g. Sta. 13+50, Monitor slight depression at the hinge.

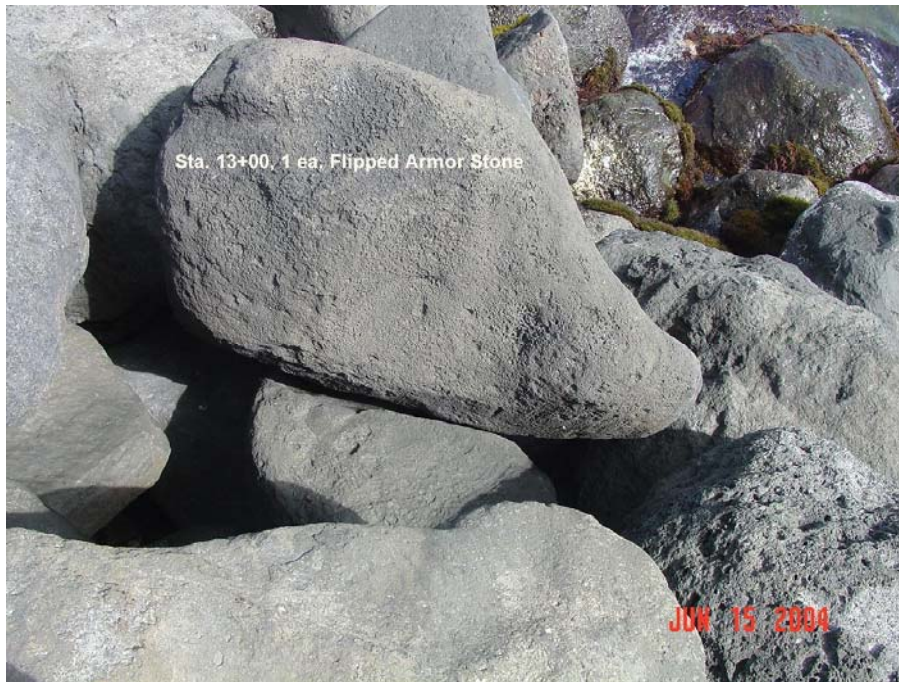
- h. Sta. 13+00, 1 ea. Monitor flipped armor stone. No change. FY04 photo.

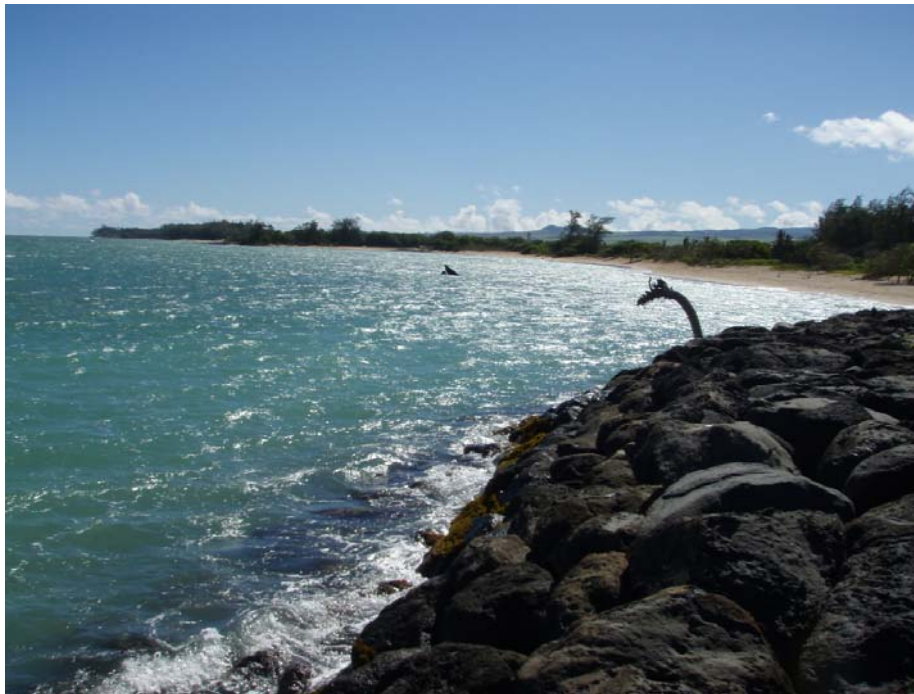
- i. Sta. 13+98, monitor armor stone movement adjacent to the toe.
- j. Sta. 14+00, 1 ea. Dislodged armor stone resting adj. toe, new this inspection.

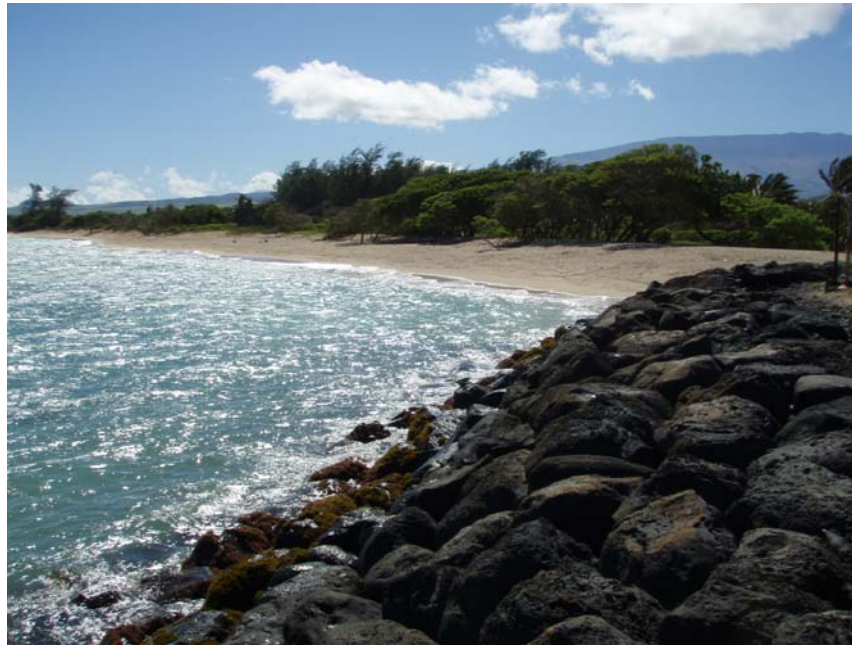
- l. Sta. 14+50, 1 ea armor stone resting at toe, no obvious voids. 2 ea. Armor stones resting adj. toe.

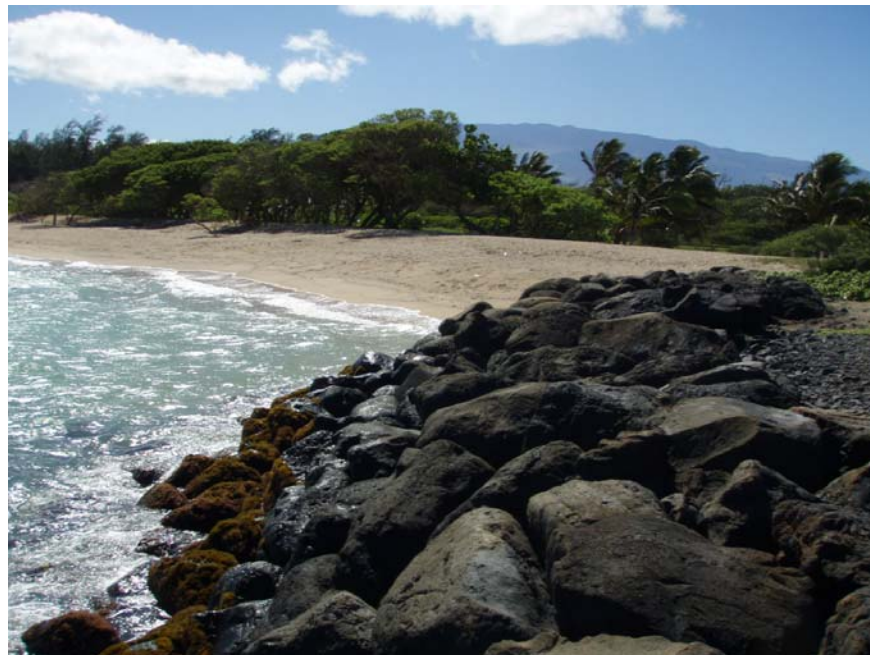
- m. Sta. 15+50 to Sta. 15+86, The void and depression have combined. Recent changes in 25 LF of sideslope settling and armor stone movement, underlayer exposed.

It has been determined by the FCCE Program Manager that the recent damages at Sta. 11+50 and Sta. 15+50 are not related to Hurricane Felicia, and not eligible for PL84-99 rehabilitation.

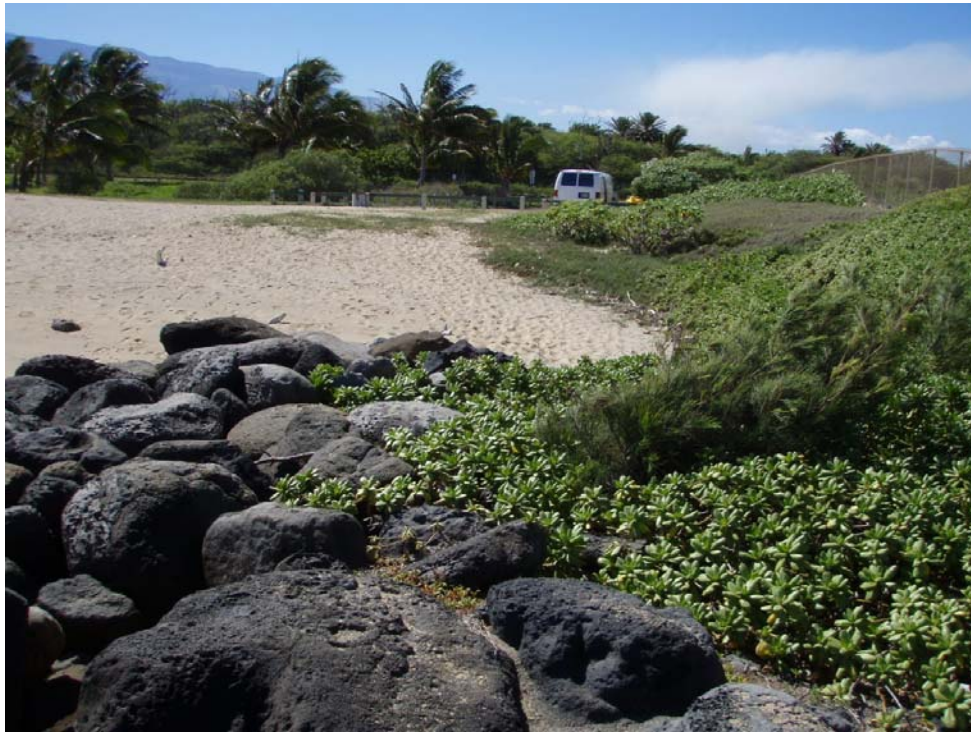
n. Sta. 15+90, Overview, remove vegetation from armor stones..

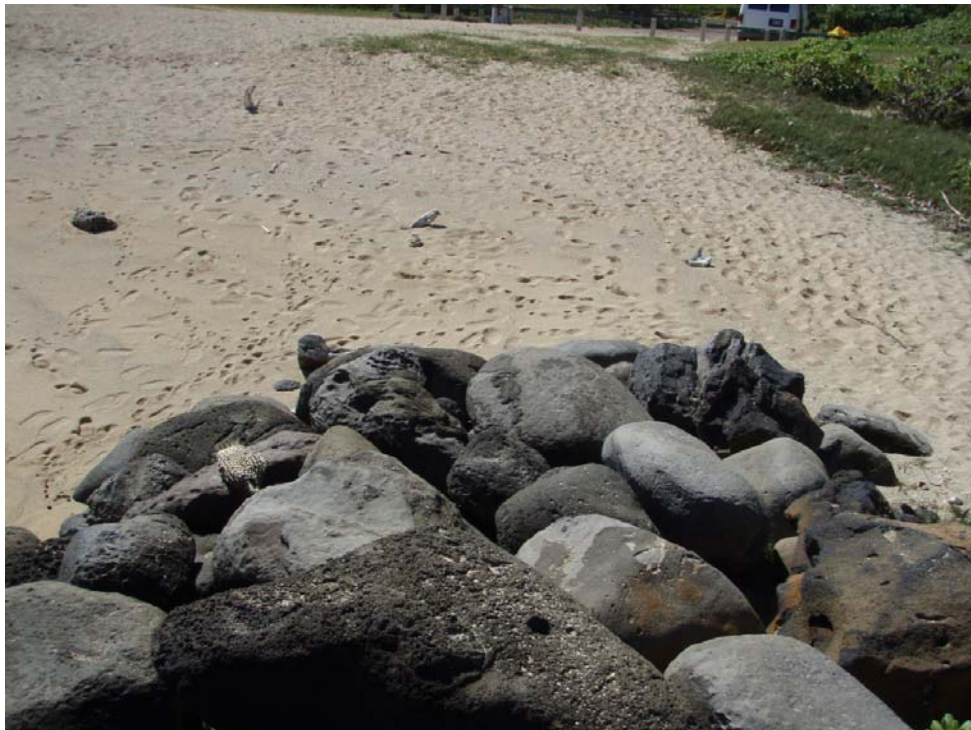
o. Sta. 16+00, Monitor sand erosion at tie-back.
