Kihei Beach SPP 1. Project Name:

2. Date of Inspection: September 17, 2009

CONTINUING ELIGIBILITY INSPECTION (CEI) REPORT FOR HURRICANE & SHORE PROTECTION PROJECTS Honolulu Engineer District

KIHEI BEACH, MAUI, HAWAII

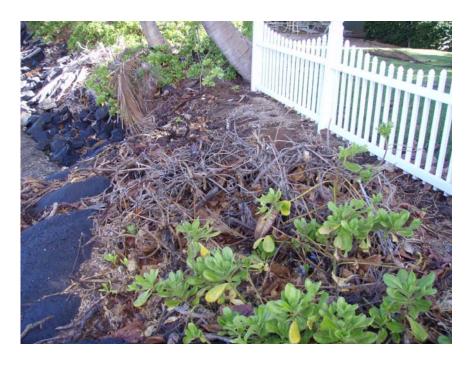
a. Sta. 0+70 to Sta. 0+90, Remove vegetation from crest and sideslope.

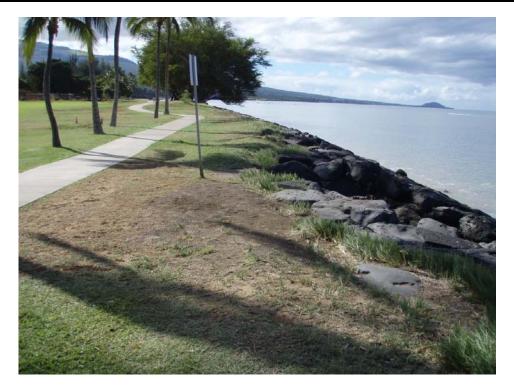
b. Sta. 2+90, Fill material added to eroded area.

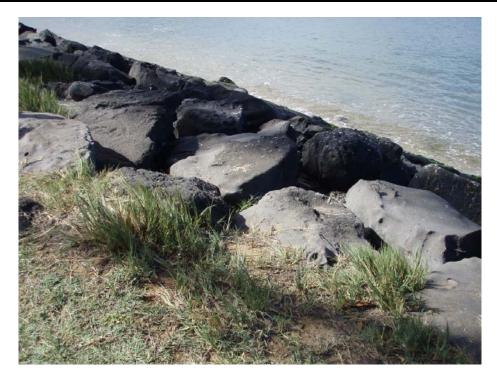
d. Sta. 3+20, Monitor minor settling at hinge. No Change.

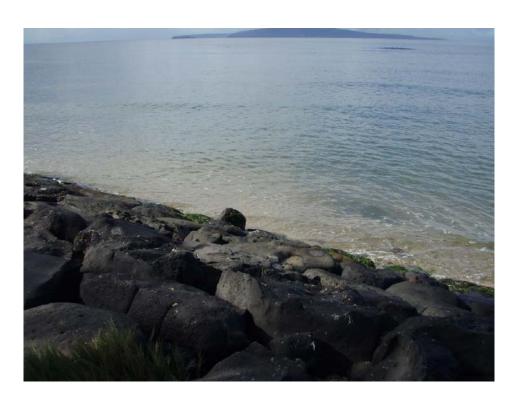
e. Sta. 3+48, Monitor the armor stone resting adjacent the toe. Minor change this year. No obvious voids.

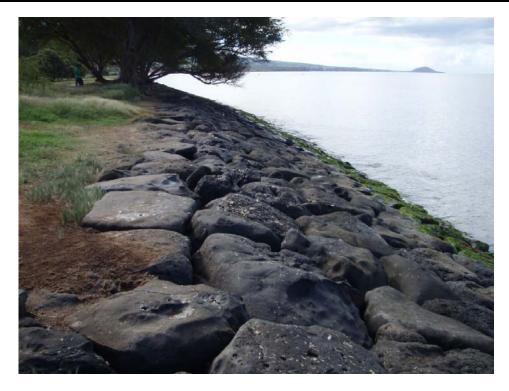
f. Sta. 3+76, to Sta. 4+06, Monitor the area adjacent to cracked armor stone for settling.

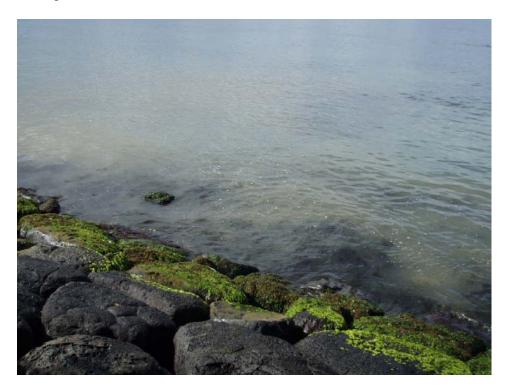
g. Sta. 3+96, 1 ea. Displaced armor stone, void at toe. Monitor Sideslope.

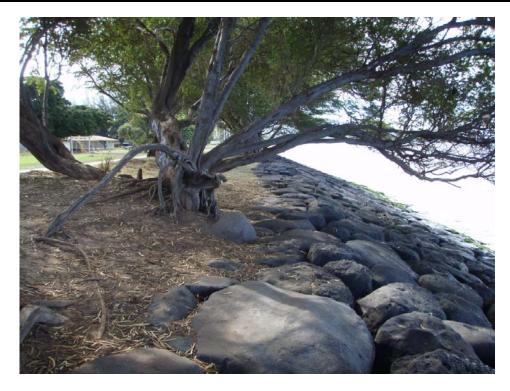
h. Sta. 5+00 to Sta. 8+00, Remove Kiawe trees (including stumps) impacting the revetment structure.

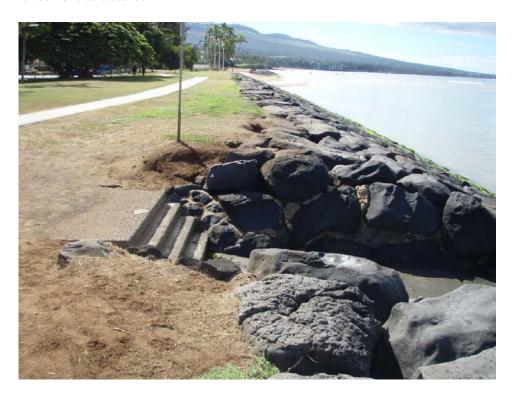
i. Sta. 8+73, 2nd Walkway, CRM, repaired.

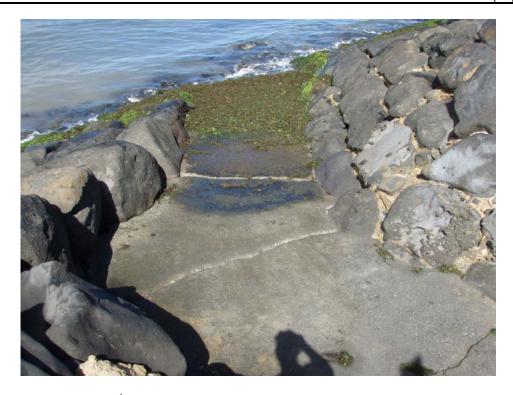
j. Sta. 8+73, 2nd, access walkway, repair cracks in sidewalk as needed.

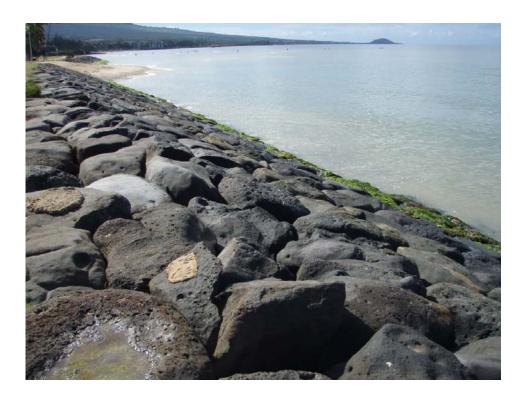
k. Sta. 10+00, Monitor settling on sideslope, no change this year.

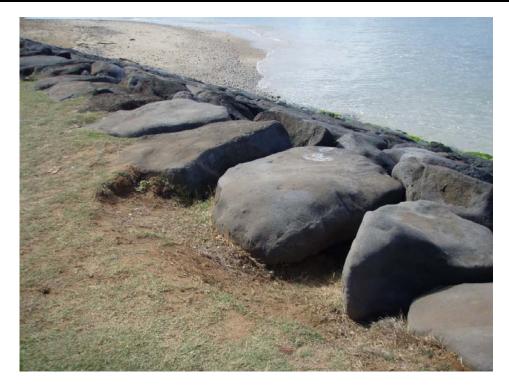
1. Sta. 11+00 Add fill material to eroded area.

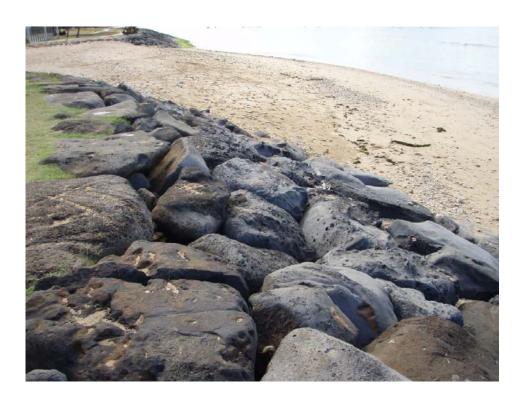
m. Sta. 12+88, Monitor sideslope settling. No change since FY03.

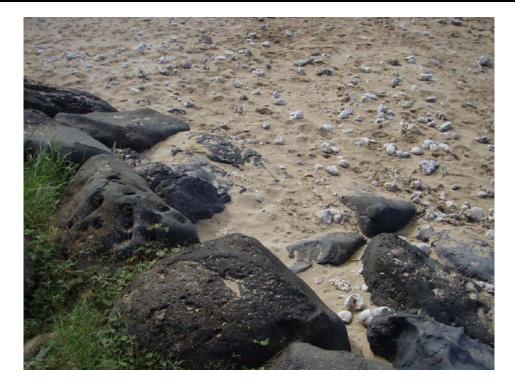
n. Sta. 12+92, Monitor the depressed area on sideslope. No change since FY03.

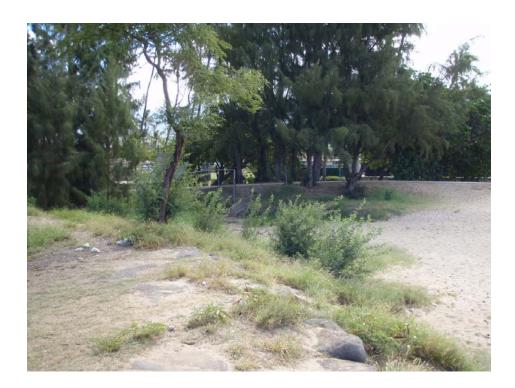
o. Sta. 13+29, Remove vegetation from revetment.

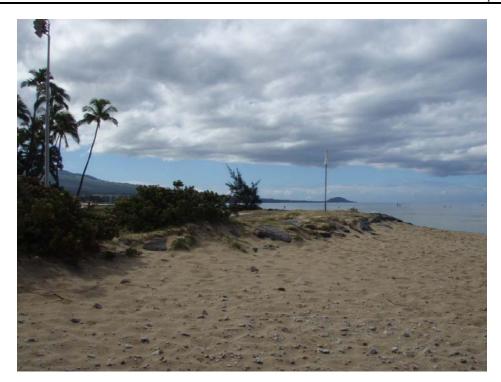
p. Sta. 13+80, No Change since FY04. Remove the vegetation from revetment .

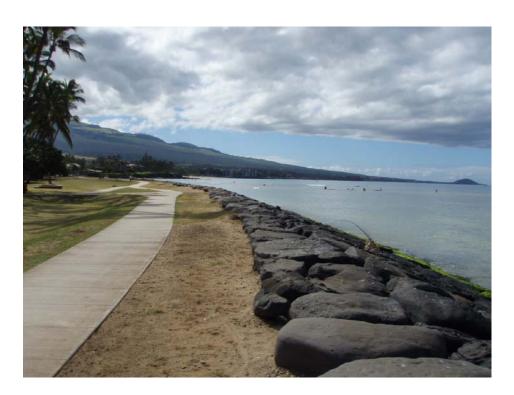
q. Sta. 23+00 to Sta. 20+00, Overview, backfill eroded area filled sidewalk new this inspection.

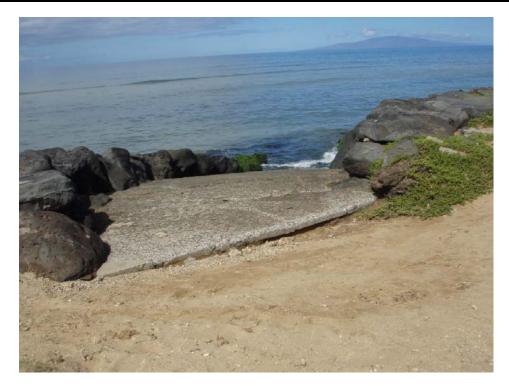
r. Sta. 23+11, 3rd Access walkway, add fill material to eroded area.

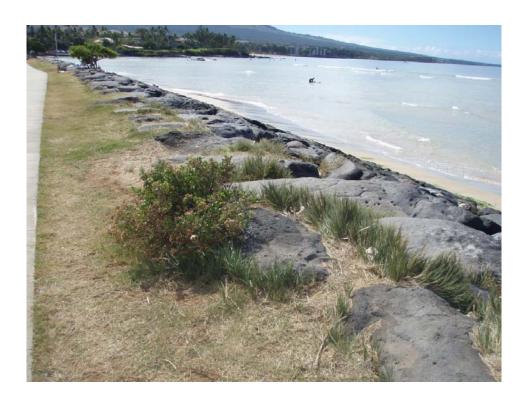
s. Remove juvenile vegetation from revetment.

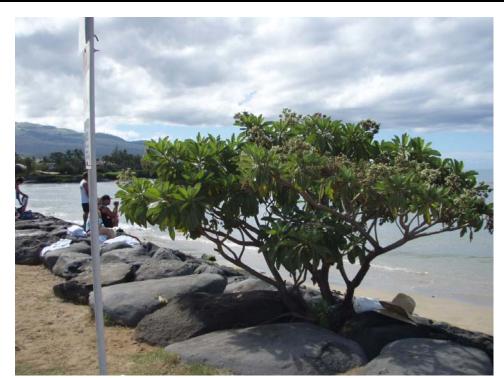
t. Sta. 24+50, Remove tree from revetment.

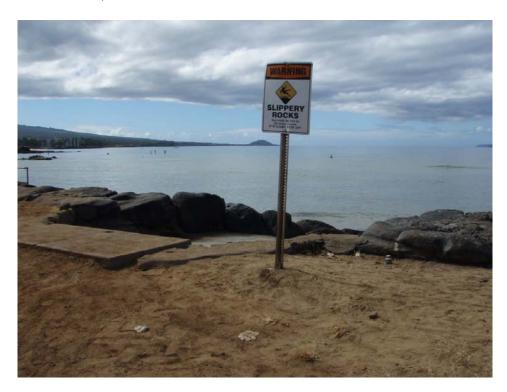
u. Sta. 23+50, Access walkway with recent repairs.

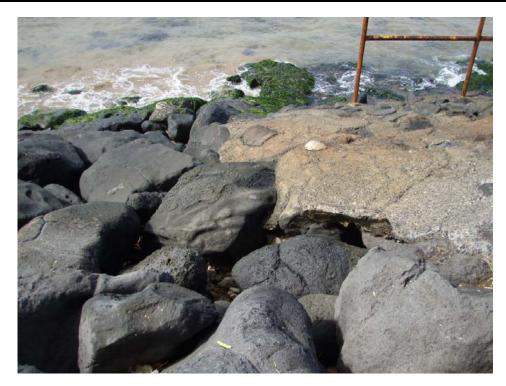
Sta. 23+75, Monitor the sideslope settling on the southside of the culvert and broken culvert rails removed.
