# Paonia Dam Outlet Works Repair

SPK-2016-00228

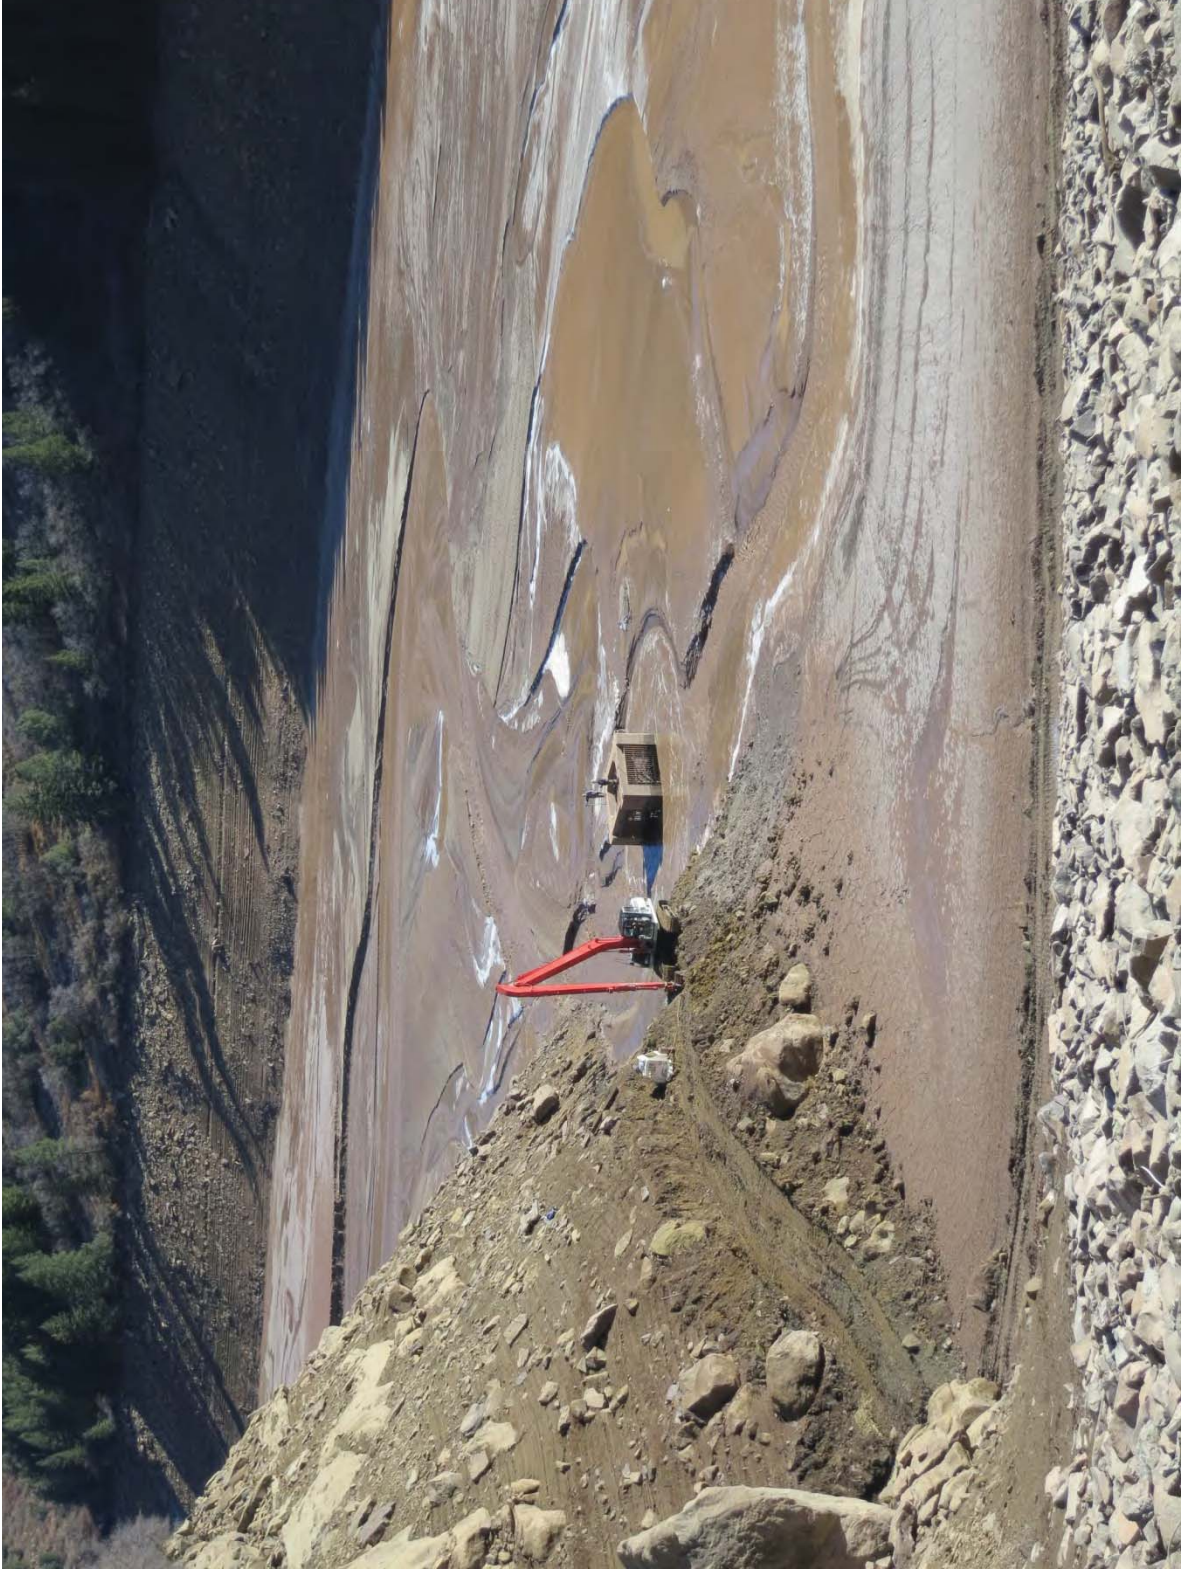
Figure 1- Access ramp to outlet works constructed in 2014.

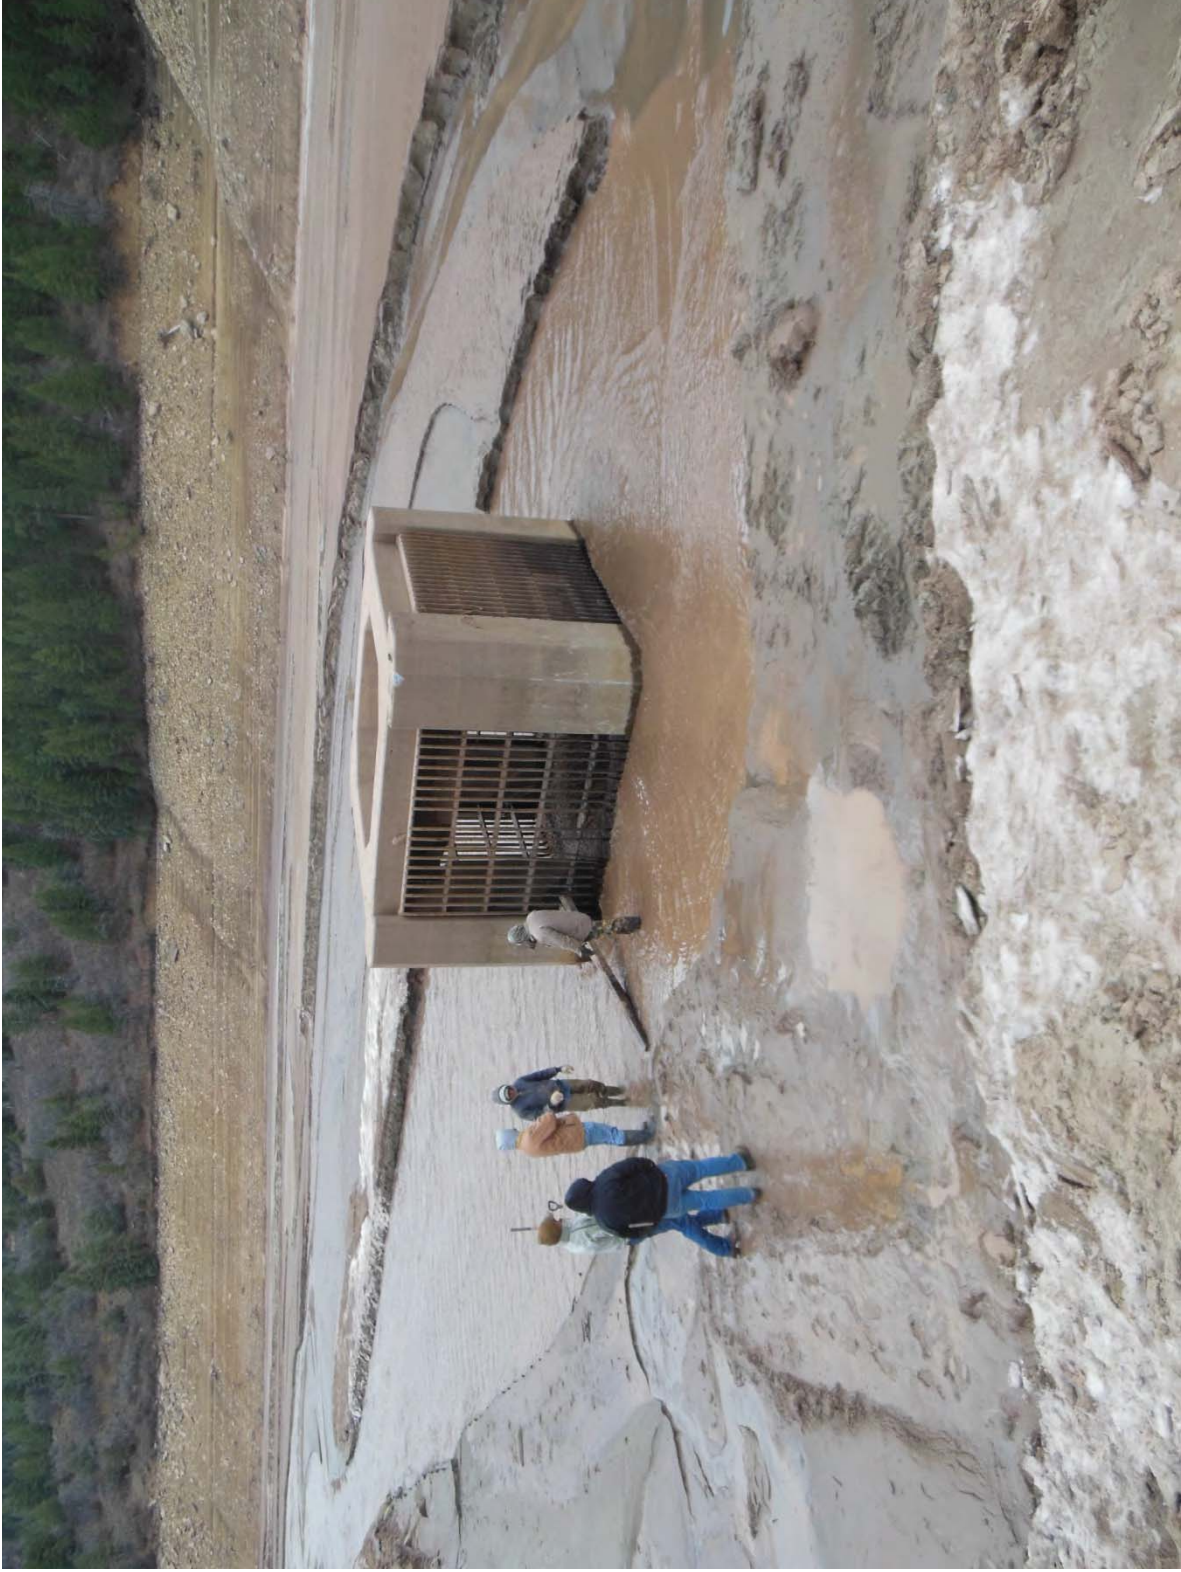
Figure 2- Low flow channel eroded through sediment deposit in 2014.

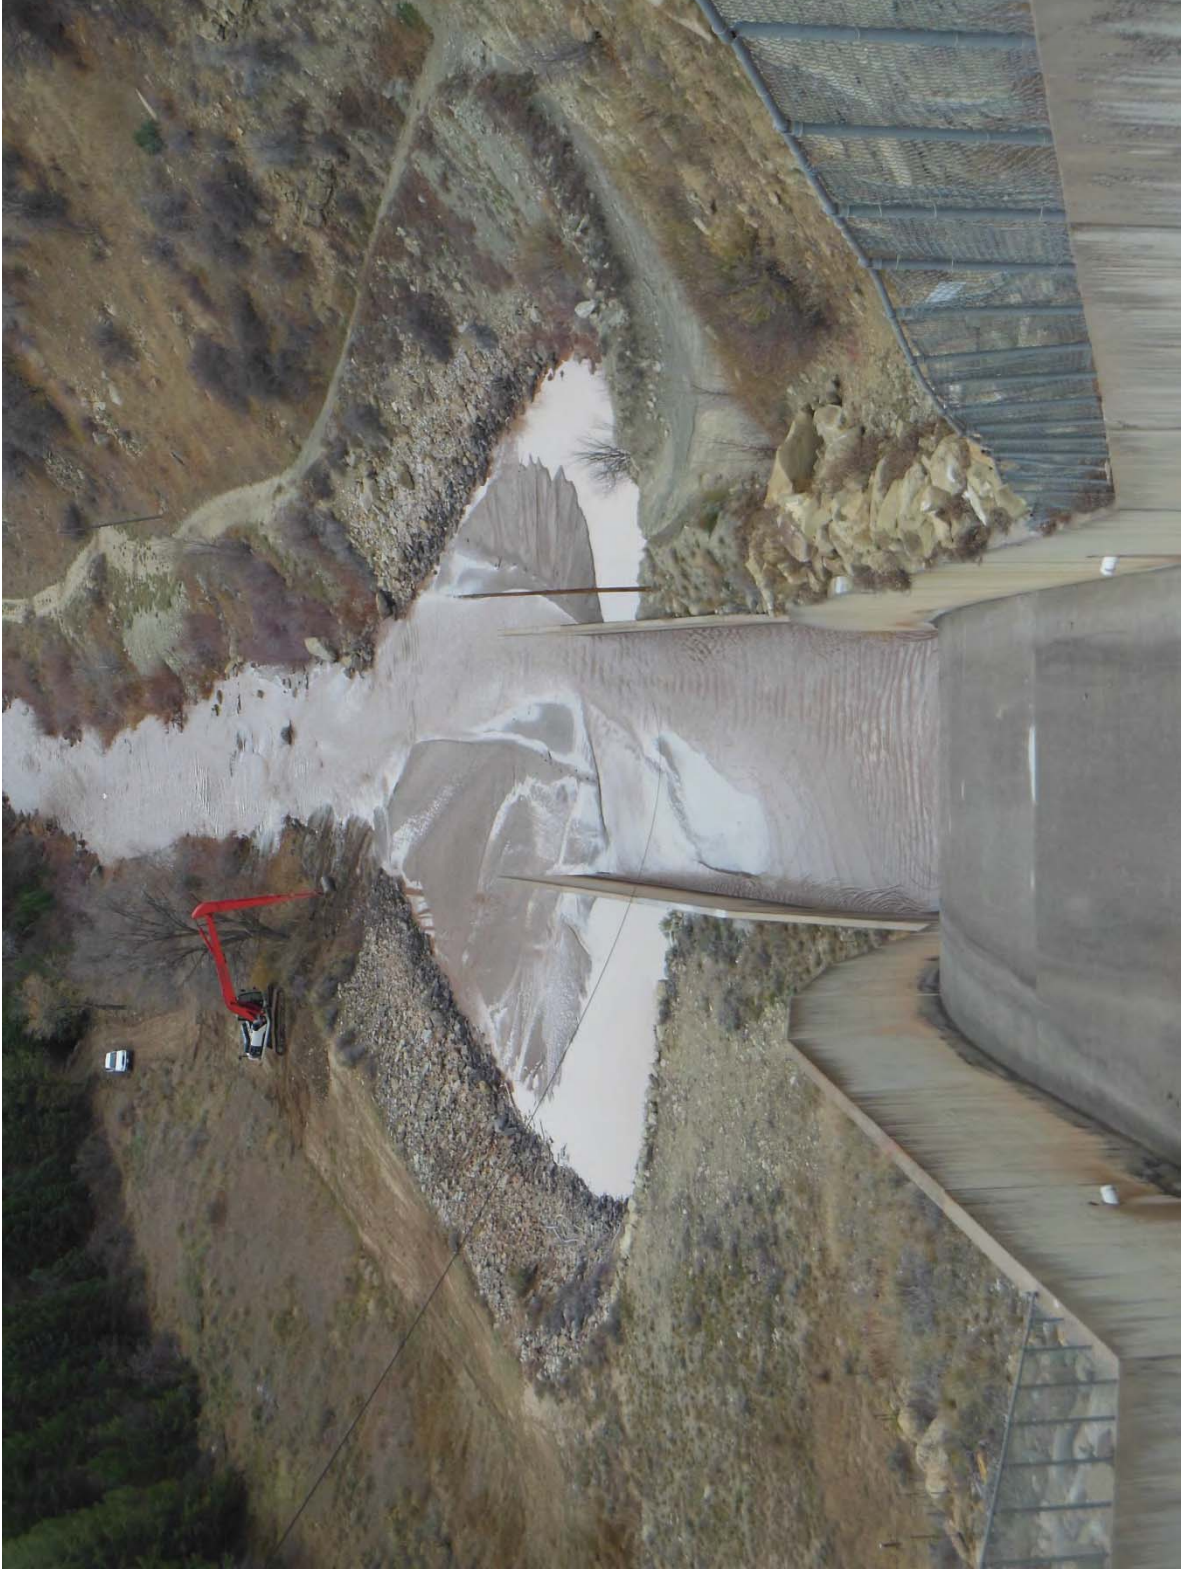
Figure 3- Sediment accumulation downstream of stilling basin observed in 2014.
