## West Sand Island Shore Stabilization

### Description

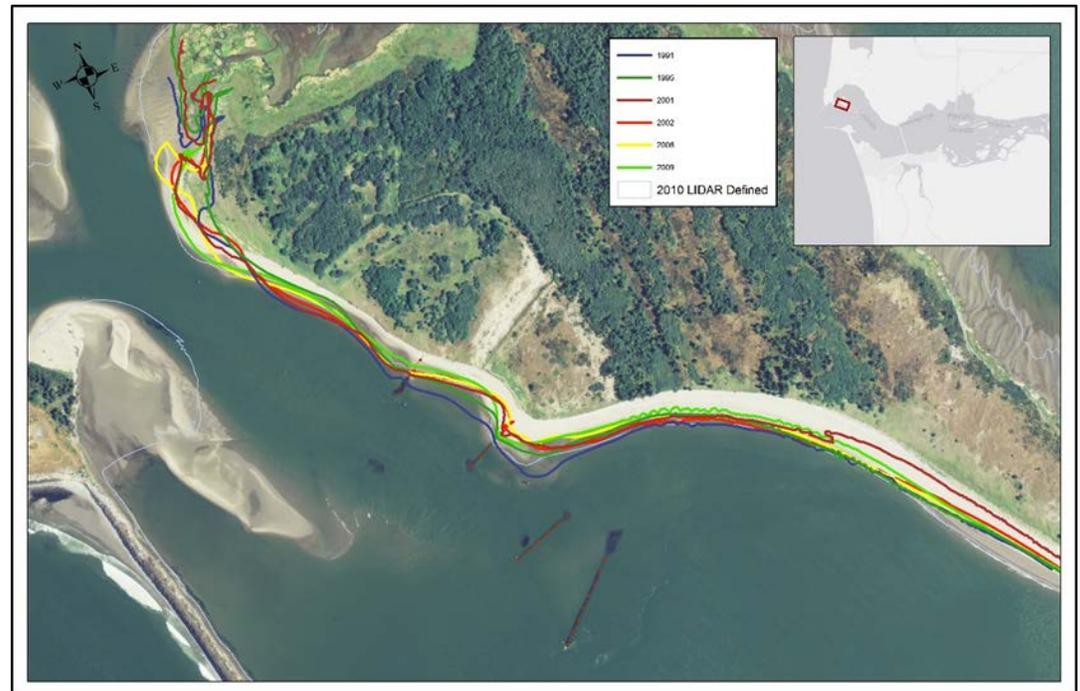
West Sand Island – Historical Photogrammetry of Shoreline Movement

Pile dikes in the Baker Bay West (Ilwaco) Federal Navigation Channel (FNC) are severely degraded. The lost shore connection between the pile dikes and West Sand Island is allowing increased flow to pass between the pile dikes and the island. The result is a rapidly eroding West Sand Island, and an increasing loss in pile dike functionality. This has caused dramatic changes to the shoaling patterns in the FNC, which has required emergency dredging multiple times due to life safety concerns. Data collection and analysis is needed to move forward with a repair to these features, NWP would like to explore the option of beneficially using dredged material from the FNC to start restoring the shore connections.
