Regional Coastal Photograph Archive of the Beach Erosion Board

Andrew Morang, Ph.D.

U.S. Army Engineer Research and Development Center

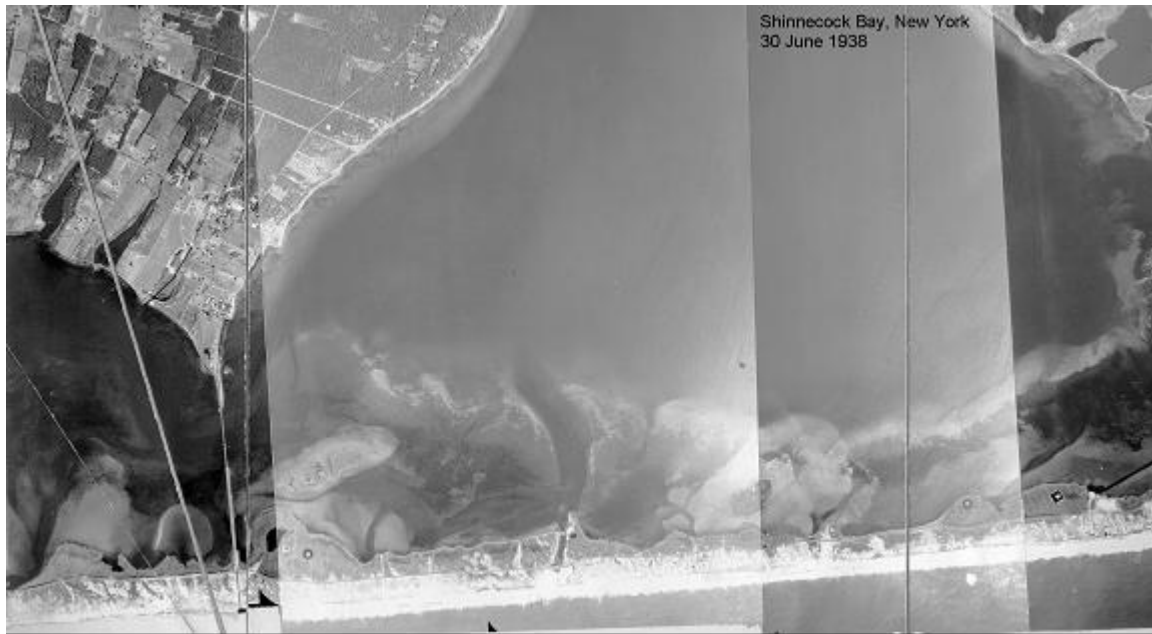
Figure 1. Shinnecock Bay, Long Island, New York, June 30, 1938. Photograph taken before the Great New England Hurricane of September 21, cut the barrier island in several locations. The present Shinnecock Inlet was cut where a channel crosses from the bay to the road. The channel may be a remnant of an artificial cut dug by the Shinnecock and Peconic Canal Company in 1896. Shoal areas in the bay near the barrier attest to former inlets that had been open long enough to form flood shoals. North is to the top, the water body in the center of the image is Shinnecock Bay, and the Atlantic Ocean is on the bottom (Mosaic prepared by the Beach Erosion Board).

June 1938, and September 24, 1938, only 3 days after the Great New England hurricane crossed Long Island and caused catastrophic damage throughout New England (Figures 1 and 2). The post-storm flights show hundreds of channels and overwash fans on the south shore beaches. Many Long Island images are labeled, “U.S. Army Air Corps, 97th Obs. Sq., Mitchel Field, NY,” demonstrating a fruitful cooperation between the Army Air Corps and the BEB. The barrier island near Ocean City, Maryland, was breached by a hurricane on August 25, 1933. In the 70 years since then, Assateague Island has receded more than 1,000 m, which can be confirmed from the 1933 photograph, where the shores on both side of the new inlet are aligned (Figure 3). The hurricane of record on the New Jersey shore was the September 14, 1944, Category 3 storm that caused over 390 deaths in the Northeast. One day later, the U.S. Navy took a series of high-quality photographs from a blimp to document property damage (Figure 4).

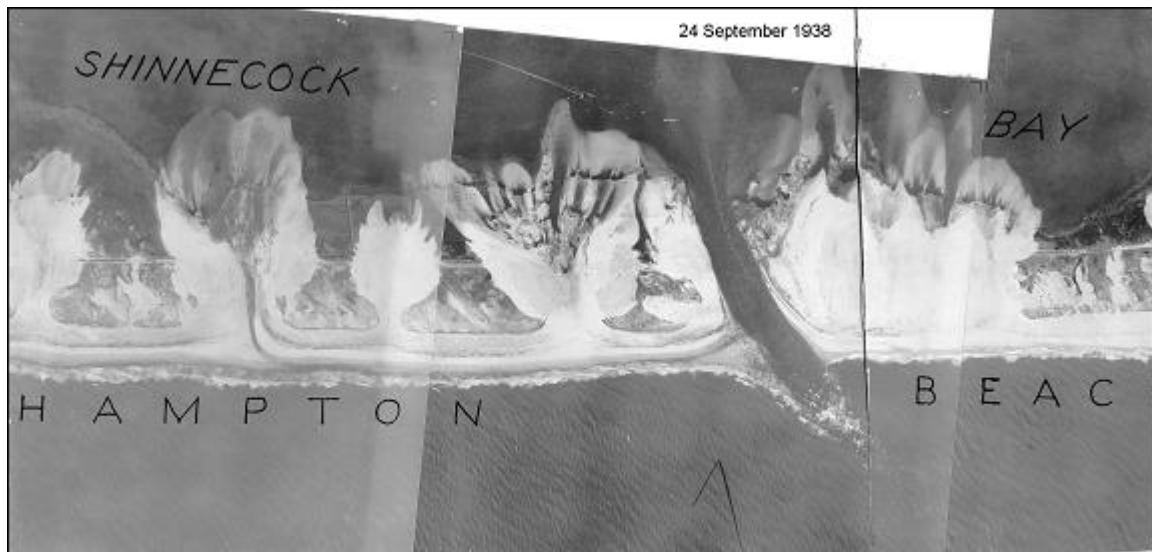
Figure 2. Shinnecock Inlet, Long Island, New York, September 24, 1938. Taken 3 days after Great New England Hurricane breached the barrier, this image shows the new Shinnecock Inlet and many overwash fans along the adjacent shore. Immediately after the storm, all the breaches along this stretch of the coast trended left of shore-perpendicular (Mosaic made at the Beach Erosion Board, original photographs from U.S. Army Air Corps, Mitchel Field).

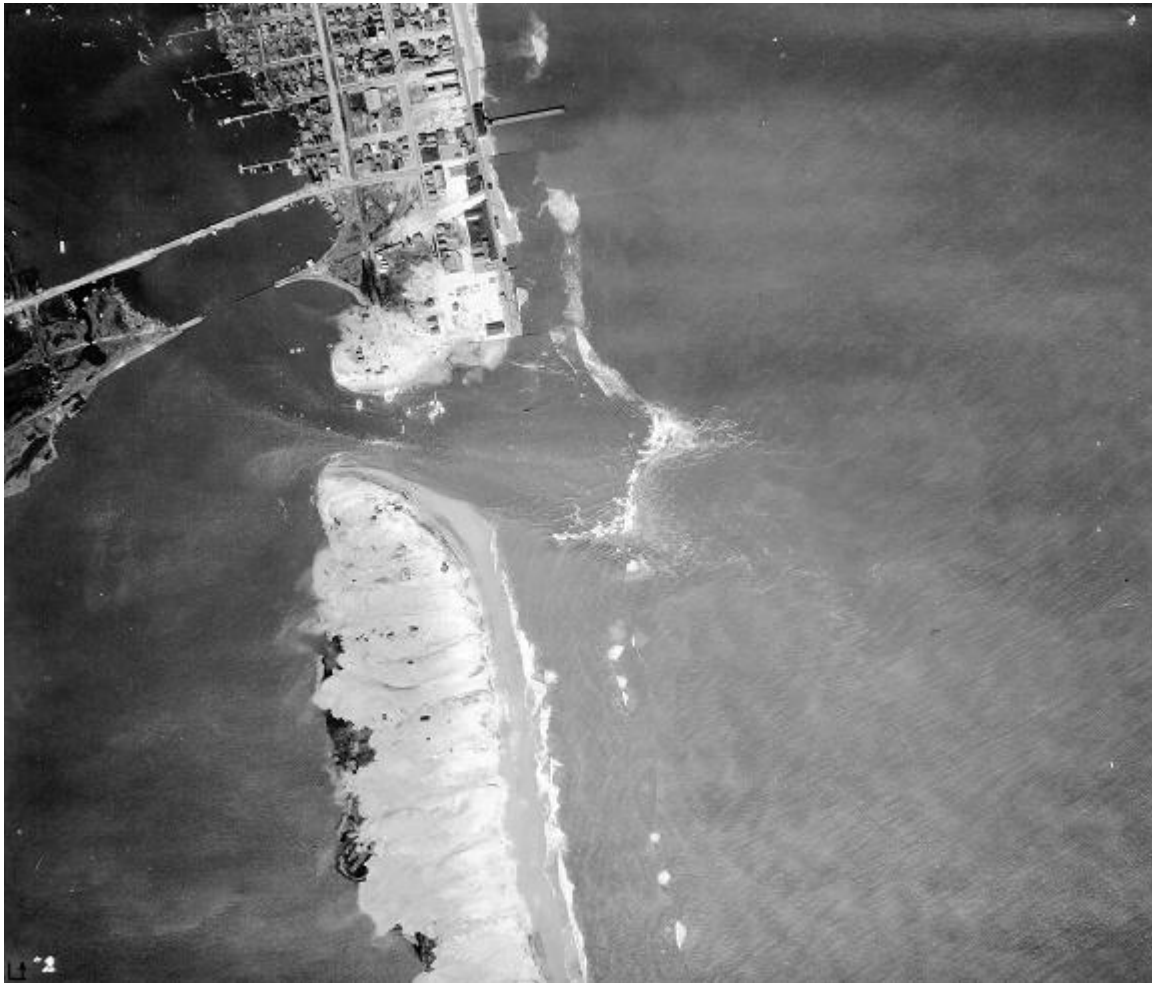
Figure 3. Ocean City Inlet, Maryland, September 1933. Ocean City is on Fenwick Island in the top center of the image, the Atlantic Ocean is to the right, and Assateague Island is on the bottom. This photograph was taken only 1 month after a hurricane breached the barrier island. Note waves breaking at the edge of a small ebb shoal.

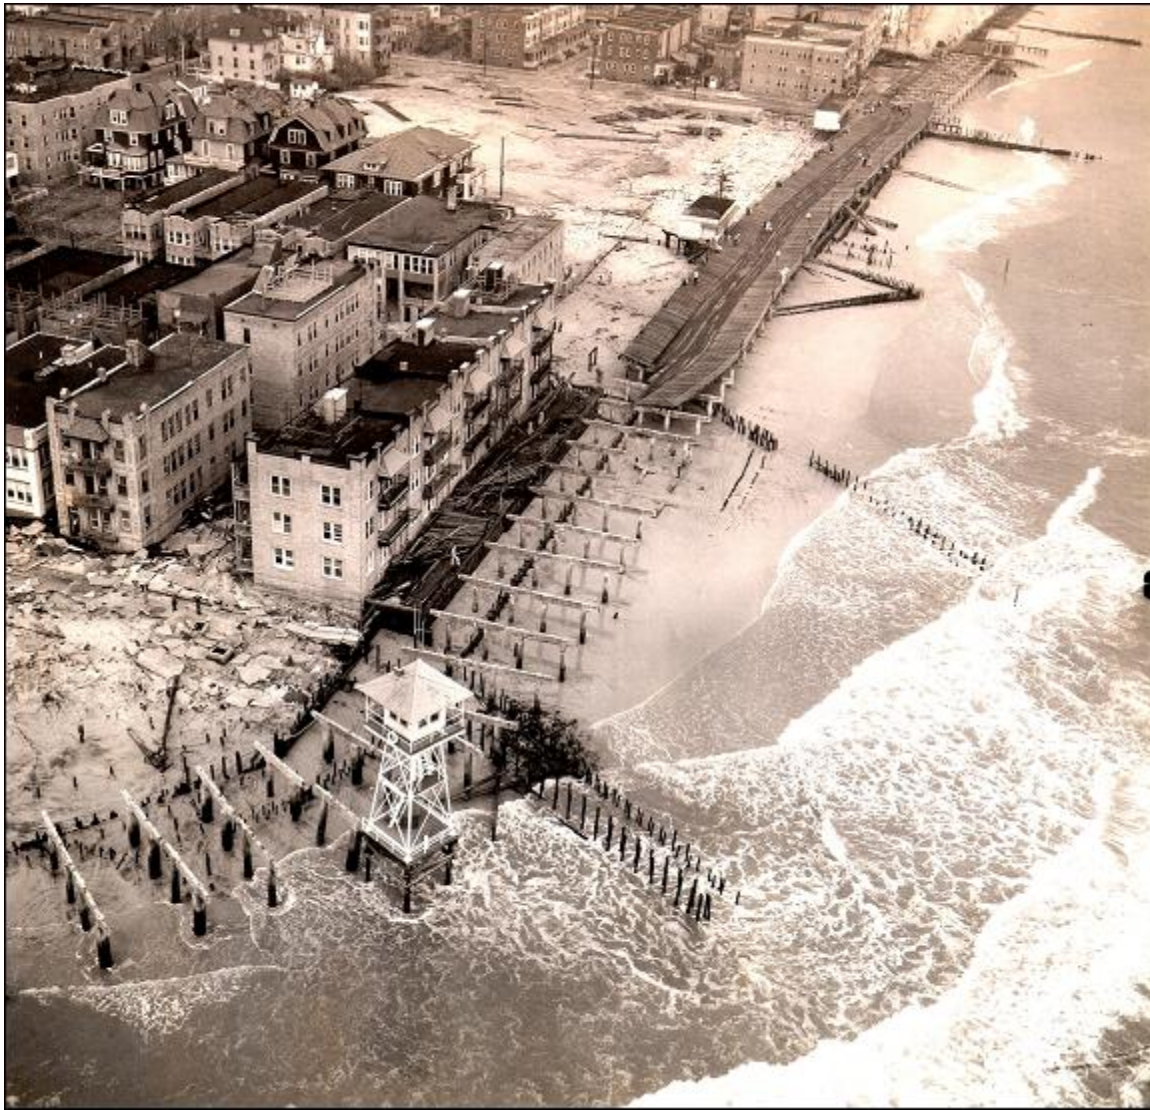
Figure 4. Atlantic City, New Jersey, at the mouth of Absecon Inlet, September 15, 1944. This is one of a series of images taken after the hurricane of September 14, a Category 3 storm that caused 390 deaths in the northeast U.S. This photograph illustrates the degree of urban development along this coast. Photograph taken from a blimp from the U.S. Naval Air Station, Lakehurst, New Jersey (Official U.S. Navy Photograph).

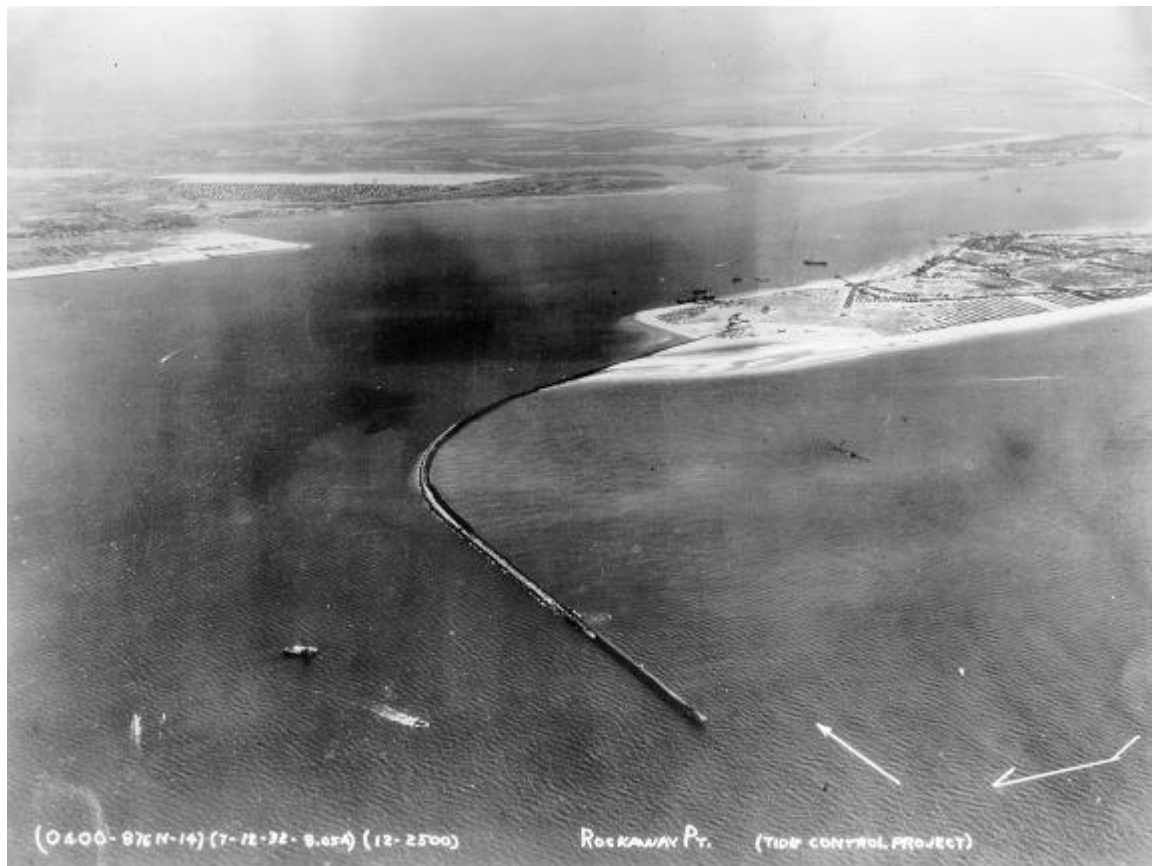
Figure 5. Construction of the jetty on the east side of Rockaway Inlet, Long Island, New York, July 12, 1932. The urban area on the opposite side of the inlet is the east end of Coney Island, and Jamaica Bay is in the distance. In 7 decades, the fillet has filled with sand to approximately the end of the jetty seen in this image.

In addition to notable storms, the BEB also documented major coastal infrastructure projects. For example, Figure 5 shows the terminal groin at Rockaway Point on Long Island under construction in 1932. Many federal jetties constructed during the late 1800s and early 1900’s were built using a railroad trestle that was erected out into the water. Rail cars brought in the stone, which was placed by crane (Figure 6). Although many inlets were first cut by hurricanes, others, like Manasquan, on the New Jersey shore, were artificially cut in 1930 (Figure 7). Other artificially-cut openings that are now Federal navigation projects include Panama City Inlet, Florida, East Pass, Florida, Duluth Cut, Minnesota, and Aransas Pass, Texas. Only 3 years after the opening of Manasquan, the south fillet was almost full, clear proof of northward longshore littoral transport (Figure 8).

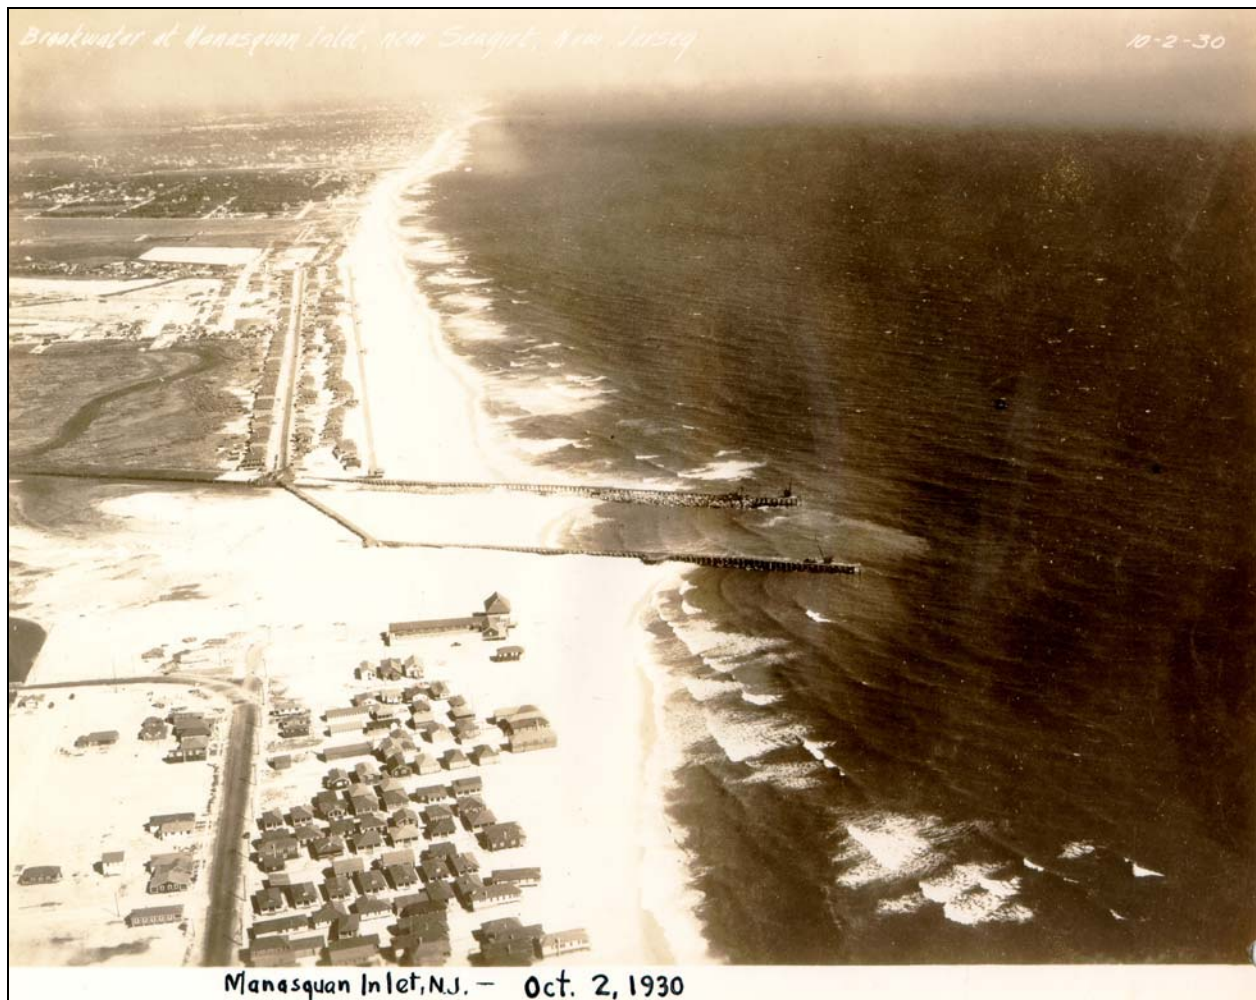
Figure 7. Construction of Manasquan Inlet jetties, New Jersey, October 2, 1930, view looking north. Material for the jetties was supplied via an elevated roadway that extended out to sea from the land. Note that sand is already accumulating on the south (lower) side of the south jetty. The shoreline is continuous, and at this site the inlet was dredged after the jetties were completed.

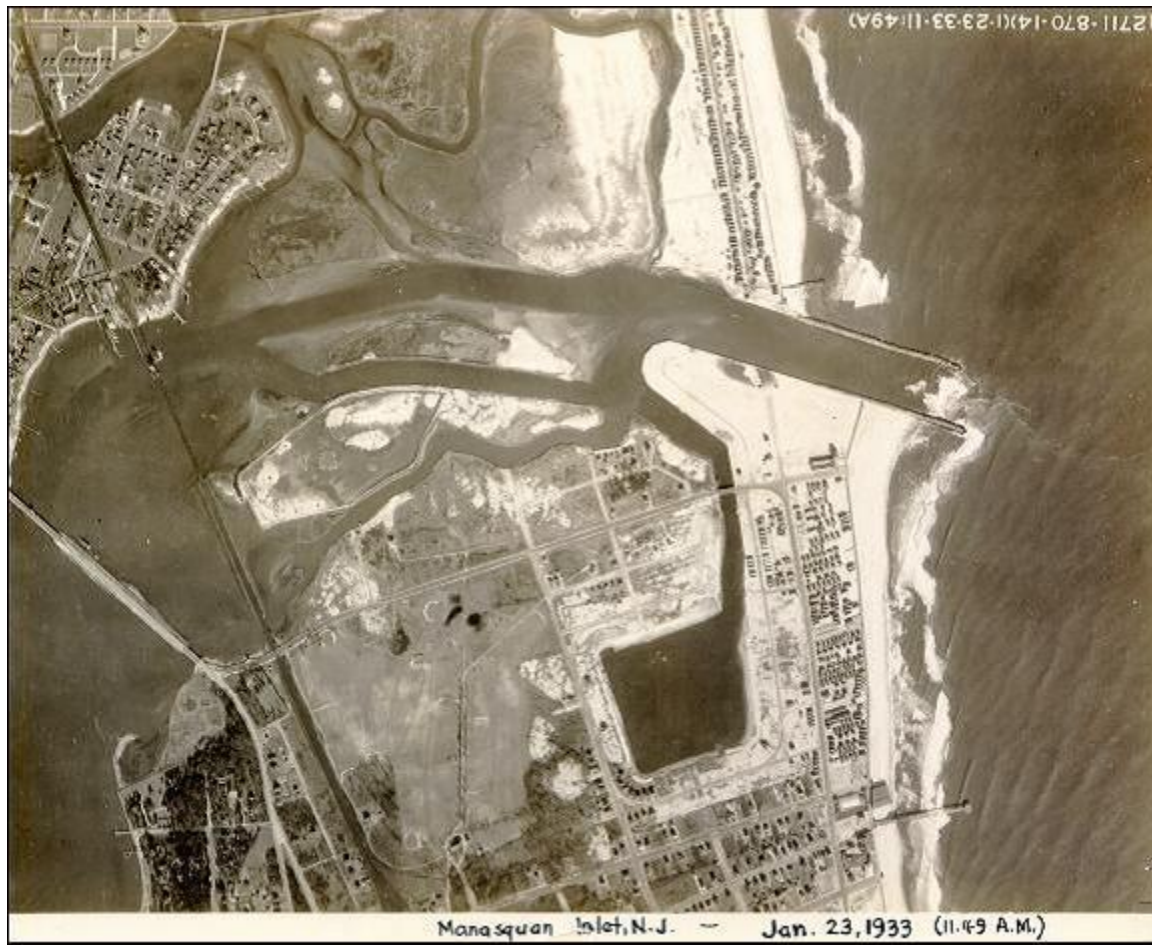
Figure 8. The recently opened Manasquan inlet, January 23, 1933. The south fillet has almost filled with sand, and developers have built a road seaward of the seaward-most row of cottages in Figure 7.

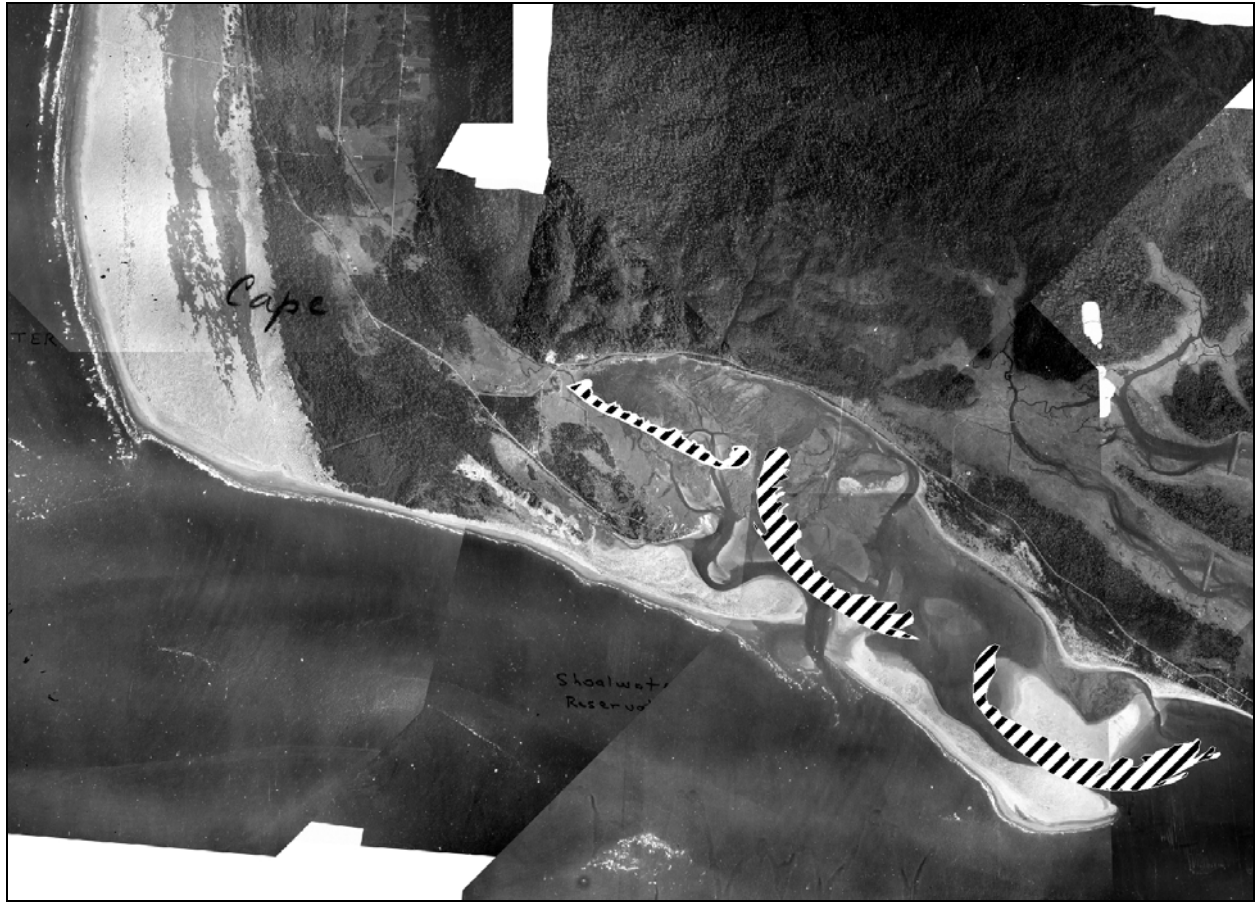
Figure 10. North Willapa Bay, Washington State. This mosaic consists of six frames flown on September 19, 1945. These have been photogrammetrically rectified to create a map projection. The three islands (hatched polygons) were traced from an October 12, 2000, orthophoto. The shoreline retreat at the spit in the center of the map was 1,100 m, or 20 m/year. (Original photographs, BEB archives, mosaic courtesy of Washington State Department of Ecology).

One of the most valuable uses of historical vertical air photographs is for shoreline change measurements. Before measurements can be made, images have to be photogrammetrically rectified to remove distortions and create map projections with real coordinates (e.g., latitude-longitude, state plane, etc.). Once the photographs have been transformed, they can be superimposed in mapping or geographic information system (GIS) software, and features can be outlined and measured. Figure 10 is an example of a 1945 photo mosaic from the north shore of Willapa Bay, Washington. This area is said to have some of the most extreme sustained erosion in the United States. Outlines of Graveyard Spit and two islands, traced from a 2000 orthophoto, have been superimposed on the mosaic to show how the shore has retreated. At the spit on the west (left), the shore retreated northward over 1.1 km in 55 years, or about 20 m/year.
