Kihei and North Shore Shoreline Change Studies

State of Hawaii Department of Land and Natural Resources

US Army Corps of Engineers, Honolulu District

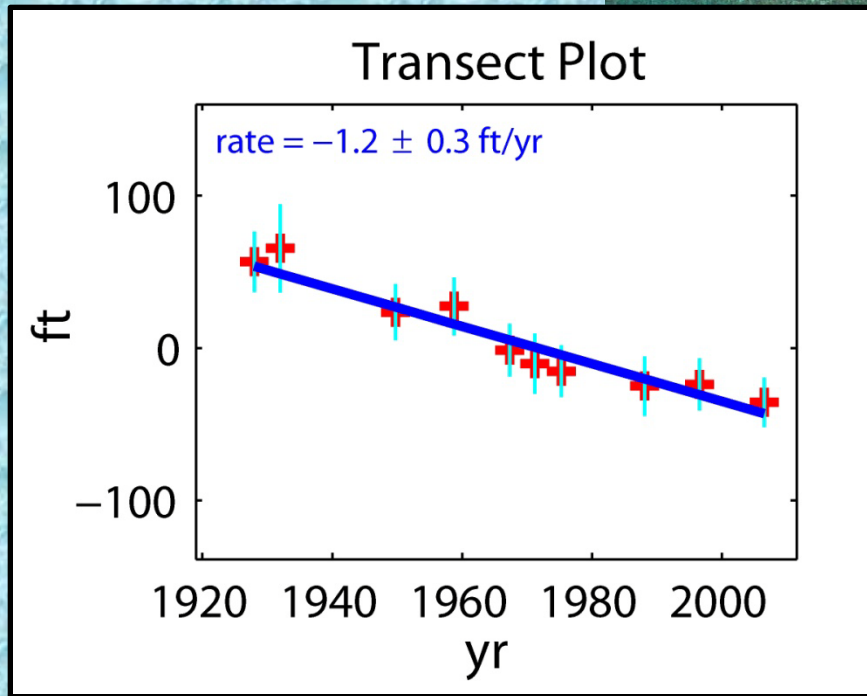
Mapping Historical Shorelines

portion of an aerial photo mosaic

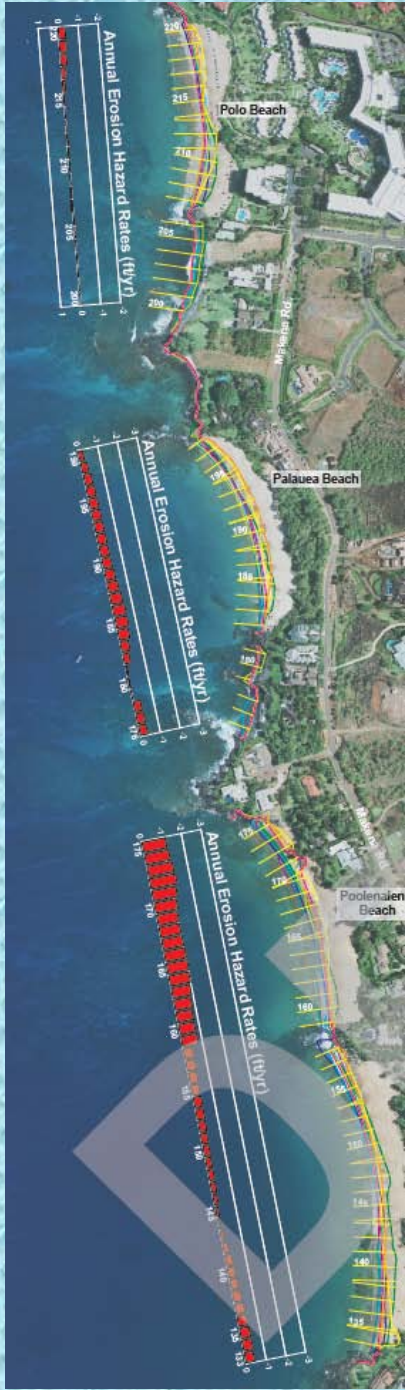
South Wailea

88	-0.322	-44.6
89	-0.249	-37.5
90	-0.154	-32.7
91	-0.151	-32.6
92	-0.187	-34.4
93	-0.188	-34.4
94	-0.870	-68.5
95	-0.783	-64.2
96	-0.656	-57.8
97	-0.505	-50.2
98	-0.392	-44.6
99	-0.324	-41.2
100	-0.284	-39.2
101	-0.234	-36.7
102	-0.175	-33.7
103	-0.124	-31.2
104	-0.106	-30.3
105	-0.127	-31.3
106	-0.159	-33.0
107	-0.164	-33.2
108	-0.133	-31.7
109	-0.105	-30.3
110	-0.165	-33.2
111	-0.289	-39.5
112	-0.471	-48.5
113	-0.193	-34.7
114	-0.249	-37.5
115	-0.337	-41.9
116	-0.456	-47.8
117	-0.803	-65.1
118	-0.832	-66.6
119	-0.617	-55.8
120	-0.601	-55.0
121	-0.595	-54.7
122	-0.587	-54.4
123	-0.498	-49.9
124	-0.515	-50.8
125	-0.431	-46.5
126	-0.307	-40.4
127	-0.165	-33.2
128	-0.074	-28.7

*Setback = 50 x AEHR + 25 ft

Erosion rates are measured every 20 m along the shoreline. These sites are denoted by yellow shore normal transects. The Annual Erosion Hazard Rate (red), is a spatially smoothed center weighted average of calculated erosion rates. Five contiguous transects are incorporated in the smoothing process. The transects are weighted: 1-3-5-3-1 with the smoothed rate assigned to the center transect. The AEHRs are shown on the shore-parallel histogram graph. Colored bars on the graph correspond to shore-normal transects; approximately every fifth transect and bar are numbered. Where necessary, some transects have been purposely deleted during data processing; as a result, transect numbering is not consecutive everywhere. Where complete beach loss has occurred, erosion rate calculations apply only to the time period when a beach existed.
