# Dredging, Sand Management and Habitat Restoration of a Jettied Inlet System, Chatham, MA

Ted Keon, Town of Chatham

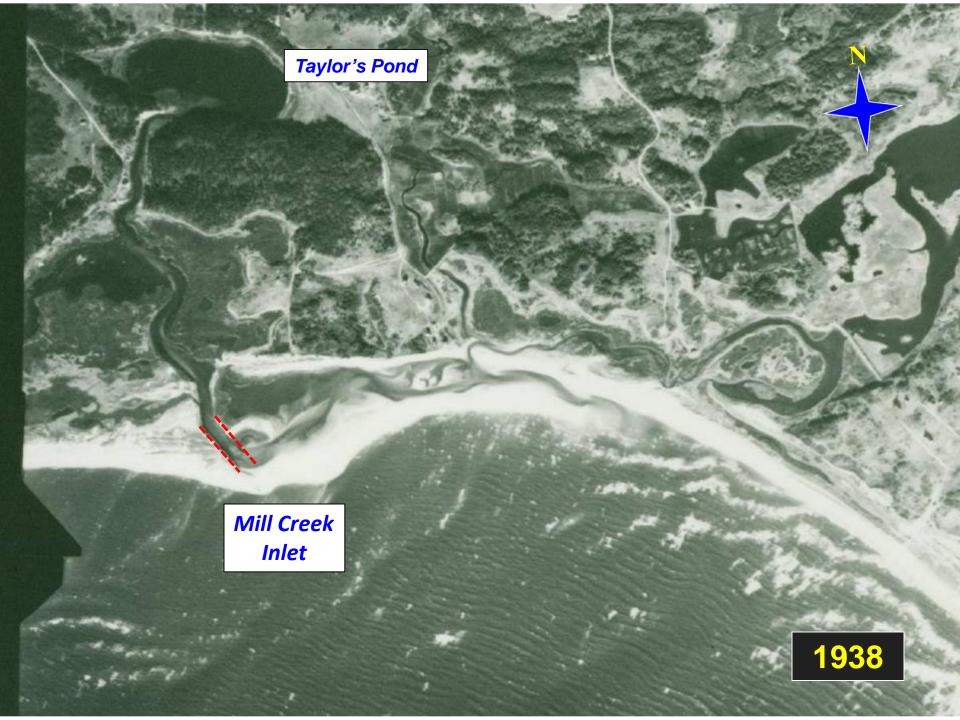
Taylor's Pond **Reduction in Sediment Flow** Early to mid-1960's: Groin field construction Re-designed western (updrift) stone jetty Old timber jetty cutoff at mudline **1966** Mill Creek Inlet

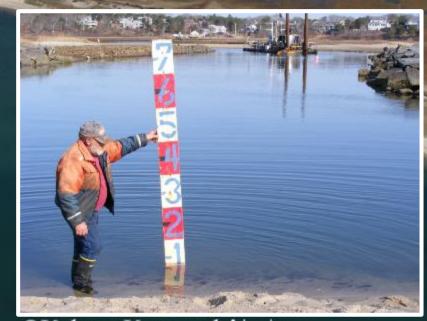
Taylor's Pond

#### <u>Issues</u>

- Poor flushing/water quality
- East jetty "flanking"
- Navigation impacts
- Shellfish habitat impacts
  - Abandonment of propagation beds

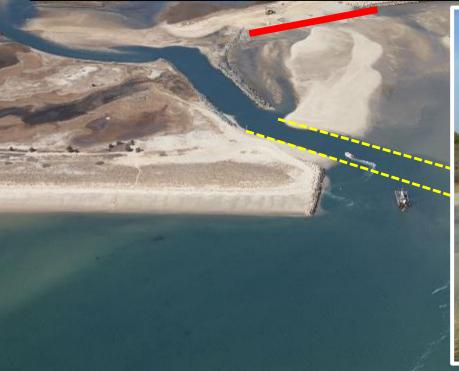
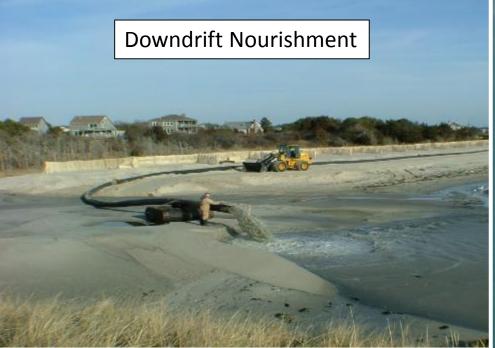
**March 2010**

## **Initial Project Completion: April 2010**

- Total volume removed: 14,000 cys
  - Channel and deposition basin only
  - Deferred fillet removal/habitat enhancement
- Flushing restored
- Shellfish propagation reestablished

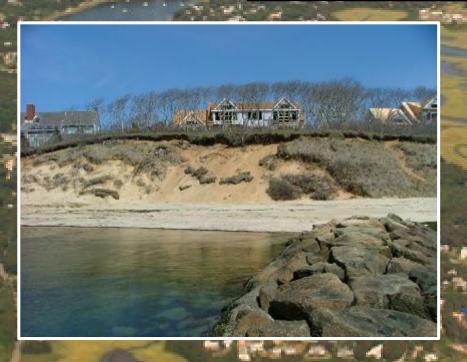
Mill Creek

Fillet Removal

# **Town Support:**

- Reduce inlet shoaling
- Sand back-passing
- Privately funded \$\$

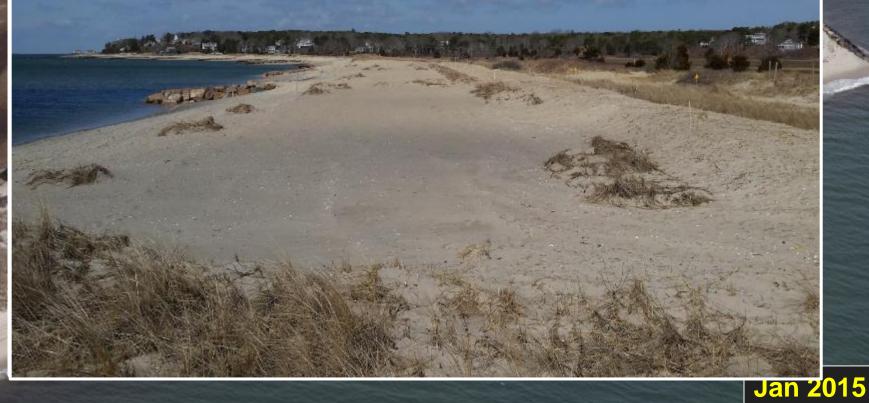
#### **Shorebird Habitat: Post-project**

- Removal of low dunes and vegetation
- Wide berm width
- Berm height above Spring Tide levels
- Gentle slopes
- Occasional grassy sand mounds (refuge)
