# Reginal Sediment Management of Watersheds, Reservoirs, and Rivers

## John Shelley, Ph.D., P.E. Paul Boyd, Ph.D., P.E. Linda Lillycrop

# Outline

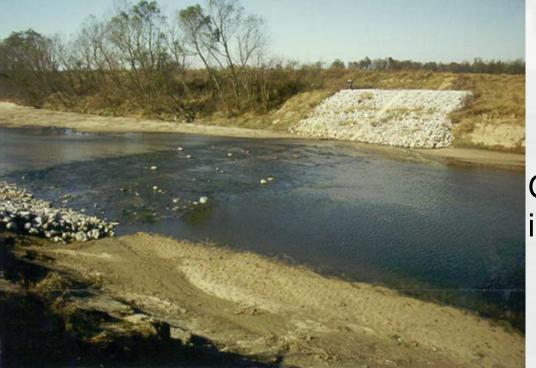
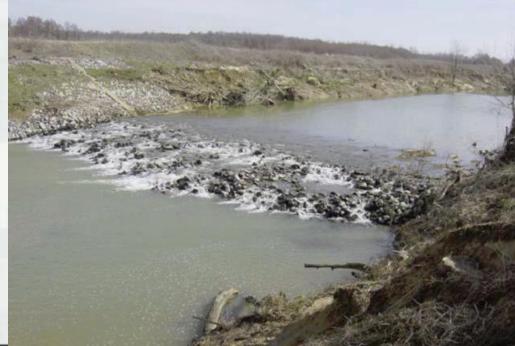
# Grade control sills, immediately after construction

# Grade control sills, after 10 years

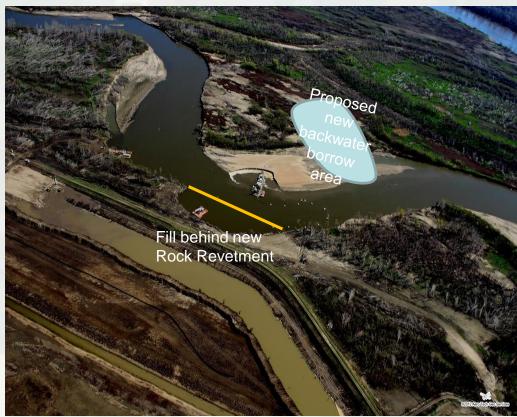
#### **Hamburg Bend Chute Levee**

Missouri River erosion in Upper Hamburg Bend Chute, which encroached on the toe of the Federal levee

To prevent further damage to levee, a rock revetment was added at the failure point 40,000 tons of riprap placed to create fill area, dredge backfill. Also dredge to create seepage berm

Initial dredging from point bar, additional dredging done to create backwater for shallow water habitat

**Result:** Dredging of backwater for shallow water habitat provides fill for repair at less cost as other sources while supporting habitat creation for the MRRP

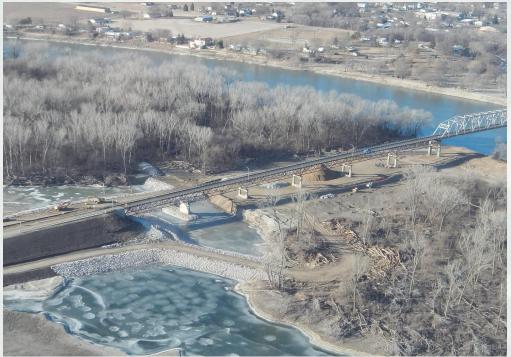
#### **Decatur Bridge Repair**

Bridge abutment toe eroded during flood Repair of bridge abutment required significant fill material

USACE worked with Iowa Dept Natural Resources, IA DOT to develop plan to armor abutment and create habitat ponds

Dredged material used to build control structures and bank stabilization near bridge abutment Project restored depth to SWH / wetlands, increasing function at lower cost than other borrow material sources

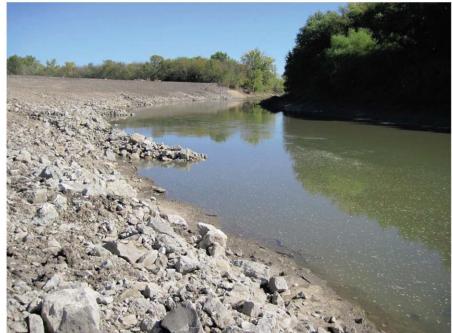
# Bank Erosion Hot Spots

21 times more cost-effective than reservoir dredging
