# Case Studies in Reclamation

## Reservoir Sediment Management & Analysis for Engineers

**Blair Greimann, US Bureau of  
Reclamation, Technical Service Center**

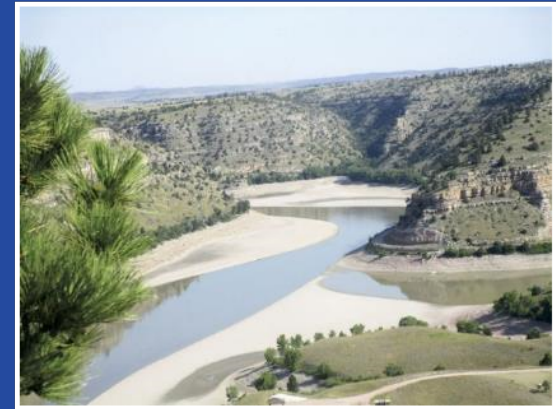
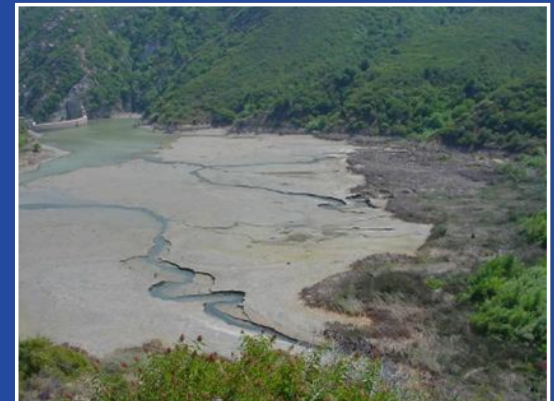
# Black Canyon Dam Payette River, Idaho

Penstock at Ele 2472 ft

Boat ramp filled in

Approximately 17,000 acre-ft  
remaining of an original 45,000

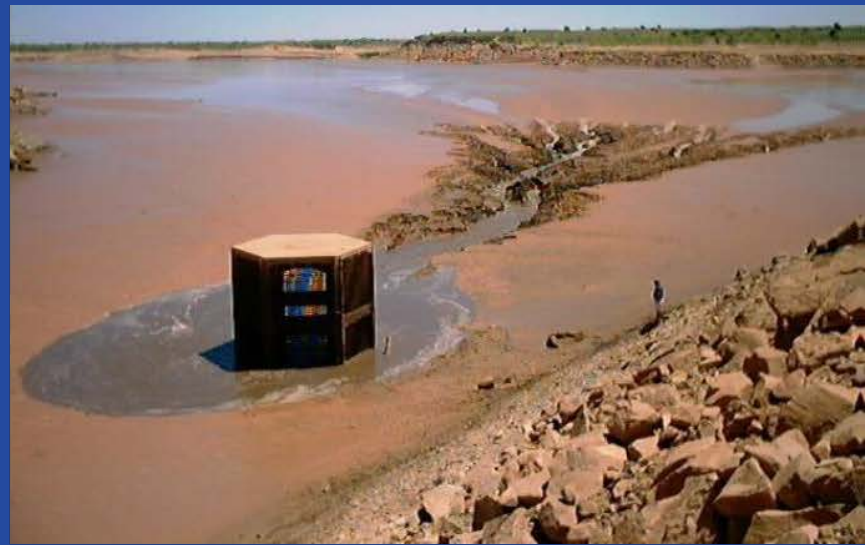
# Sumner Dam

- Zoned Earthfill Embankment, 164 ft high
- Located in NM on Pecos River
- Completed in 1937
- Primarily used for irrigation
- Constructed with a capacity of about 100,000 acre-ft, and now about 50% full of sediment
- Sedimentation Rate slowed with construction of upstream dam in 1979 (Santa Rosa Dam)

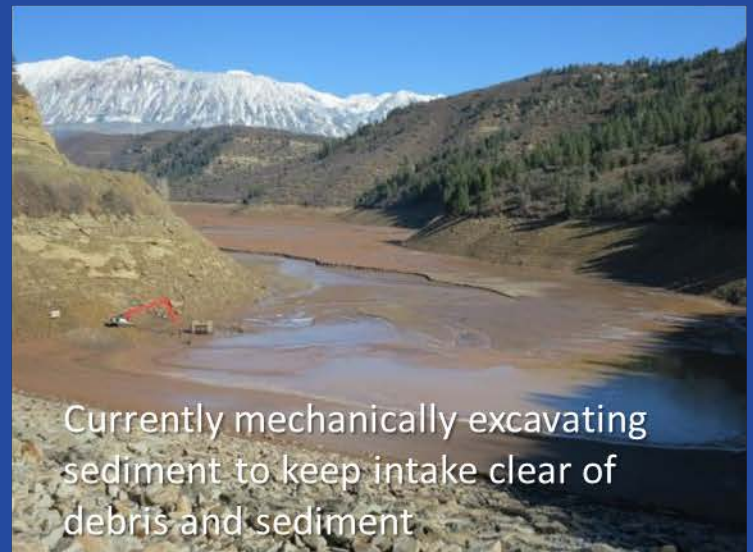
Intake tower was constructed 18 m  
above bed

Currently mechanically excavating  
sediment to keep intake clear of  
debris and sediment

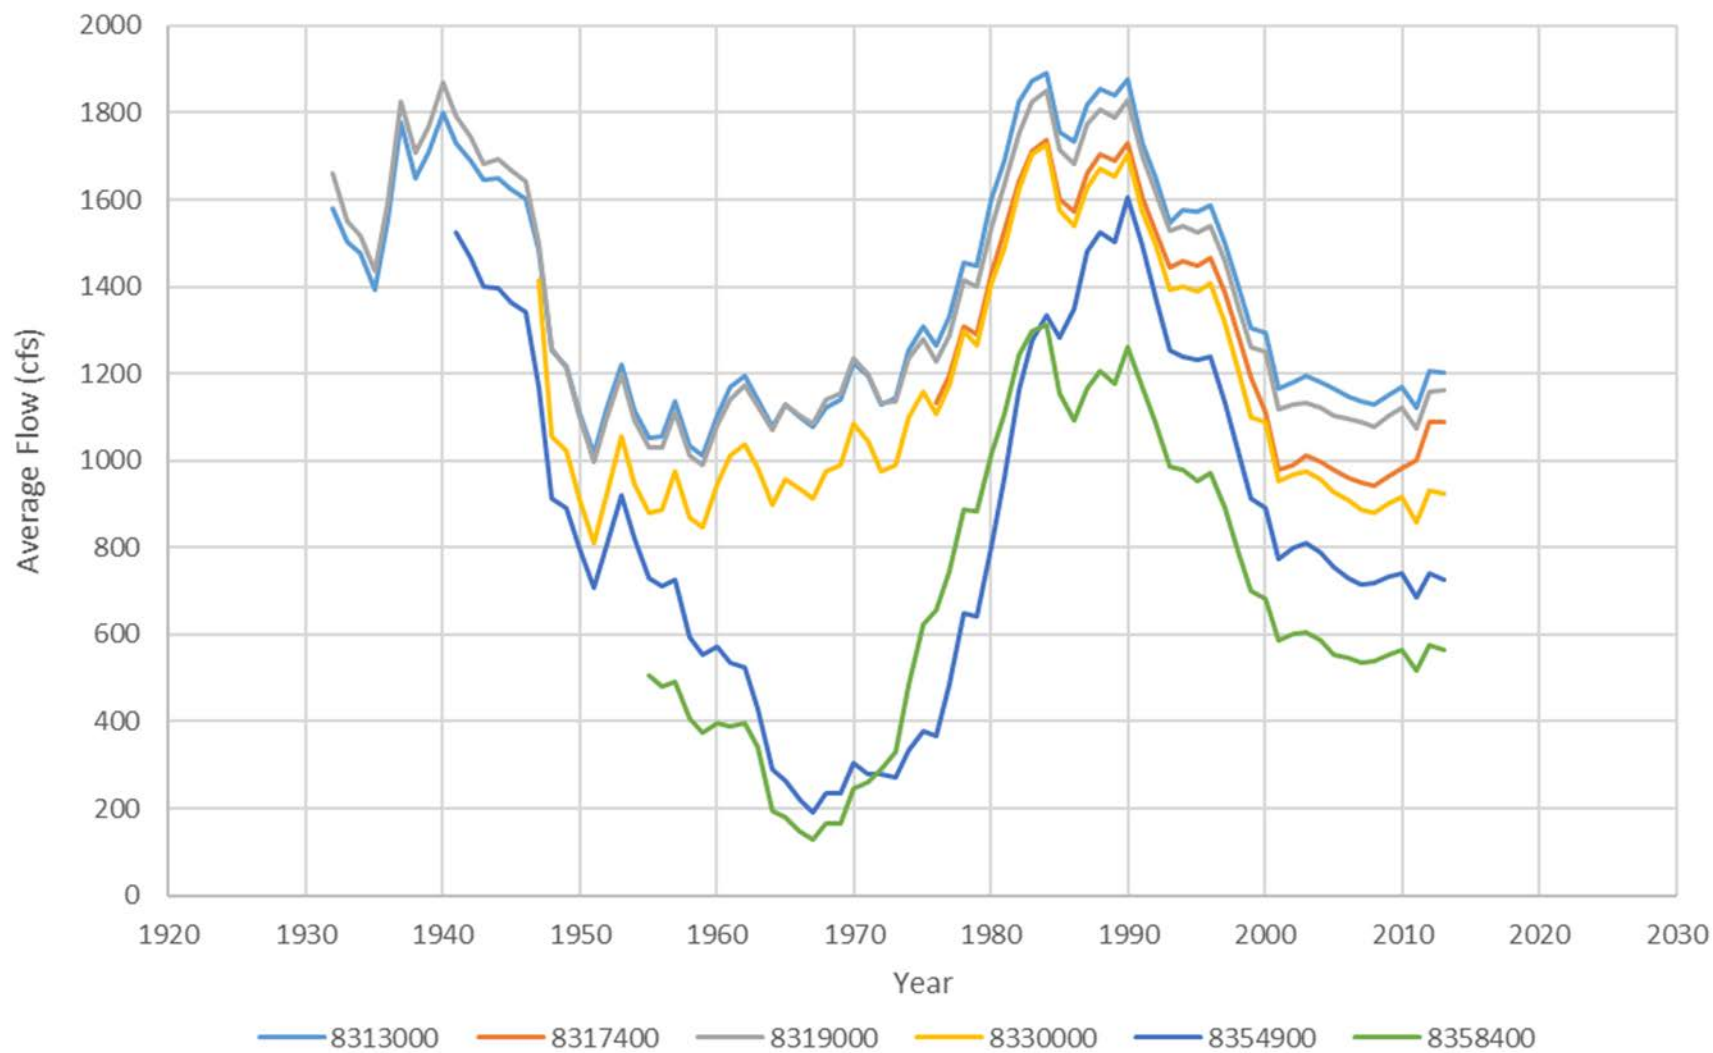
10 yr Moving Average Flow on Middle Rio Grande at Various Stream Gages
