Pressure Flushing of Reservoir Sediment

**Reservoir Sediment Management
& Analysis for Engineers**

**Blair Greimann, US Bureau of
Reclamation, Technical Service Center**

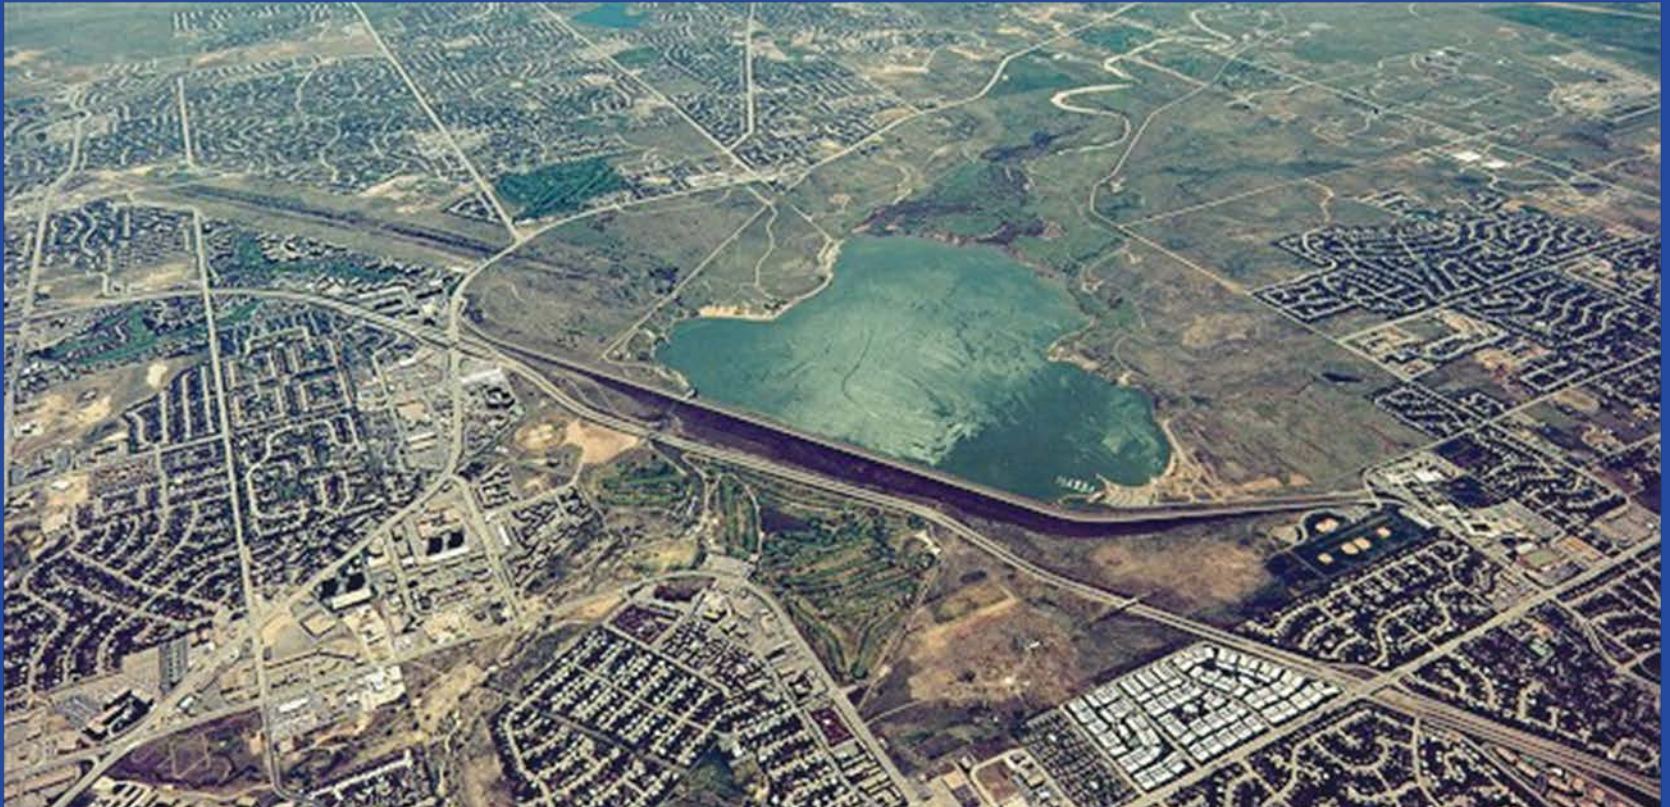
Cherry Creek Flush

- Pressure flush to maintain operational capability at low level outlet
- Every year alternating high (1300 cfs) and low (250 cfs) flow

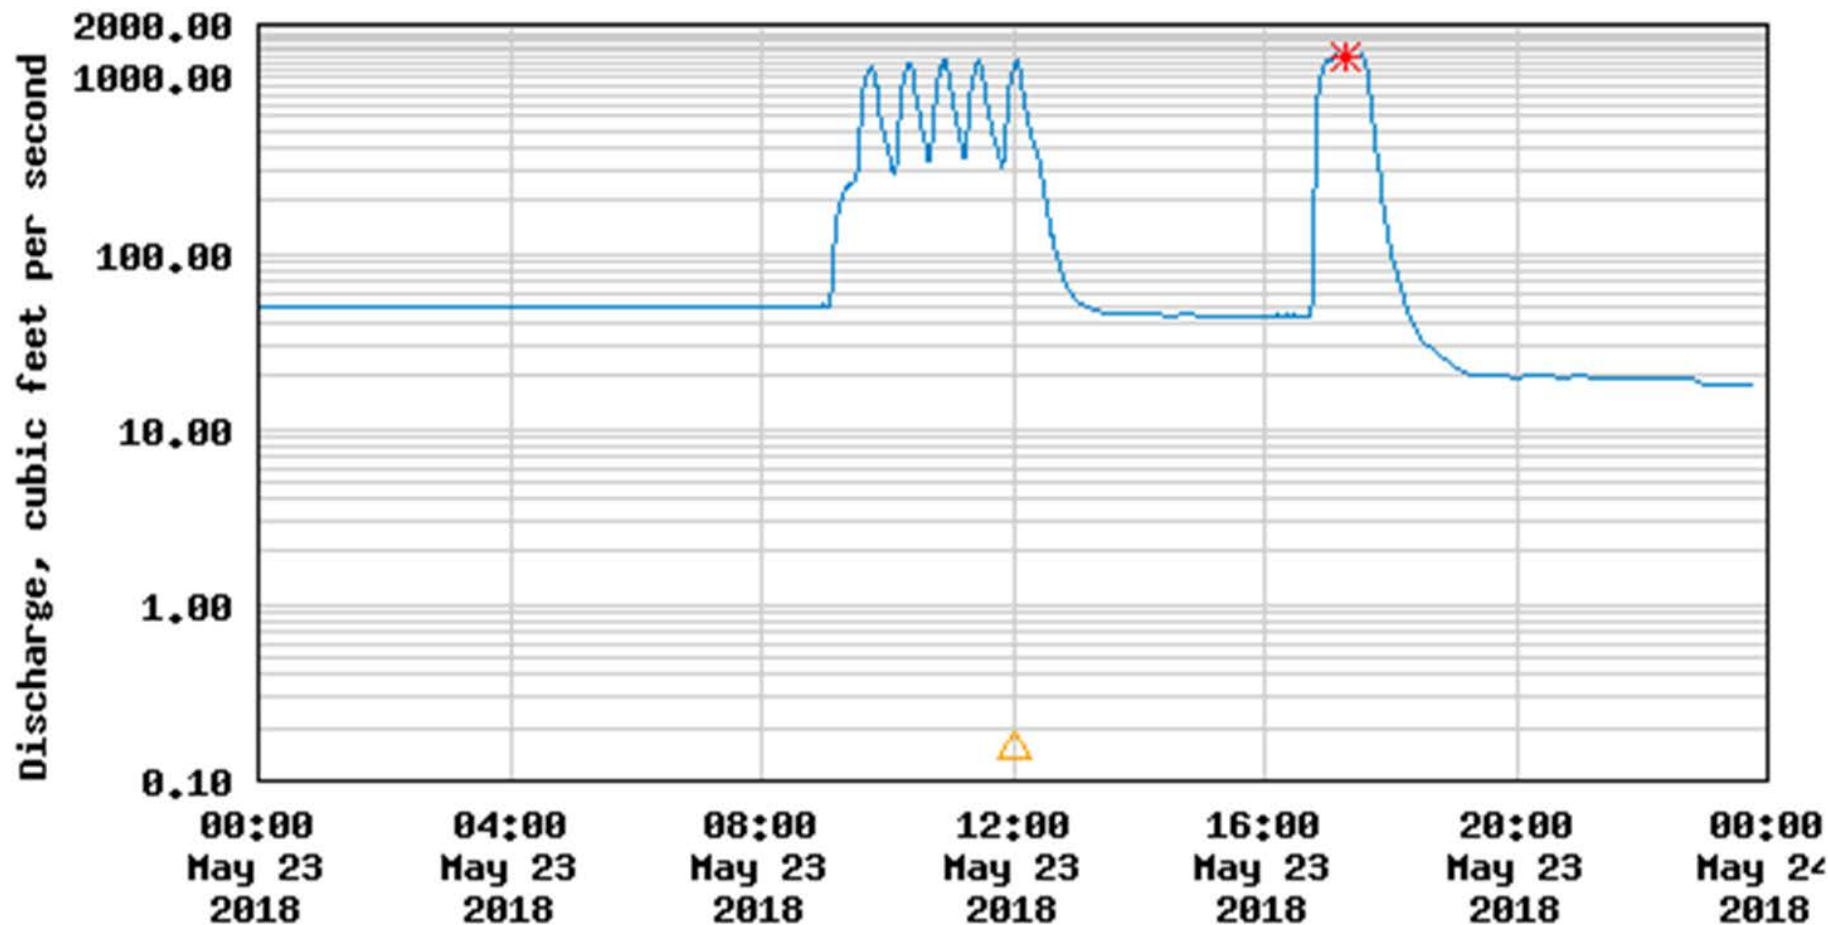
USGS 06713000 CHERRY CREEK BELOW CHERRY CREEK LAKE, CO

Cherry Creek Flush: Flow Rate

△ Median daily statistic (58 years) * Measured discharge
— Discharge

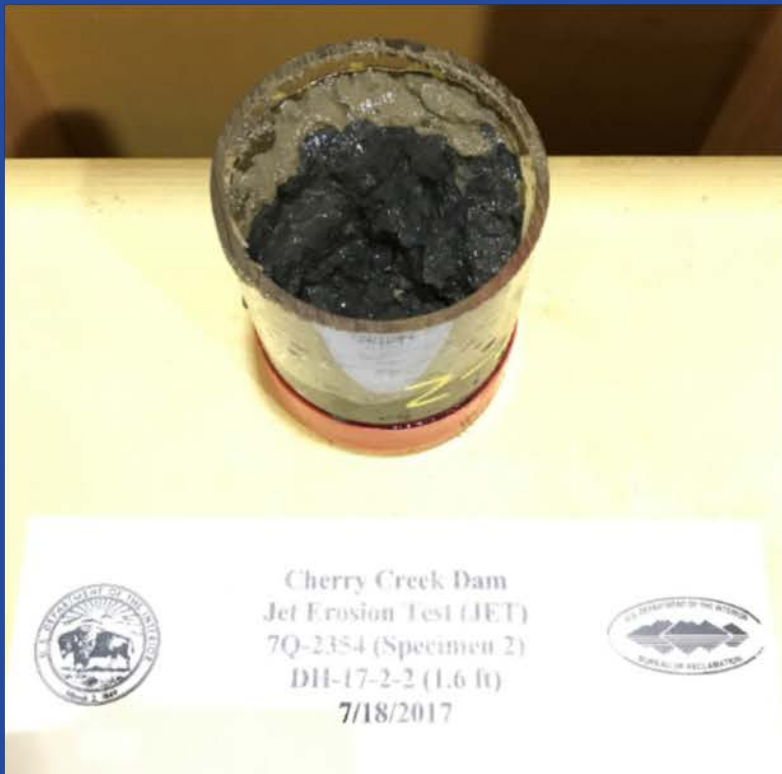
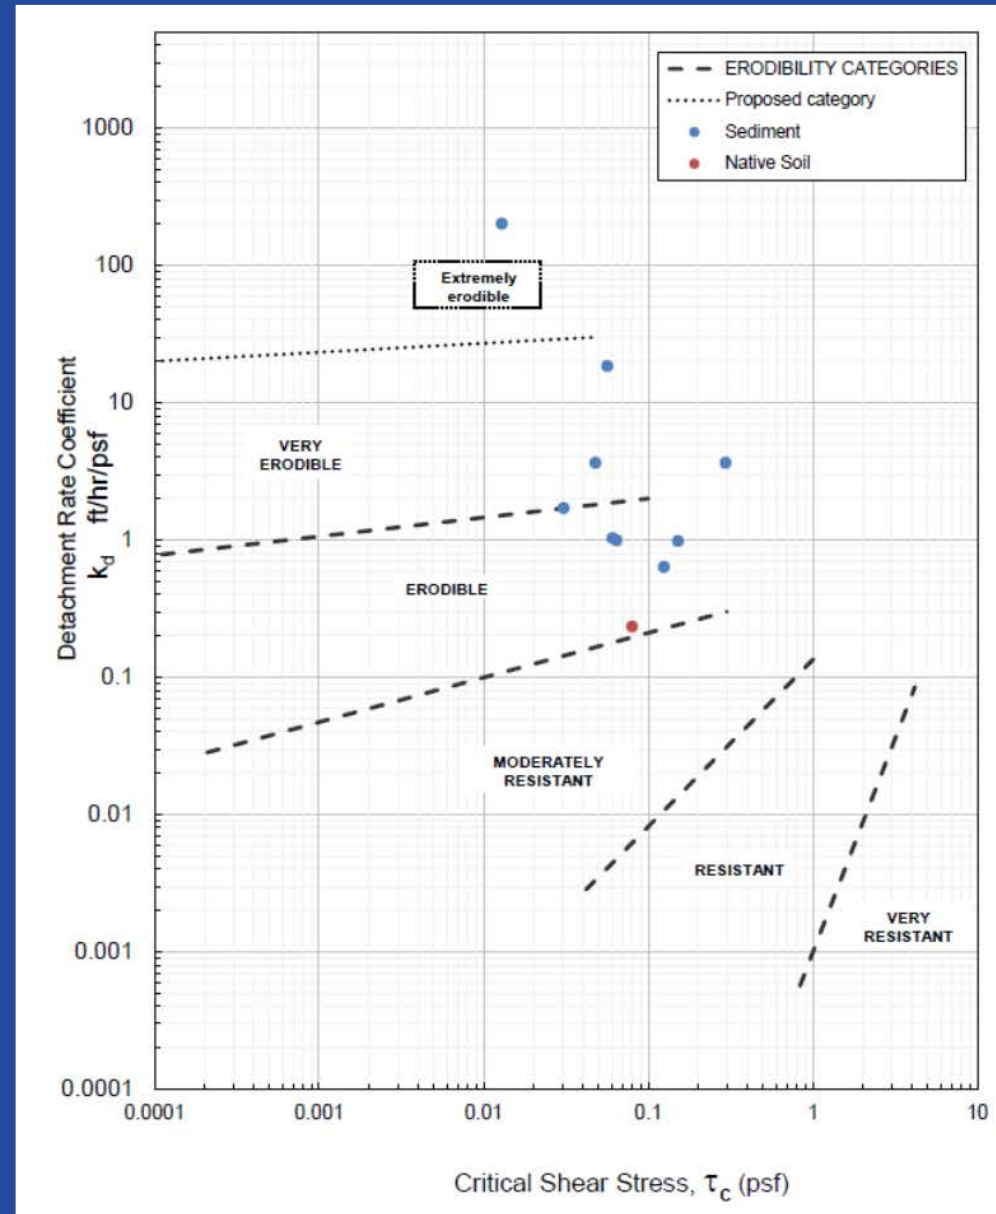
Cherry Creek Flush: Reservoir Sediment

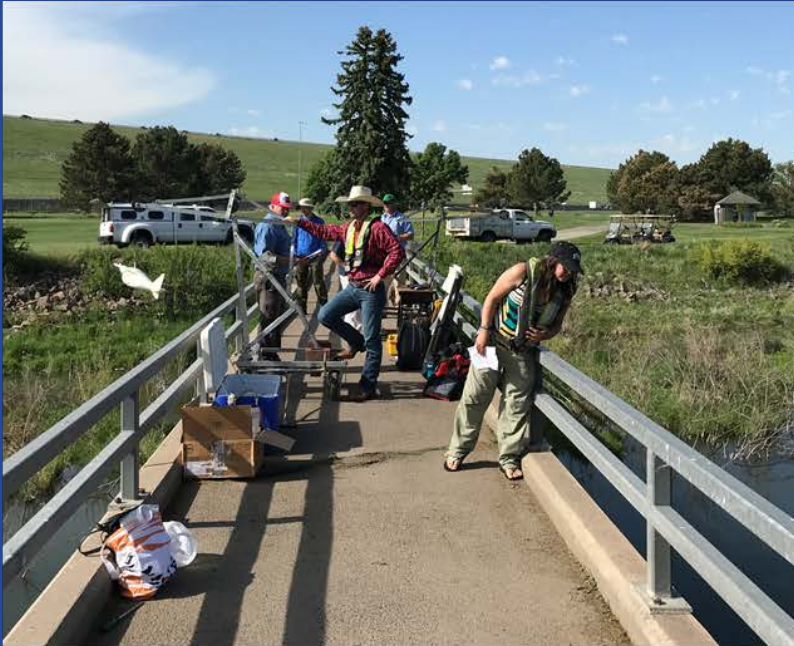
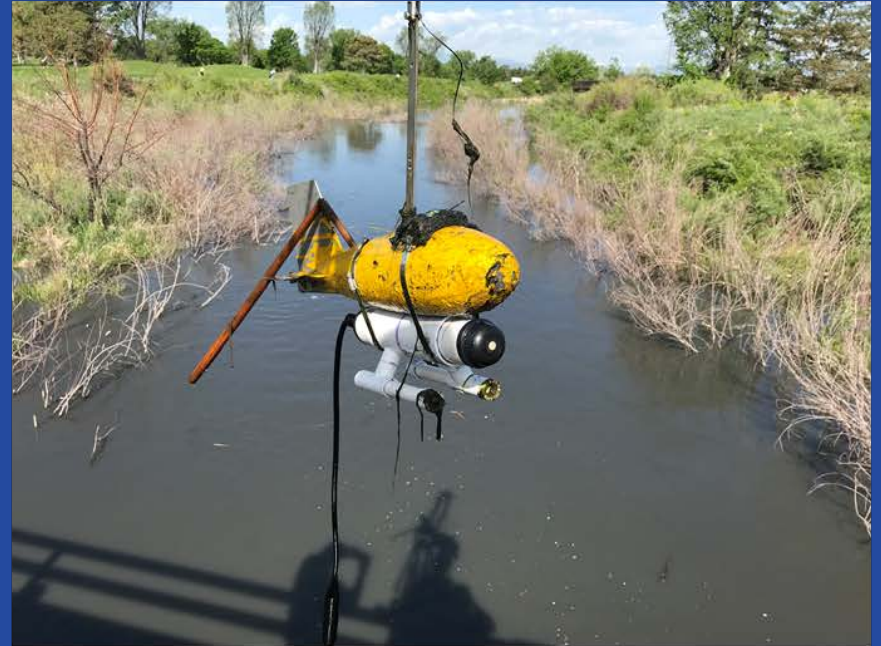
Suspended Sediment Concentration

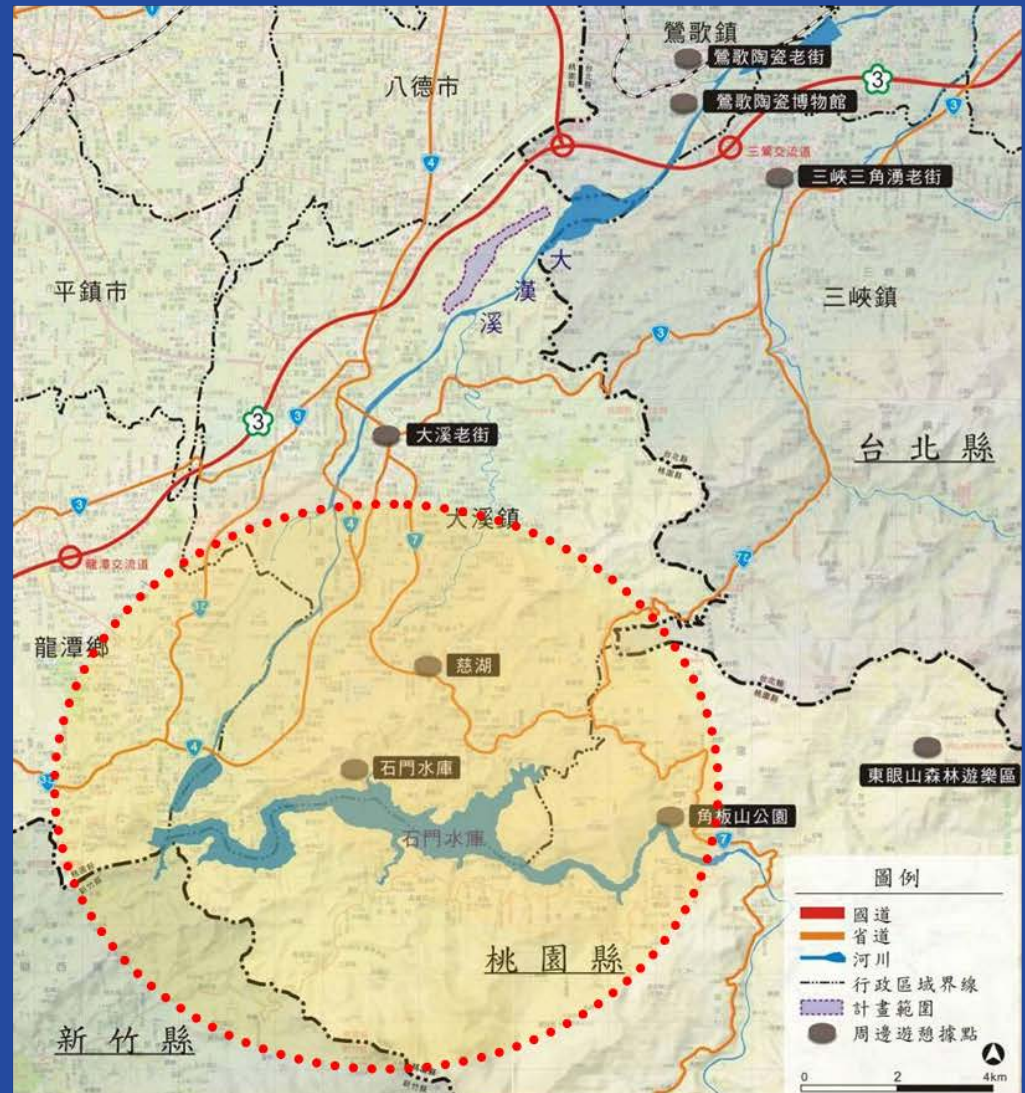
Shihmen Reservoir

- **Height:** 133 m
- **Length:** 360 m
- **Storage (Design):** 309 million-m³ at 245m Max EL
 - 252 m-m³ Effective

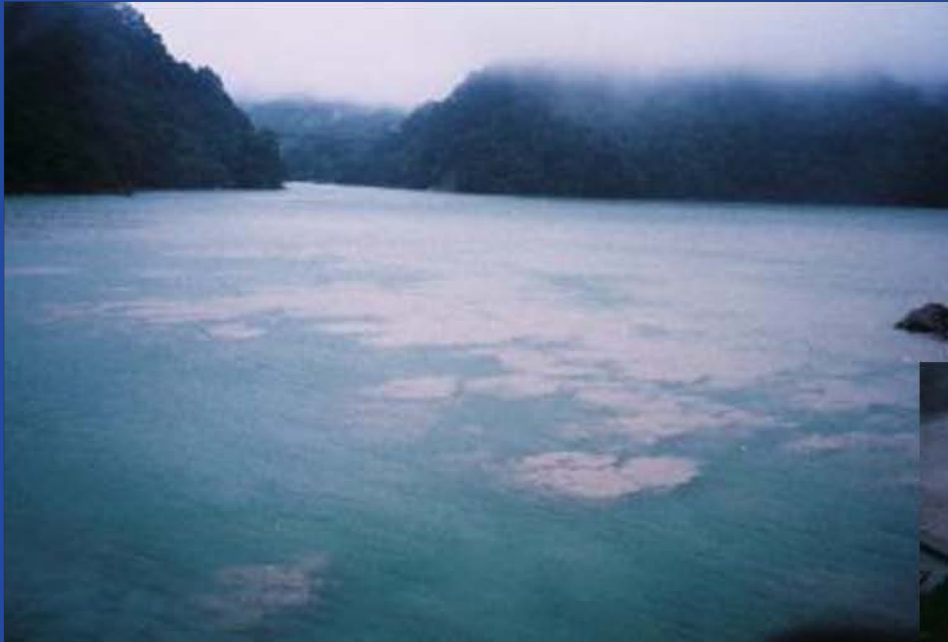
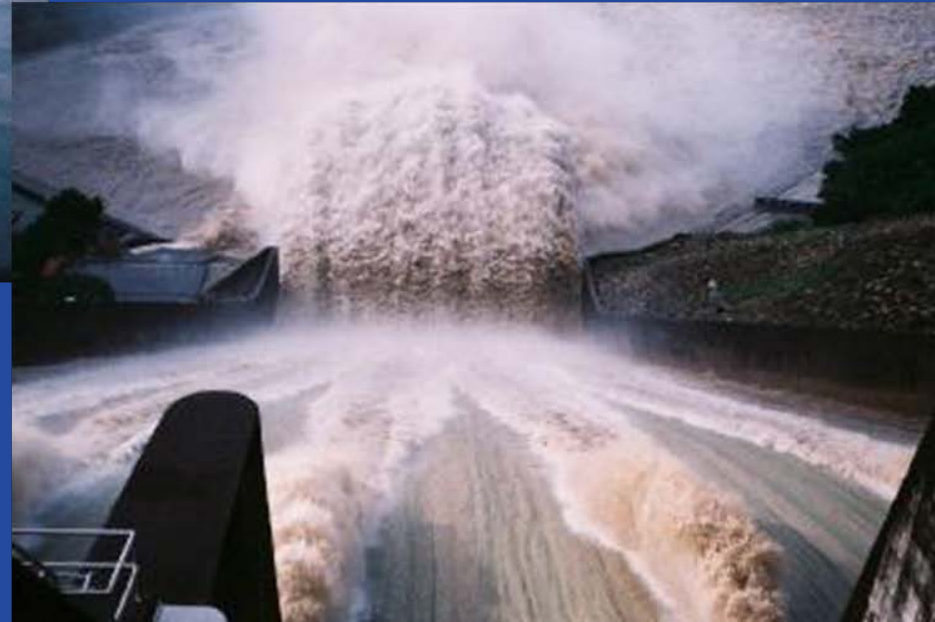
During Typhoon

Large amount of sediments enters reservoir during large storm

- Photo: during typhoon 海棠 (July 2005)

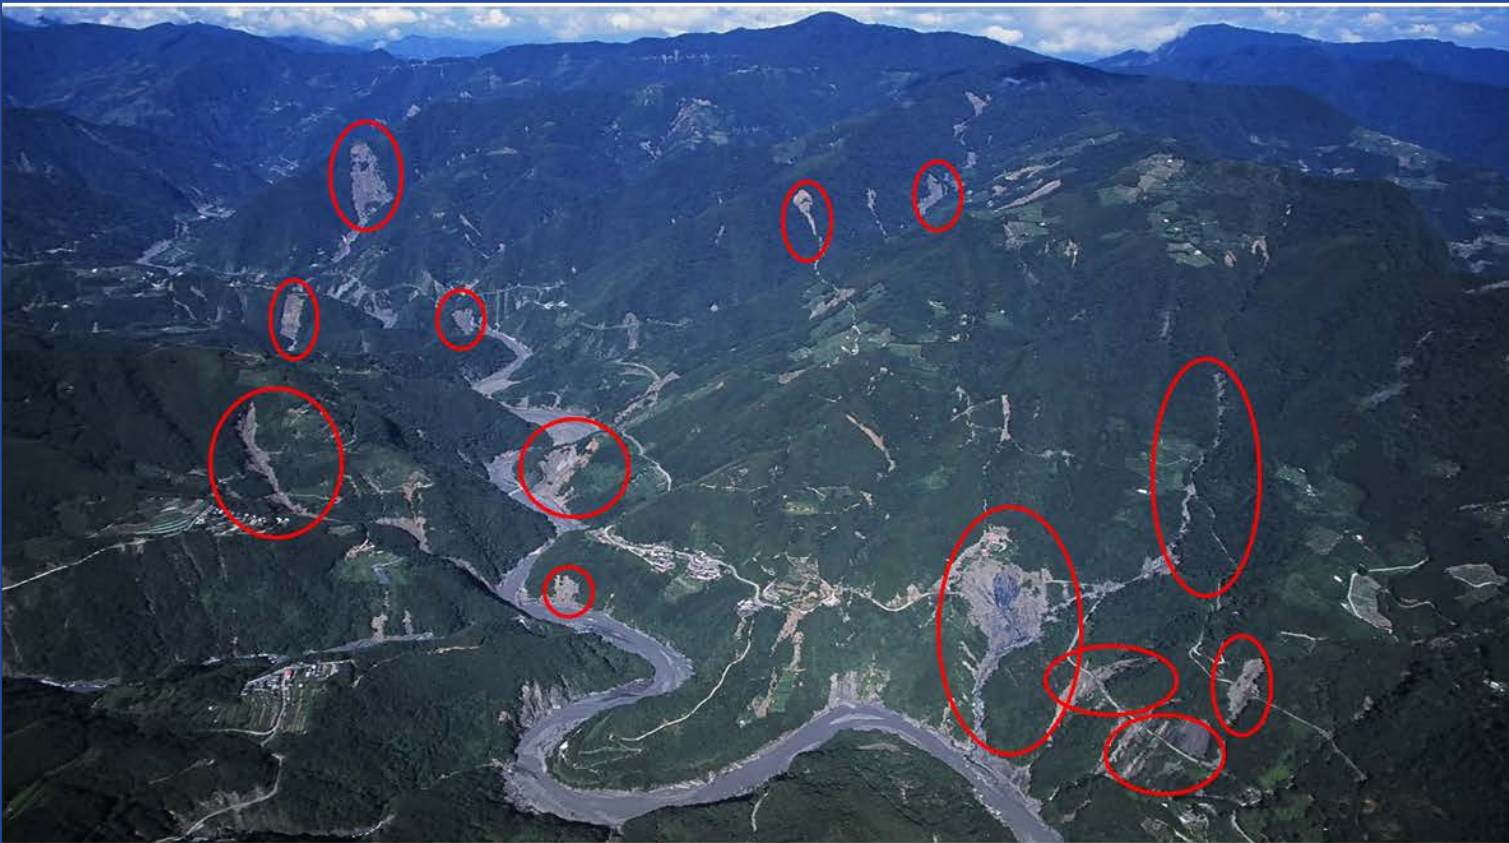
Typhoon Aere

- **Time:** August 23-26, 2004 **Rainfall:** 973 mm
- **Peak Discharge:** 8,594 cms **Deposit:** 27.9 mill-m³
- **Reservoir Capacity Loss:** 11%
- **SSC > 100 g/L** for 3 weeks
- **Water supply stopped for 17 days**

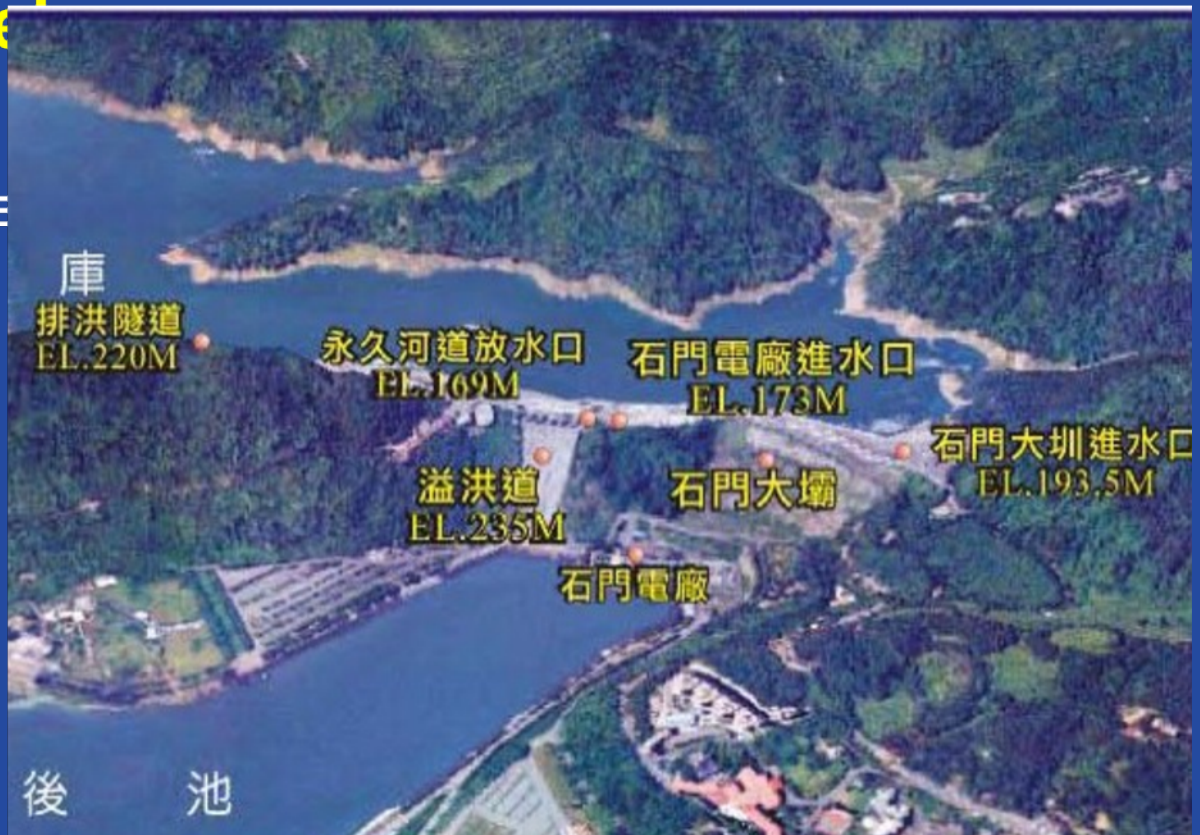
Existing Outlet Modifications

- One of the two intakes (#2) is dedicated for sluicing
- 300 cms capacity; 171 m EL

- Up to 31.5 cms; 169.5 m EL (rarely used before)

- 2,400 cms capacity
- 220 m EL
- Under Study: 190 m EL

- 11,400 cms capacity
- 235m EL

- 193 m EL & Up

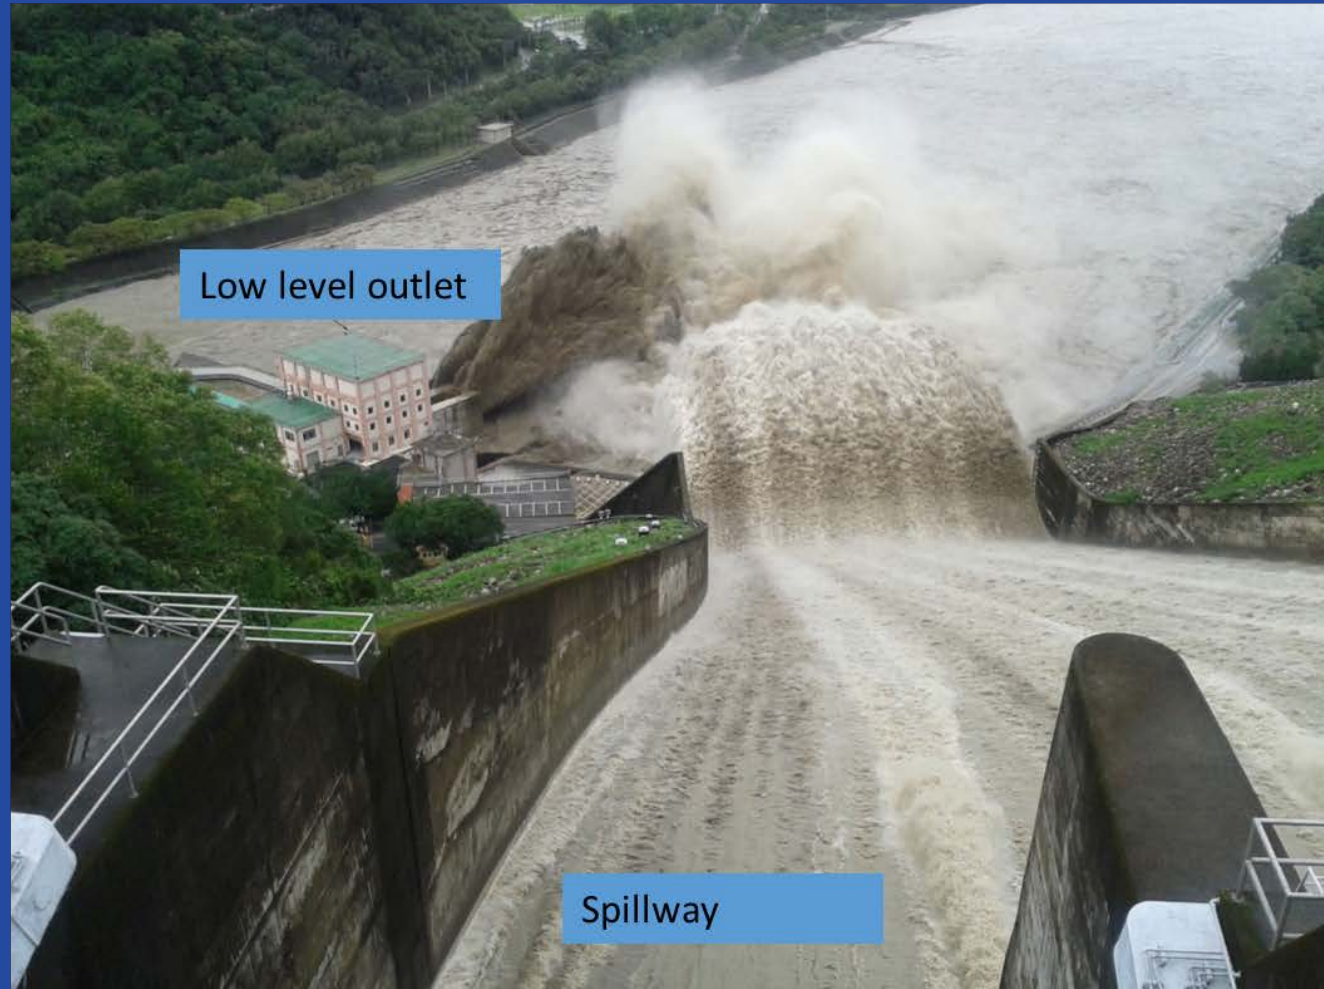
Sediment Pass through with Turbidity Currents

Shihmen Reservoir,
Taiwan

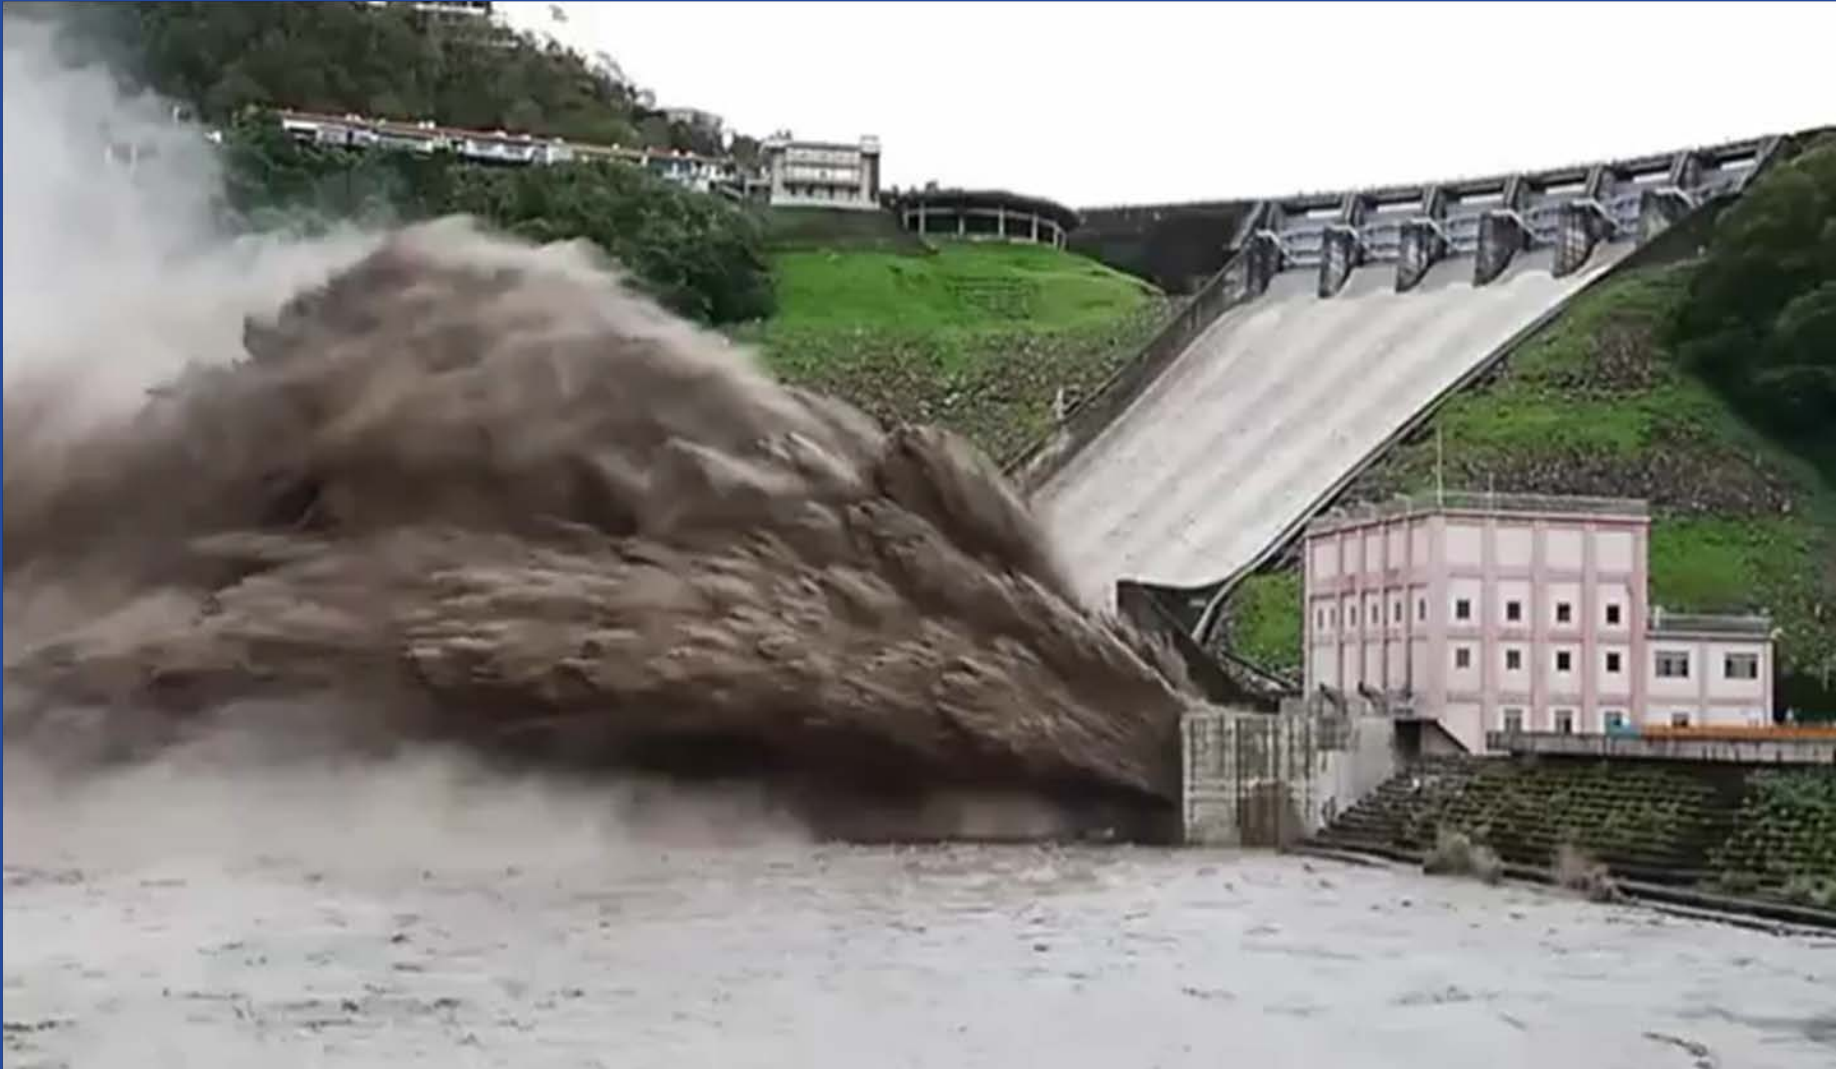
Flushing during spillway flow
