O&M REPORT
FOR Kahului Bay Prevention & Mitigation of Shore Damages
Honolulu Engineer District
CEPOH-EC-T

1. Project Name: Kahului Bay Prevention & Mitigation of Shore Damages
2. Date of Inspection: October 14, 2010
3. Inspection Personnel:

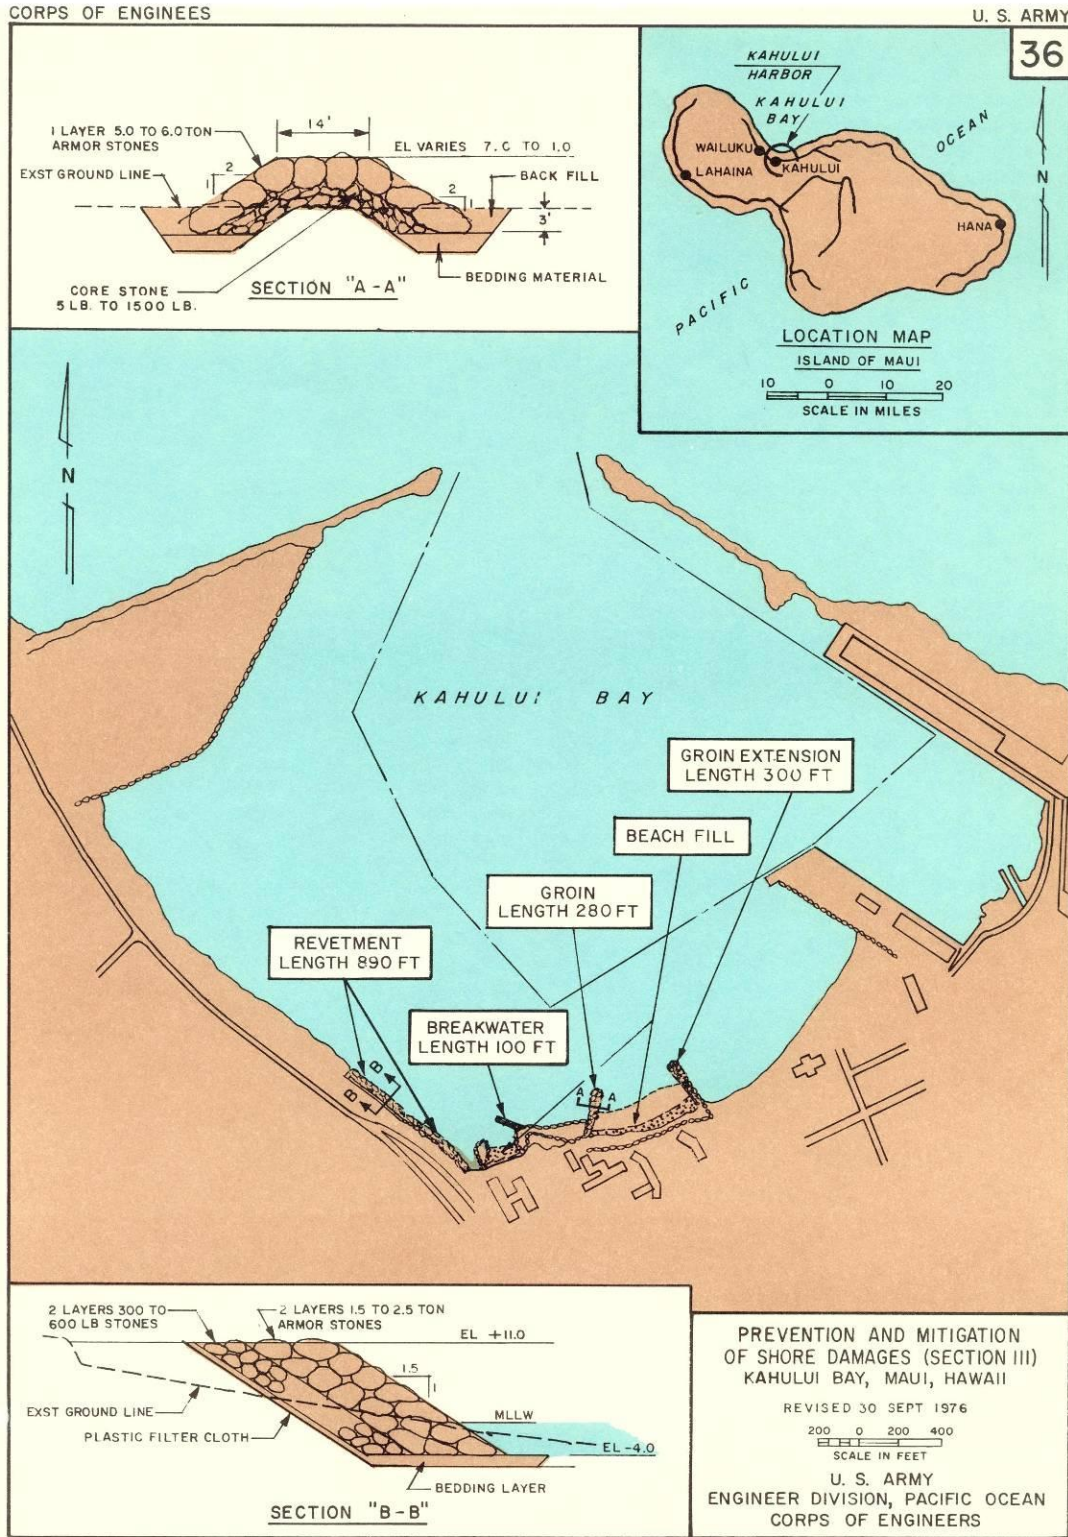
PREVENTION AND MITIGATION OF SHORE DAMAGES
KAHULUI BAY, MAUI, HAWAII

CONDITION OF IMPROVEMENT 30 SEPTEMBER 1989

EXISTING PROJECT: Authorized under Section 111 of the River and Harbor Act of 1968, Public Law 90-483. Provides for (a) rubblemound breakwaters on the east and west sides of the harbor, approximately 2,766 and 2,315 feet in length, respectively; (b) an entrance channel 600 feet wide between the breakwaters; and (c) a harbor basin 2,050 feet wide, 2,400 feet long, and 35 feet deep. The existing revetment located slightly west of the central section of the shoreline and adjacent to the road was initially constructed by the State in 1964, and later repaired by the State and County of Maui in 1966 and 1968.
