# Paonia Dam Outlet Works Repair

SPK-2016-00228

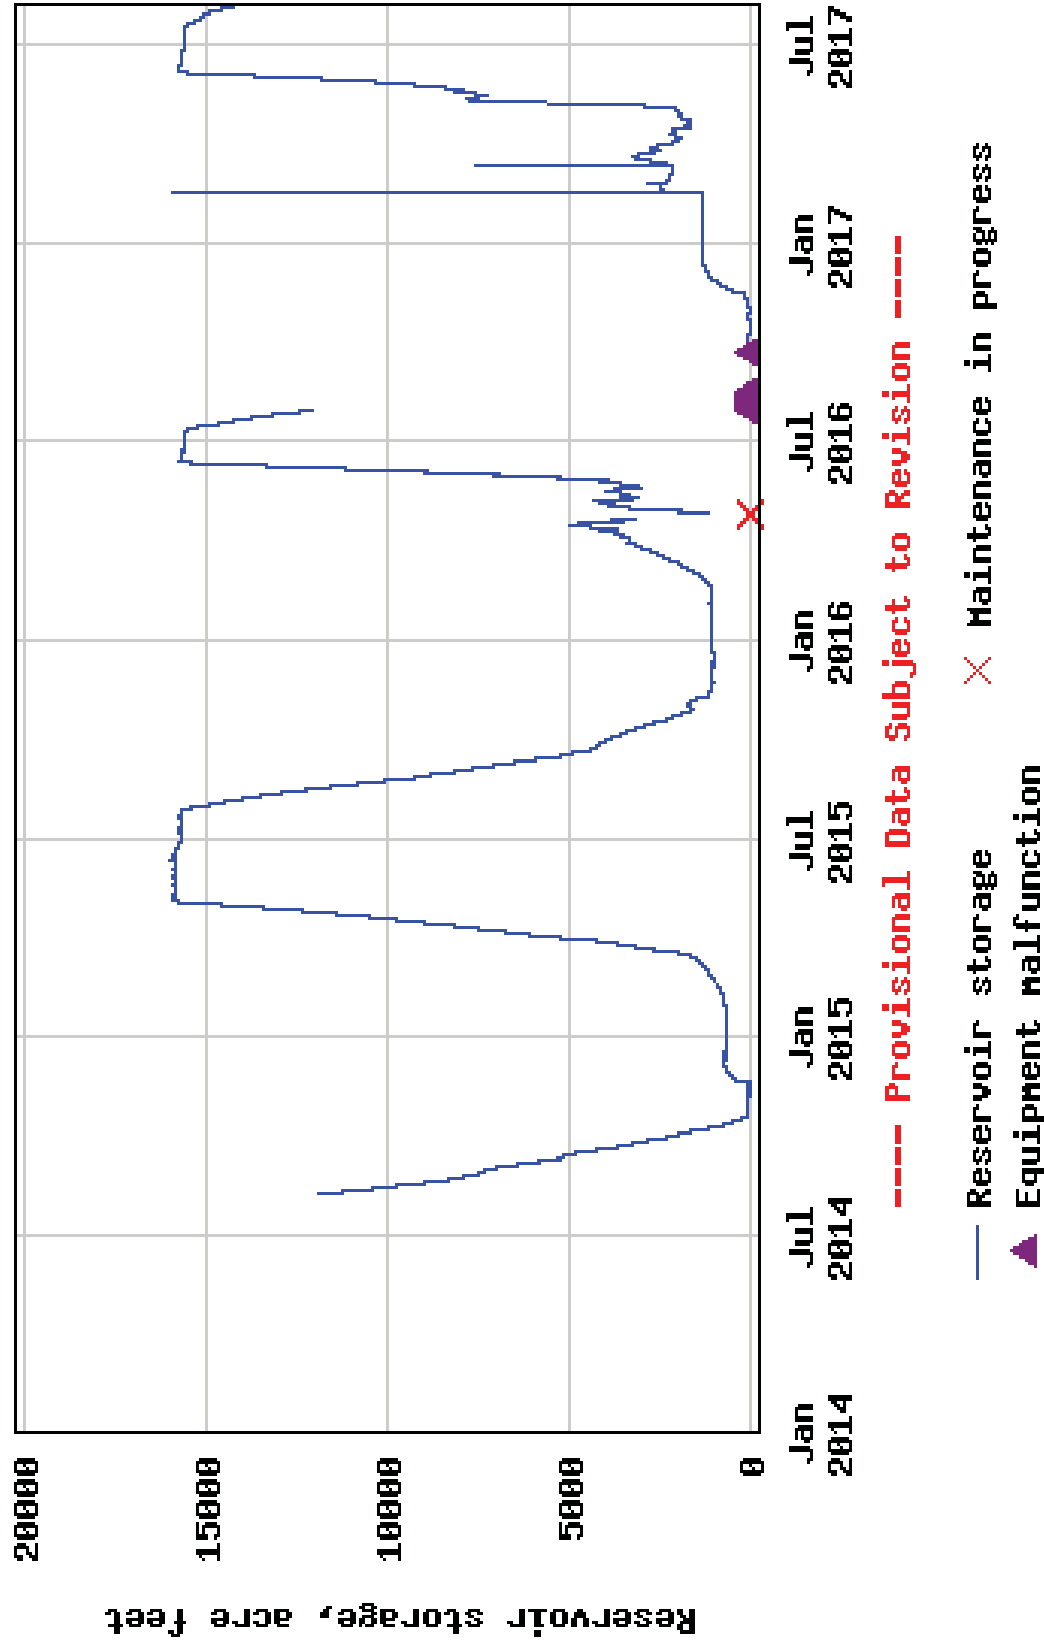
Figure 2. Paonia Reservoir storage level, 2014-present.

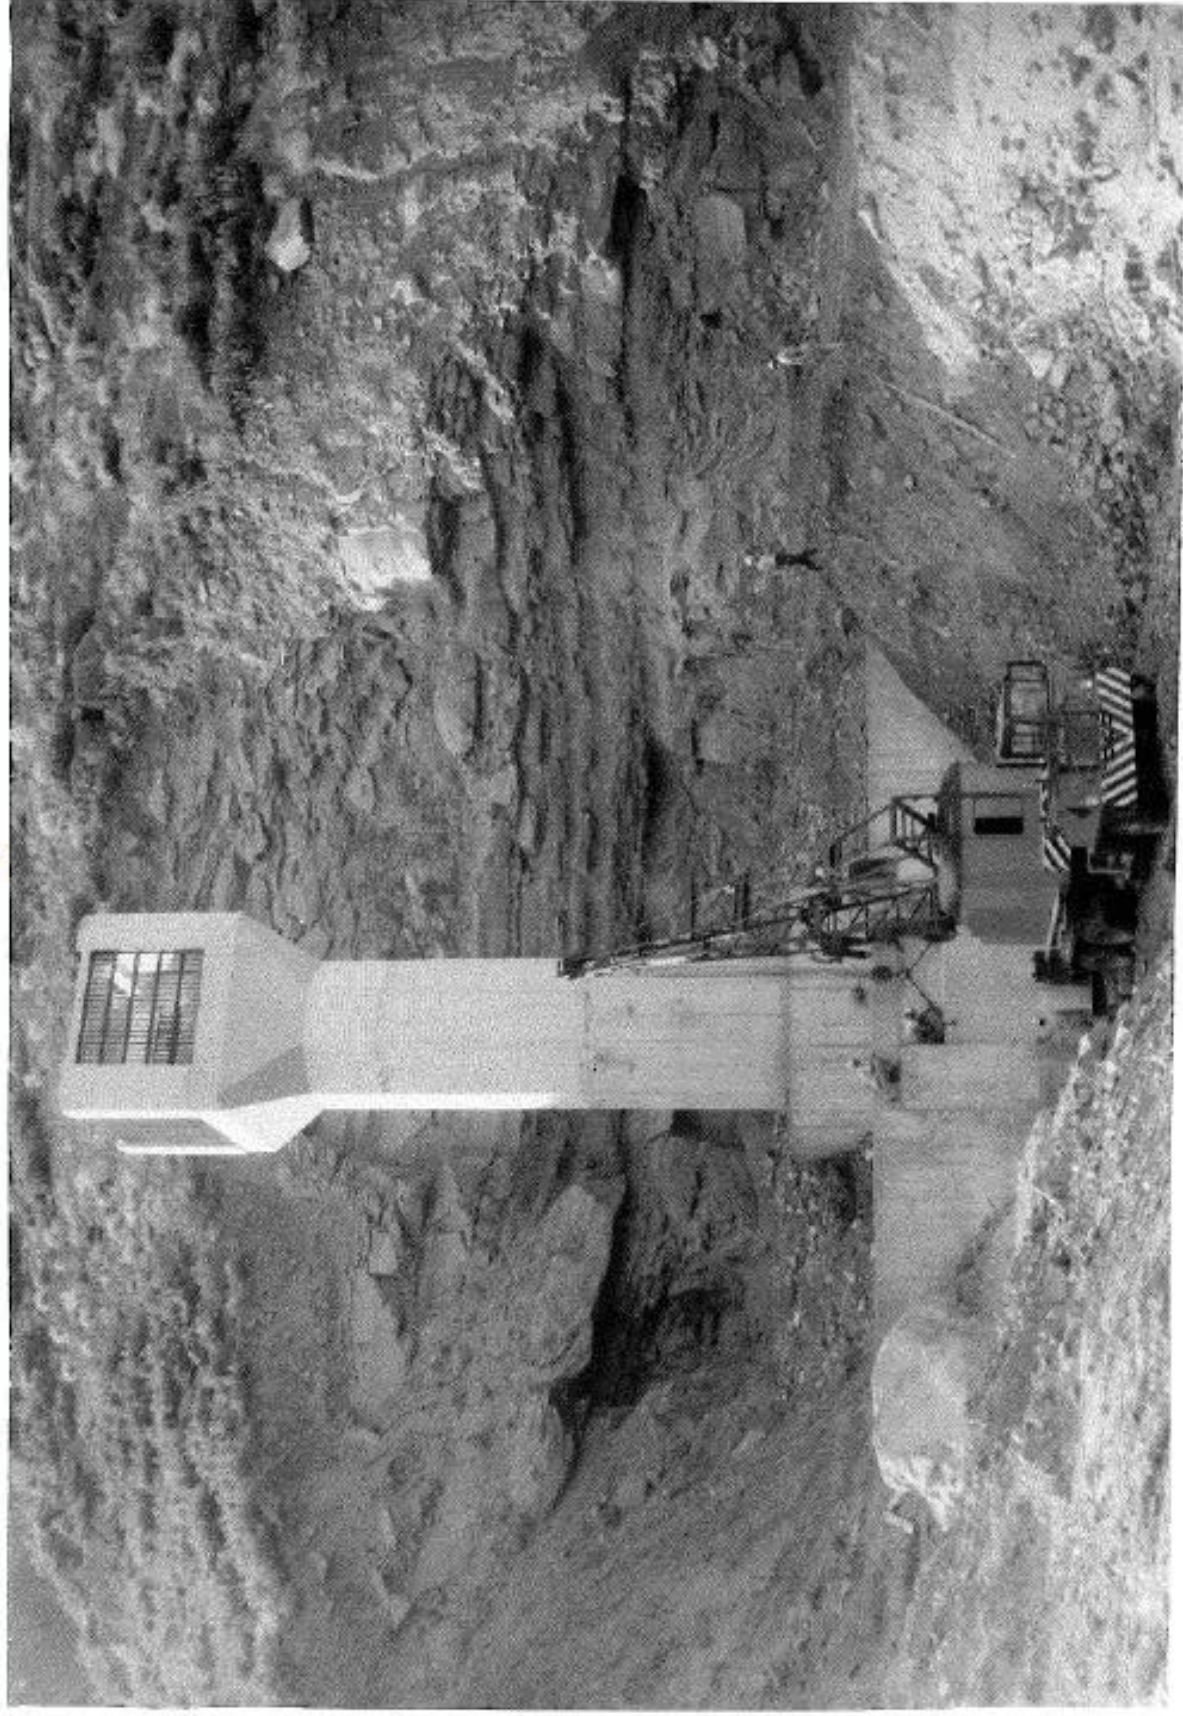
P551-417-2302 Paonia Dam--Paonia Project, Colorado. General view of outlet works intake structure as temporary irrigation bulkhead is being installed. Work by Bud King Construction Company, Specs. No. DC-5117. 7-11-61 Bureau of Reclamation photo by E. J. Peterson

**Figure 2.—Photo of the construction of the intake tower at Paonia Dam in 1961 (photo courtesy of Philip Ipson, Western Colorado Area Office).**
